Updates Regarding the Implementation of the Recommendations from the *2005 Little Wekiva Watershed Management Plan*

December 2021

Little Wekiva River

Geomorphic Observations and Sedimentation Analysis

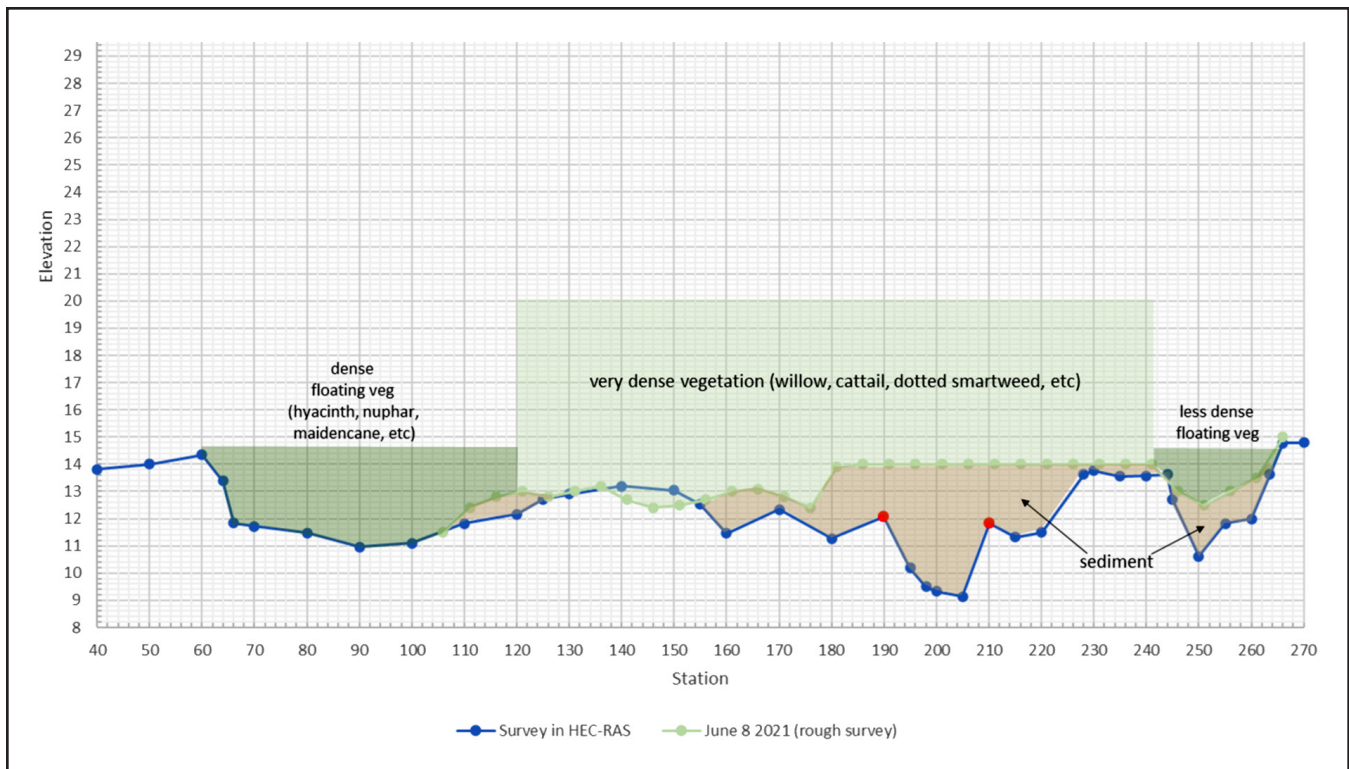
Figure A1-2. Sabal Point transect channel profile 2013 and 2021.

SJRWMD minimum flows and levels (MFL) field work corroborates these findings. Two transect sites north of S.R. 434 demonstrate sediment accumulation over time (Appendix A, Figure A1-1). The northern Sabal Point transect showed significant sediment accrual between 2013 and 2021 (Appendix A, Figure A1-2), which appeared to displace the main channel to the west from its historical footprint. However, historical imagery suggests that this area has potentially captured sediments in the past and can have dynamic channel migration (Appendix A, Figures A1-3 and A1-4). The southern Springs Landing Blvd. site also appeared to have net sediment accruals of 0.5–1.0 feet from 2017–2021 (Appendix A, Figure A1-5).

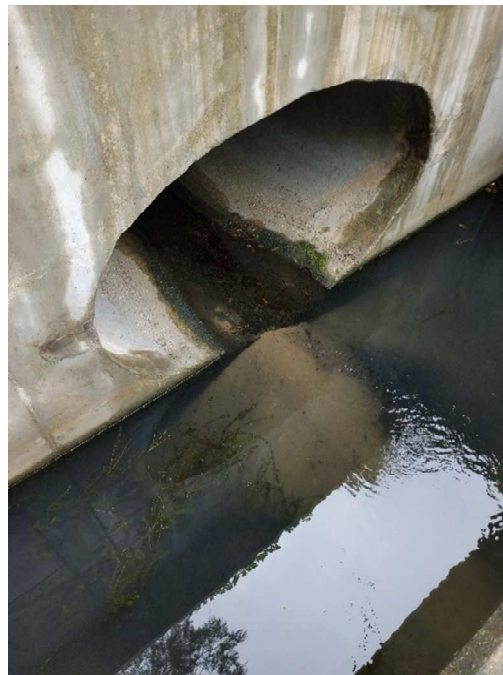
The outfall location consisted of a concrete storm water pipe discharging into a large stilling basin and sediment retention structure with a rundown that flows into a small tributary stream which then flows into the Little Wekiva River. This outfall is combined storm water discharge from multiple sources including the I-4 construction project stockpile area. At the time of the field visit there was some sediment accumulation in the stilling basin as shown in Figure 3. The stilling basin still had a lot of sediment capacity left at the time of the field visit though it was not known when the last time the basin was cleared out. Only clear water discharge from the structure was observed. No evidence of sedimentation was observed from the outfall of the sediment retention structure to its confluence with the Little Wekiva River.

Figure 3: Sediment accumulation in sedimentation basin located at the end of the outfall pipe from the I4 runoff.

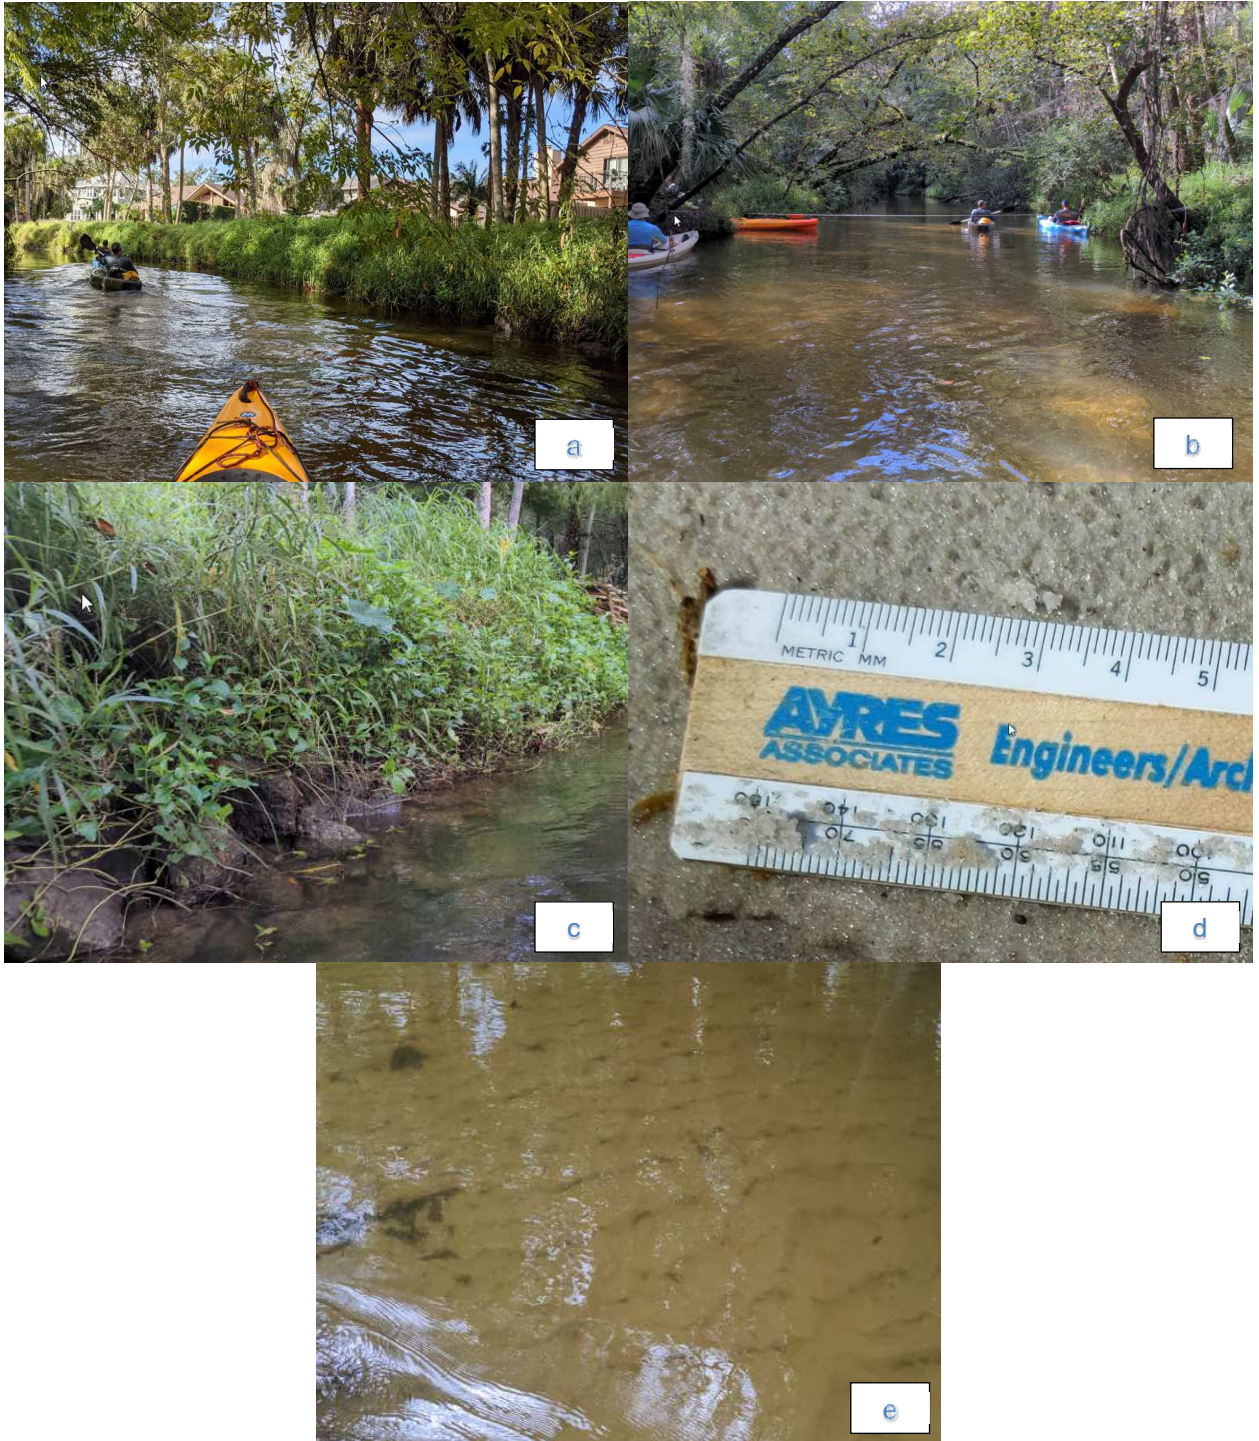
Reach 1 is located between the intersection of W State Road 434 and the outfall location as shown in Figure 2. The river is a perennial sand bed channel approximately 30 ft wide. The channel width is consistent and homogenous throughout the reach. The floodplain is suburban development with little to moderate riparian buffer zone. The floodplain vegetation along the reach varies from forested to grass lawns in some locations. There was evidence of vertical incision as seen by steep bank slopes shown in Figure 4a. Additionally, there was evidence of lateral channel migration as shown by leaning trees (Figure 4b) Riprap was also seen placed along some of the homeowner banks, most likely as a countermeasure to prevent further lateral migration (Figure 4c). A representative sediment sample size was captured in Figure 4d. The sediment is medium to fine grained sand. Bedforms are generally limited to ripple formations (Figure 4e), indicating primarily bedload transport. While minor sedimentation throughout the reach was witnessed, it was mainly concentrated along the insides of bends and localized low velocity areas.

Figure 4: (a) Tall and steep bank slopes; (b) Sign of lateral instability shown by leaning trees into channel; (c) Riprap placed along banks of channel; (d) Representative sediment size shown; (e) Ripple bedforms shown.

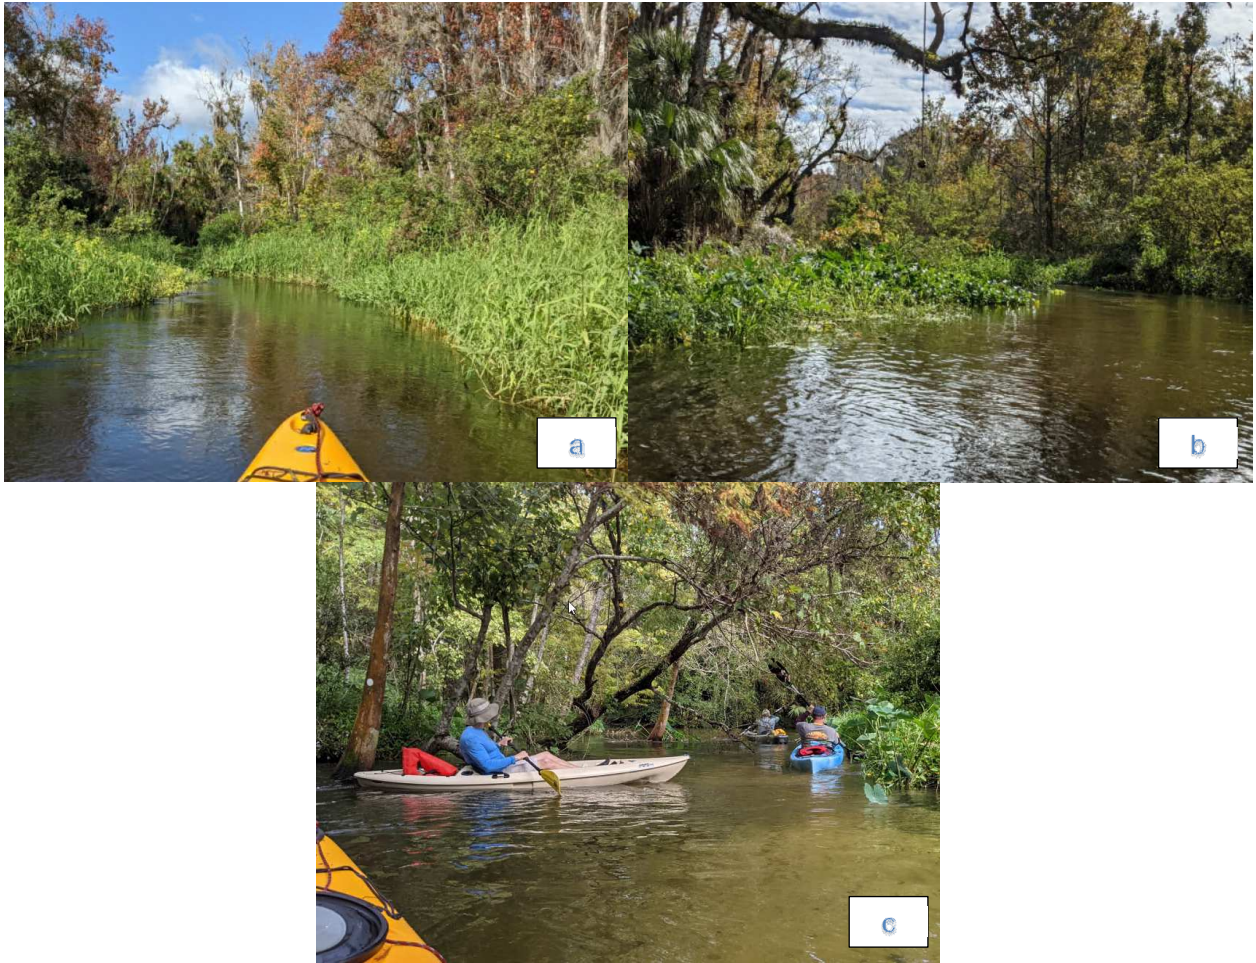
Reach 2 is located between the outfall location and the crossing of Springs Landing Boulevard as shown in Figure 2. The river here is sinuous with more variable bankfull width throughout the reach. The floodplains consist of suburban developments with a moderate riparian buffer zone. The floodplain vegetation along the reach varies from forested to grass and heavy shrubs, transitioning into wetland species with in-channel plant growth along the lower portions of the reach (Figure 5 a&b). No strong evidence of vertical incision was noted. As a result, the reach has more floodplain connectivity than reach 1. Lateral instabilities were noted in the form of downed and leaning trees throughout the reach (Figure 5c). Sediment size remains consistent with Reach 1, medium to fine grained sands, and was confirmed through a visual inspection. Bedforms continue to be dominated by ripple features like Reach 1. While minor sedimentation throughout the reach was witnessed, it was mainly concentrated along the insides of bends and localized low velocity areas.

Figure 5: (a,b) Wetland vegetation seen toward downstream portion of reach; (c) Sign of lateral instability shown by leaning trees into channel

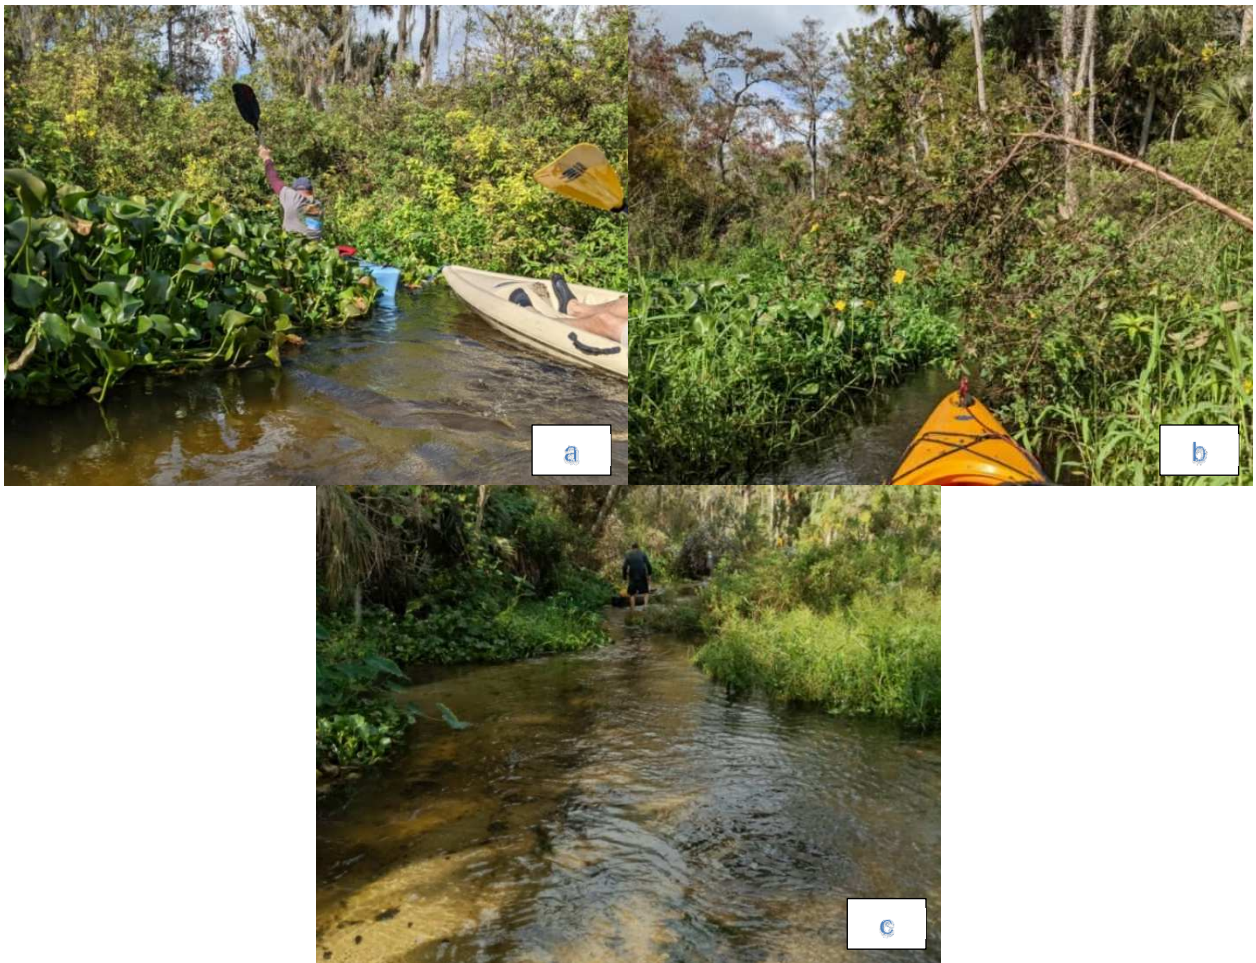
Reach 3 is located from the crossing of Springs Landing Boulevard to a point approximately 1 mile downstream as shown in Figure 2. The river here is sinuous with random variations in width. The floodplain land cover is a wide rural wetland with a large riparian buffer zone. There is little to no bankline visible through much of the reach either due to the presence of thick vegetation or very wide overland flow. The vegetation along the reach is forested with wetland type grasses and heavy shrubs. Numerous locations along the channel are completely blocked off due to aquatic vegetation (Figure 6a&b). These species consisted of multiple varieties (FDOT): water hyacinth (*eichhornia crassipes*); water lettuce (*pistia stratiotes*); salvinia (*salvinia rotundifolia*); para grass (*brachiaria mutica*), red ludwigia (*Ludwigia repens*), Peruvian water primrose (*ludwigia peruviana*). Many of these species are known invasives to Florida. There is no evidence of vertical incision throughout the reach. There was little evidence of lateral instabilities, though through a majority of reach it is believed that a large amount of flow is being conveyed through the wetlands adjacent to the channel. From a visual inspection, the sediment present was also consistent with the other reaches, medium to fine grained sand. In the lower portions of the reach the sand was topped with a layer of mud indicating a further reduction in sediment transport capacity. Ripple bedforms were present in the upper portion of the reach, however towards the lower, more vegetated sections, the bed was plane form indicating little to no transport capacity and flow velocity (Figure 6c). The lower portions of the reach have heavy sedimentation issues as evidence of the very shallow flow and sand choked channels.

Figure 6: (a,b) Thick in channel vegetation shown; (c) Shallow, slow flow shown with no bedforms present

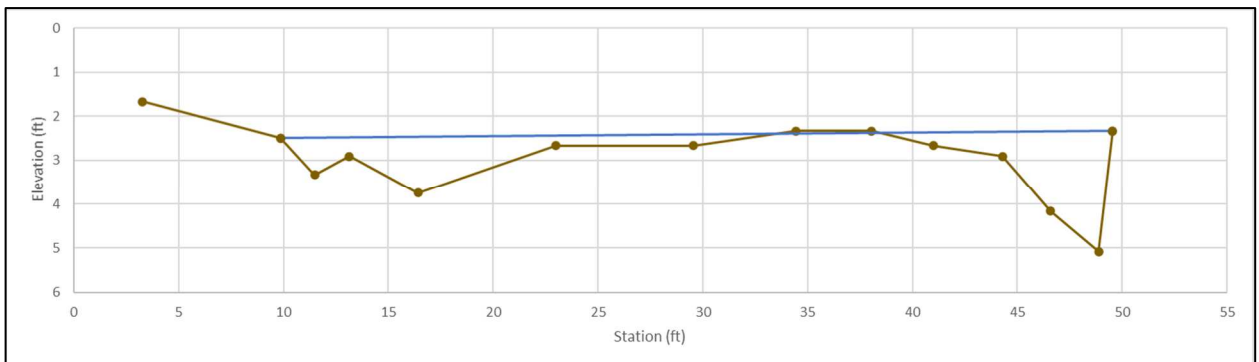
Figure 11: XS 4 plotted, the brown line represents ground points, the blue line represents the water surface.

Cross sections 1, 2, and 3 showed similar width to depth ratios and were all in the range of 12-20 which can all be classified as moderate (NEH, 2007). XS 4 width to depth ratio exceeded 60 which can be classified as very high. The entrenchment ratio, which is the measure of how vertically contained a river is (NEH, 2007), was the lowest at XS 1. XS 1, 2, and 3 entrenchment ratios can all be classified as slightly entrenched. XS 4 is not entrenched, and the entrenchment ratio value suggests a multiple thread channel. Surface velocities were virtually identical for XS 1, 2, and 3. The velocity at XS 4 was considerably slower at 0.3 ft/s.
