ASSESSMENT OF EFFECTS OF GROUNDWATER WITHDRAWALS ON GROUNDWATER-DOMINATED WETLANDS IN THE CENTRAL FLORIDA WATER INITIATIVE PLANNING AREA

Central Florida Water Initiative's Environmental Measures
Working Group

January 2025

FINAL REPORT APPENDICES

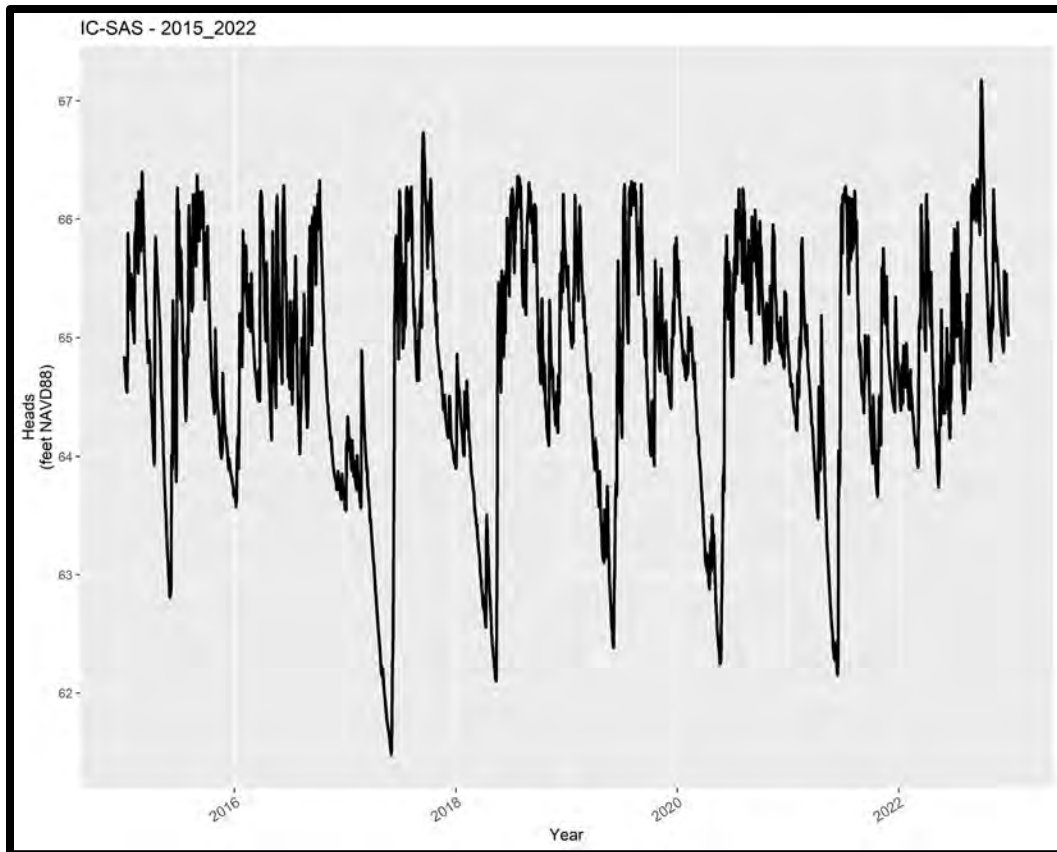
Figure B-4. Selected period-of-record (2015-2022) water level data for Intercession City (DMIT-35).

This wetland is included in the Data, Monitoring, and Investigations Team (DMIT) long-term wetlands monitoring program, and monitoring transects were established in 2018. The 5-year monitoring event was conducted in 2023. The site was assessed in 2023 by conducting pedestrian transects throughout the entire system and was determined to be Not Stressed. It was also determined to be Not Stressed for the analysis conducted in support of the 2020 CFWI RWSP.

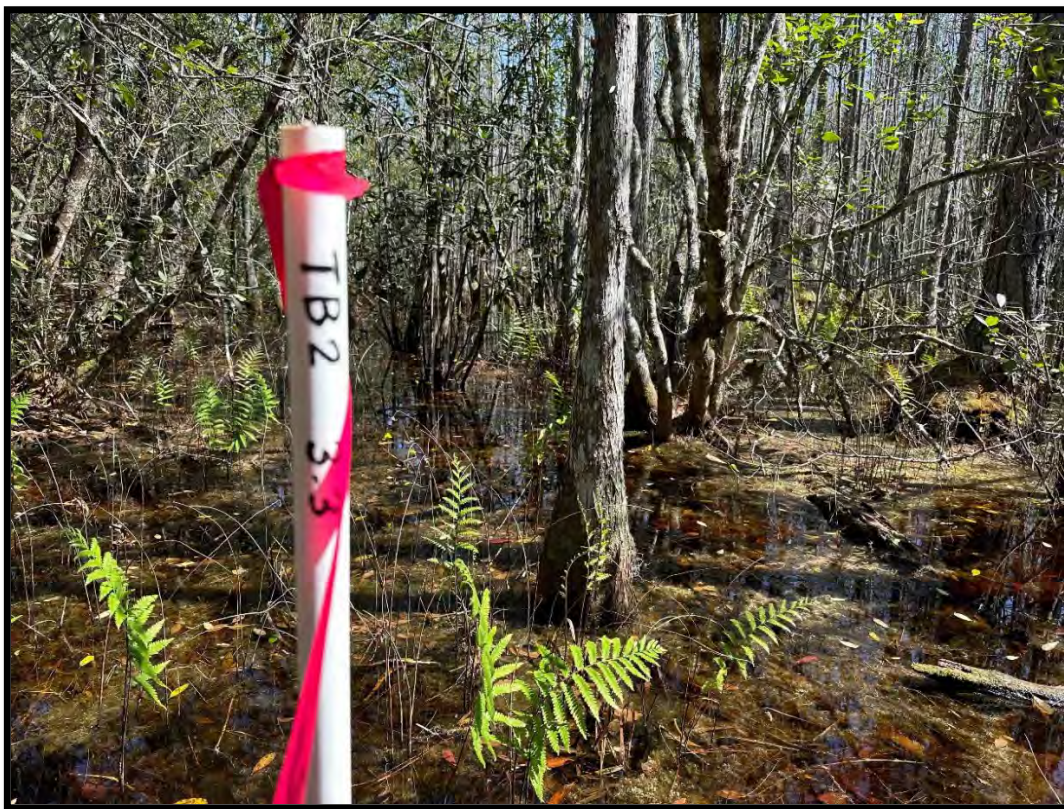
Figure B-7. Tibet Butler (DMIT-131), February 2023.

Tibet Butler is a Plains wetland that is a small cypress dome located within the Tibet-Butler Preserve (**Figures B-5 and B-6**). This cypress wetland is an established DMIT long-term wetlands monitoring program site. Monitoring transects were setup in 2018, and the 5-year monitoring event was conducted in 2023.

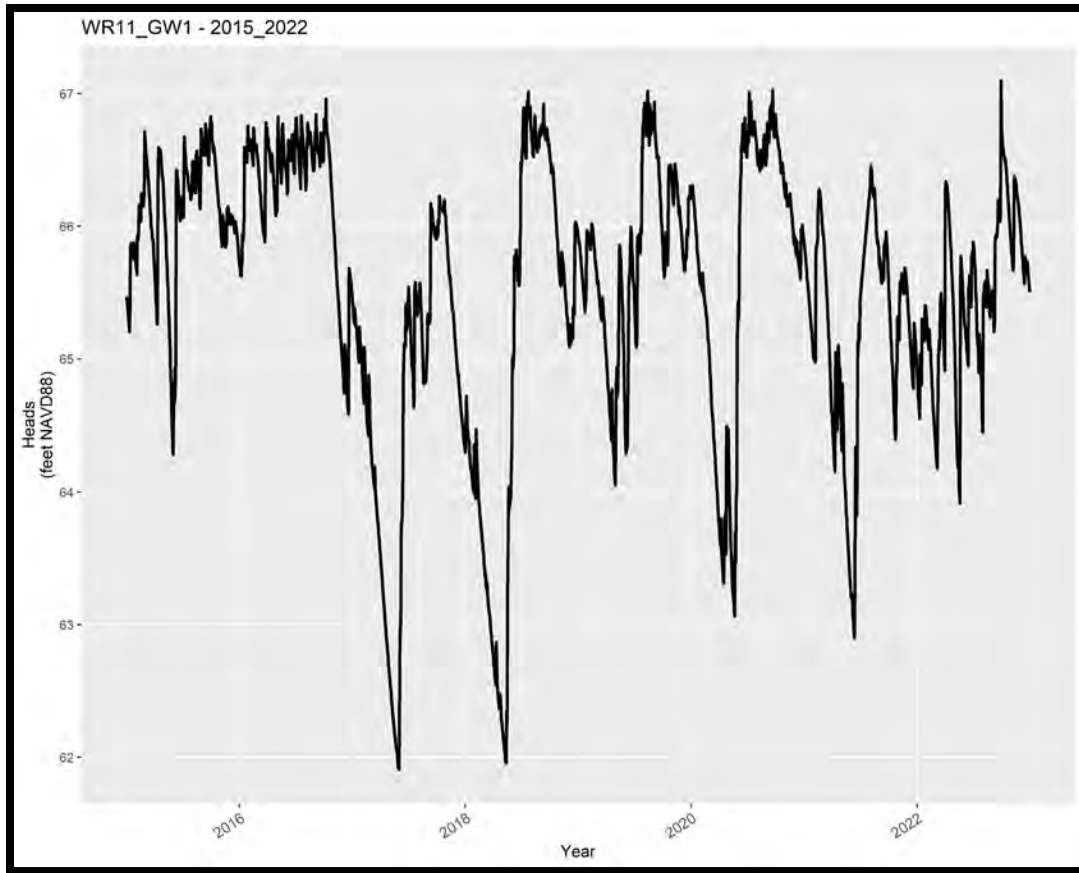
Figure B-12. Selected period-of-record (2015-2022) water level data for Walker Ranch – WR11 (DMIT-190).

Monitoring of this wetland system is conducted by the SFWMD as part of their regional hydrologic monitoring network (**Figure B-12**). The evaluation included pedestrian transects throughout the entire system. This wetland is included in the DMIT long-term wetlands monitoring program. Monitoring transects were established in 2019, and the 5-year DMIT monitoring event was conducted in 2024.

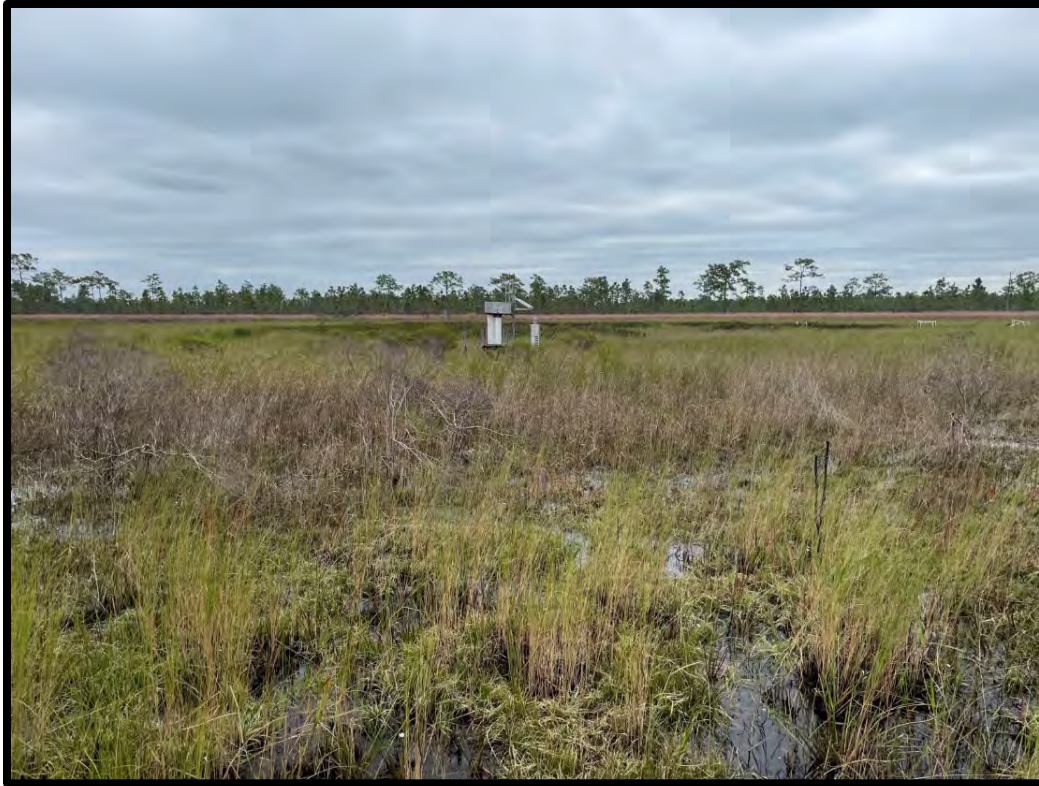
Figure B-13. View of center of Walker Ranch – WR9 (DMIT-191), November 2023.

Walker Ranch – WR9 is a Plains wetland that is included in the DMIT long-term wetlands monitoring program. Monitoring transects were established in 2019, and the 5-year DMIT monitoring event was conducted in 2024. This system is located within the Disney Wilderness Preserve, which is owned and maintained by TNC (**Figures B-13, B-14, and B-15**).

Observations of stress made in November 2023 by conducting pedestrian transects throughout the entire wetland were consistent with previous assessments, and the marsh was determined to be Not Stressed. The adjacent pine flatwoods is maintained in its native state through the use of frequent prescribed burns. Monitoring of this wetland system is conducted by the SFWMD as part of their regional hydrologic monitoring network (**Figure B-16**).

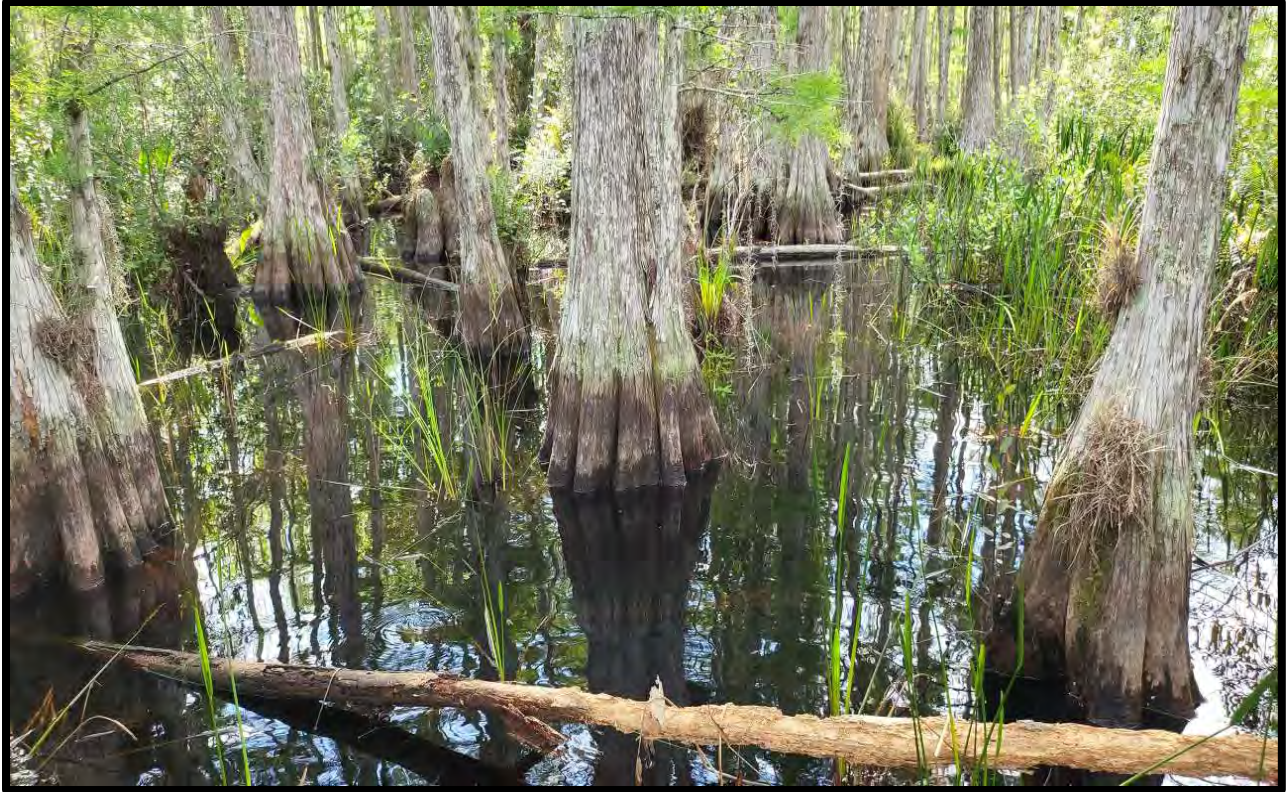
Figure B-18. Tree fall on northern portion of Split Oak (SF-WT), February 2023.

This Plains wetland was assessed in February 2023, and it was determined to be Stressed. It was determined by the SFWMD to be Not Stressed in 2008; however, an assessment of the site in May 2018 during the annual compliance review for the STOPR monitoring sites indicated that the site was Stressed. Indicators of hydrologic stress observed in the system include leaning trees, rotting cypress knees, tree fall, the presence of soil fissures within central portion of the cypress dome, exposed tree roots, and evidence of oxidation of the muck layer of the soil (**Figures B-18 and B-19**). It should be noted that new indicators of stress were not found in the 2023 assessment, and water levels were extremely low from 2017 through 2021 (**Figure B-20**). Access to this site is off Clapp Simms Duda Road (**Figure B-17**).

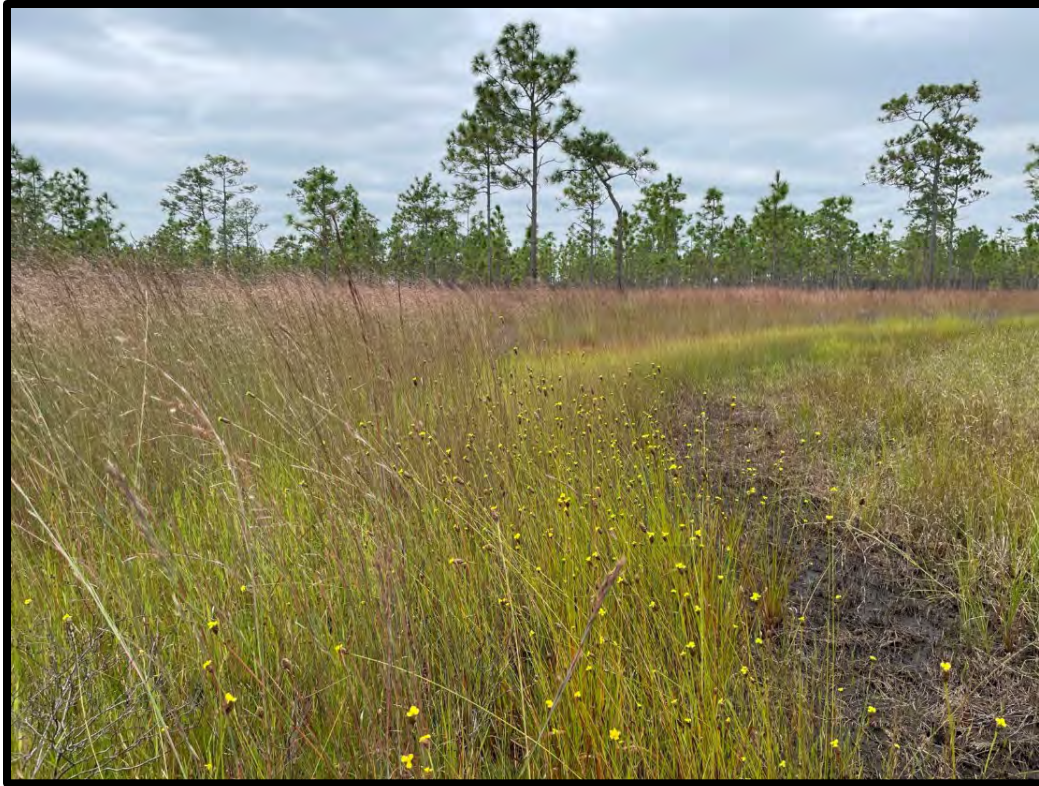
Figure B-23. Near wetland boundary of Walker Ranch – WR6 (SF-XX), November 2023.

Walker Ranch – WR6 is a Plains wetland that is located within the Disney Wilderness Preserve, which is owned and maintained by TNC (**Figures B-21, B-22, B-23, and B-24**). Observations of stress made in November 2023 were consistent with those made in the prior evaluations; the marsh was determined to be Not Stressed.

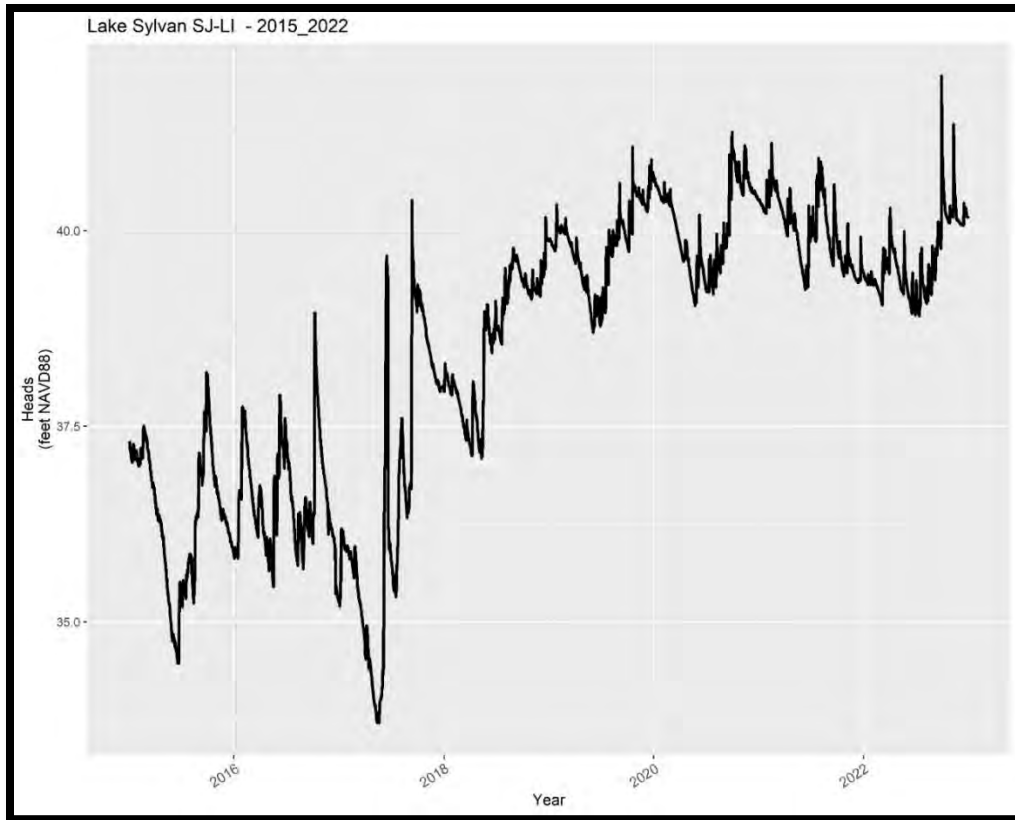
Figure B-27. Selected period-of-record (2015-2022) water level data for Lake Sylvan (DMIT-59).

Although recent water levels have been much higher compared to past levels (**Figure B-27**), the assessment conducted in support of the analysis conducted for the 2025 CFWI RWSP determined that the lake was Stressed. Since the lake was determined to be Not Stressed during the evaluation conducted for the 2015 CFWI RWSP analysis, the lake has been visited multiple times. Monitoring of this wetland system is conducted by Seminole County as part of the wetland monitoring program established by their Consumptive Use Permit. Indicators of hydrologic stress observed during low water periods within the system include the presence of soil fissures within exposed lower reaches of marsh areas, encroachment of pines and invasive species into the wetland areas, exposed tree roots, and the absence of regeneration of wetland tree species along the wetland boundaries (**Figure B-28**).

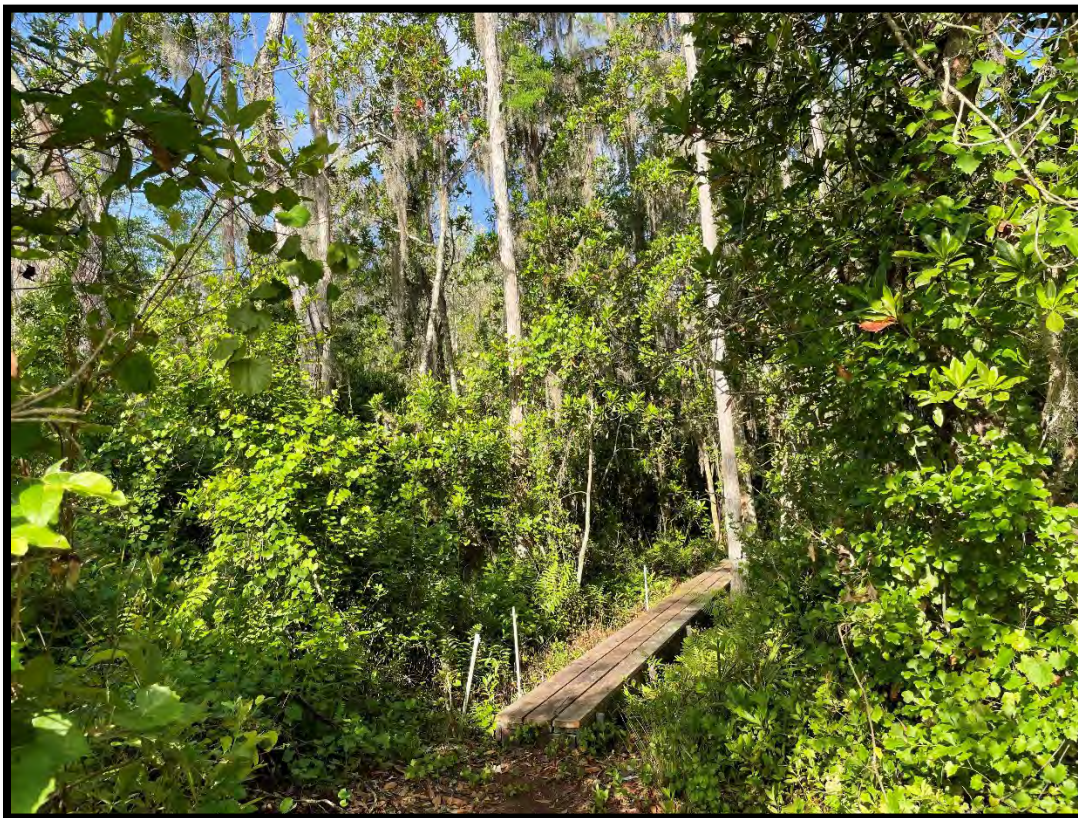
Figure B-60. Alston Bay (DMIT-1), April 2023.

The wetland is accessed from Deems Road and through a locked SWFWMD gate (**Figure B-63**). This preserve is typically very wet, so getting to the site with an ORV/ATV/side-by-side is recommended. The April 2023 assessment, which was conducted from the east side of the wetland, determined that the wetland was Not Stressed. It was also determined to be Not Stressed during the 2018 assessment.

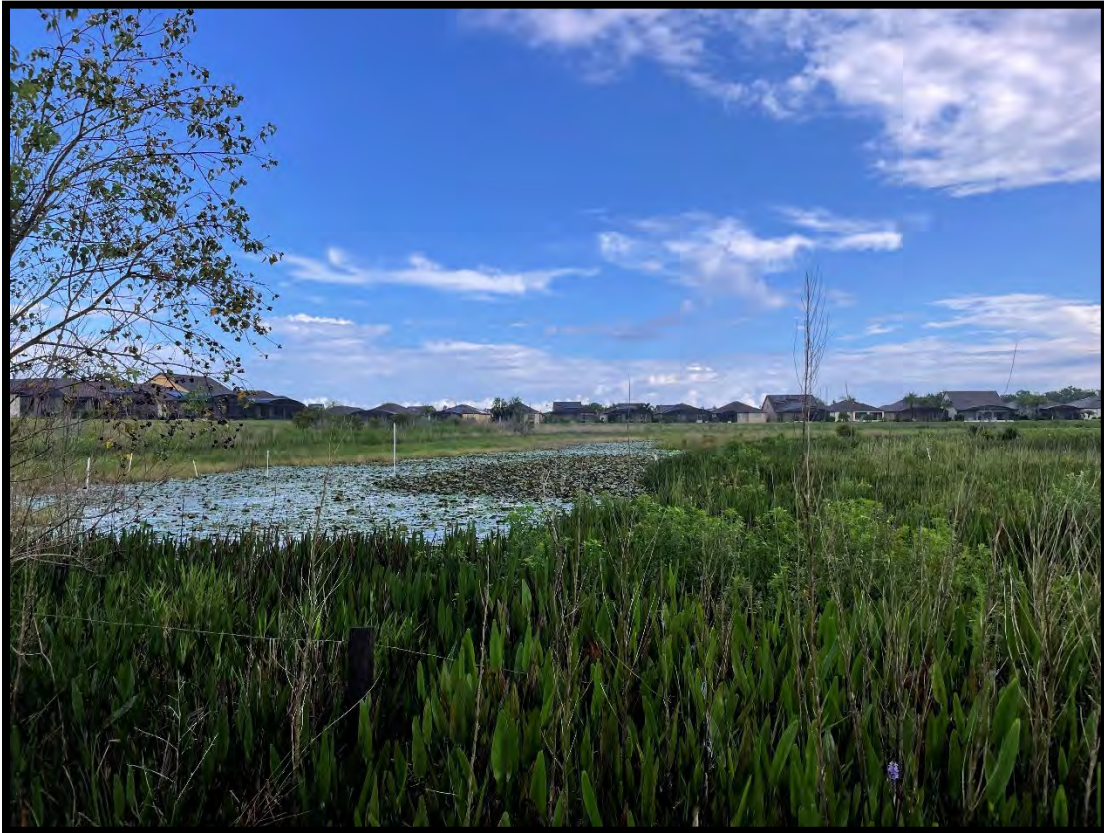
Figure B-116. Davenport P1 (SW-AF), August 2023.

Davenport P1 is a large marsh located in a Plains setting that is located in an area of rapid residential development. The south and eastern boundaries of this wetland are rimmed with houses (**Figures B-116, B-117, B-118, and B-119**). The wetland is accessed from Andalusia Loop off of North Boulevard, east of U.S. Highway 27 (**Figure B-119**).

This wetland is one of the wetlands monitored under the City of Davenport’s WUP (No. 5750) issued by the SWFWMD, with established WAP transects. This wetland was originally a Class 2 wetland; however, because there is a long-term record of water level data collected from the site’s staff gauges (**Figure B-120**), and the elevation of the wetland edge is known, it was included in the Class 1 wetlands dataset for the analysis conducted in support of the 2025 CFWI RWSP. It was determined to be Not Stressed in August 2023.

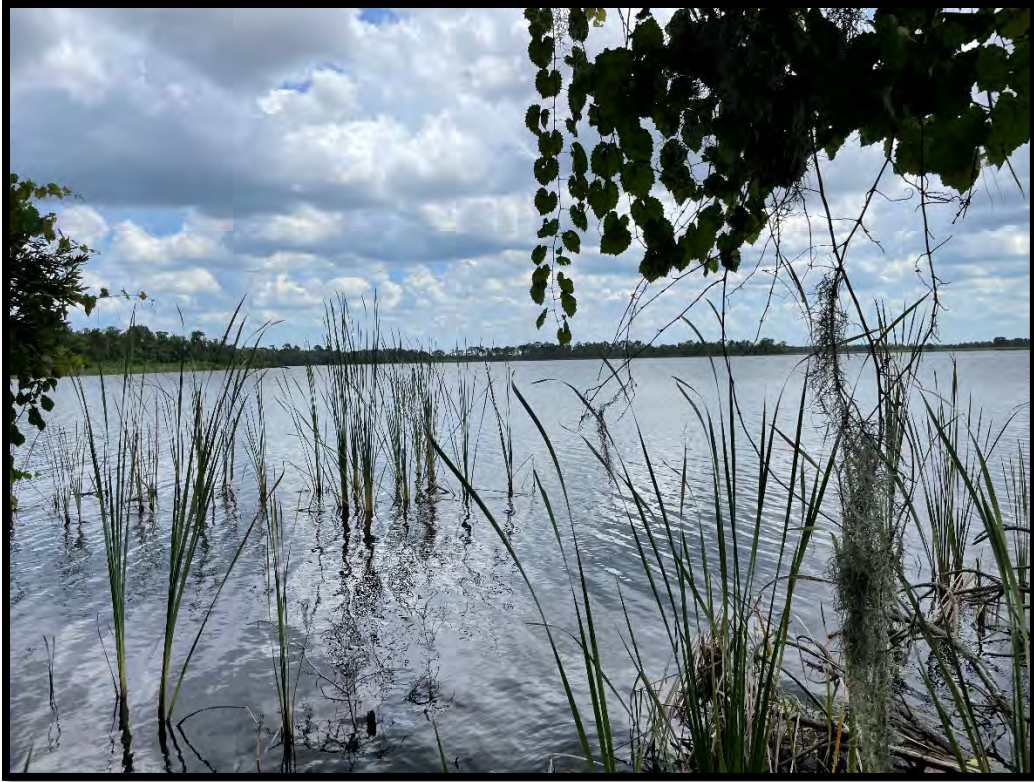
Figure B-180. Gator Lake (SW-QD), August 2023.

While the lake was determined to be Stressed during the 2018 assessment, the August 2023 assessment indicated that Gator Lake was Not Stressed. Evidence indicates that hydrologic stress, in the form of a shift in plant communities (e.g., upland plants invading wetlands) and slight soil subsidence and oxidation, has occurred historically along the lake shore on the site where the staff gauge is accessed (**Figures B-183 and B-184**). However, there was no change from April 2017 through August 2023, indicating stable conditions. A review of the historical aerials from the 1940s through the present indicated no change in the lake level. **Figure B-186** includes the period-of-record water level data used for the current analysis.
