# Central Florida Water Initiative

## ASSESSMENT OF EFFECTS OF GROUNDWATER WITHDRAWALS ON GROUNDWATER-DOMINATED WETLANDS IN THE CENTRAL FLORIDA WATER INITIATIVE PLANNING AREA

January 2025

FINAL REPORT APPENDICES

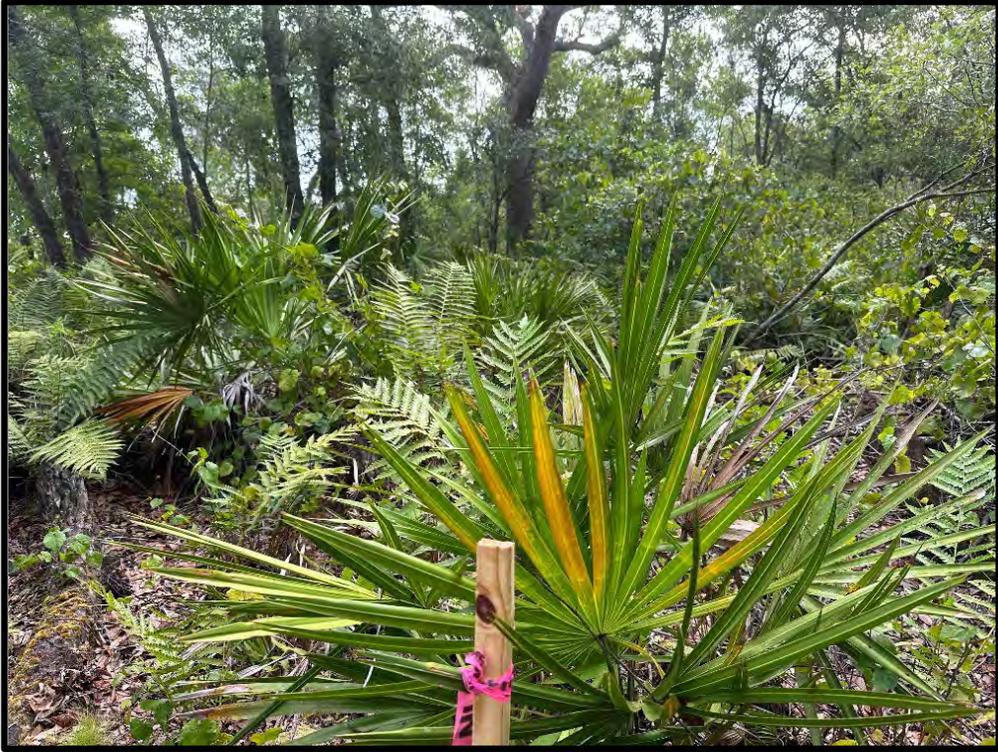
**Figure B-2.** Landscape view of uplands, Intercession City (DMIT-35).

Intercession City is a Plains wetland that is part of Upper Reedy Creek and consists of water oak, cypress, red maple, bay trees and slash pine (**Figures B-1, B-2, and B-3**). The property is owned and maintained by the South Florida Water Management District (SFWMD). The SFWMD regularly uses prescribed burns on the adjacent pine flatwoods to maintain the native community. The site contains three wells, which were constructed to facilitate aquifer testing and long-term monitoring of the Florida Aquifer System. **Figure B-4** includes the selected period of record of water level data from the Surficial Aquifer (SA) monitor well that was used for the analysis conducted in support of the 2025 Central Florida Water Initiative (CFWI) Regional Water Supply Plan (RWSP).

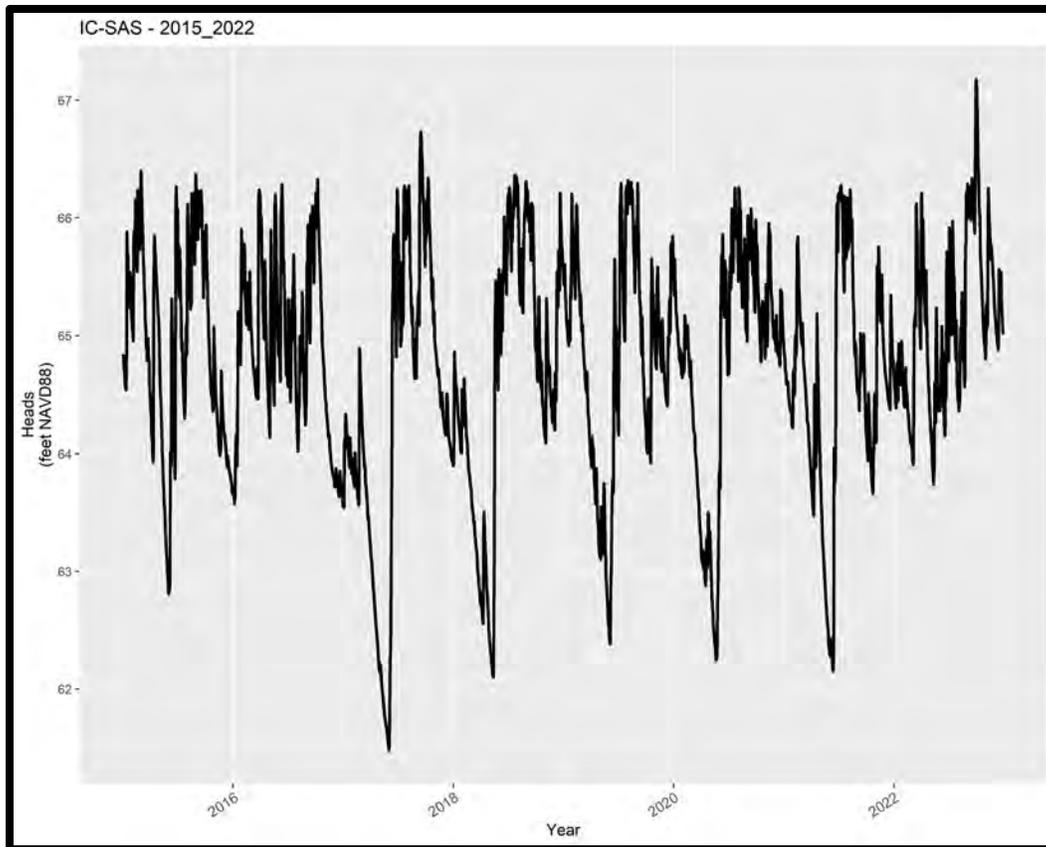
**Figure B-4.** Selected period-of-record (2015-2022) water level data for Intercession City (DMIT-35).

This wetland is included in the Data, Monitoring, and Investigations Team (DMIT) long-term wetlands monitoring program, and monitoring transects were established in 2018. The 5-year monitoring event was conducted in 2023. The site was assessed in 2023 by conducting pedestrian transects throughout the entire system and was determined to be Not Stressed. It was also determined to be Not Stressed for the analysis conducted in support of the 2020 CFWI RWSP.

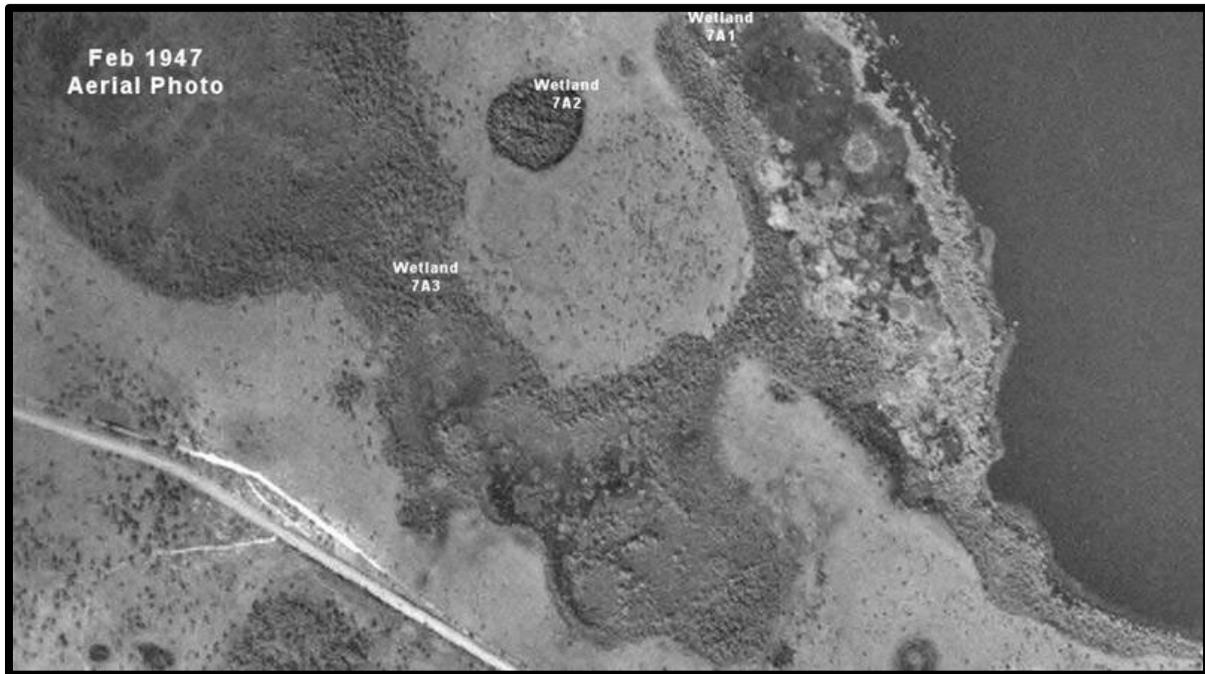
**Figure B-6.** Tibet Butler (DMIT-131), labelled as Wetland 7A2 in the February 1947 aerial photo.

Tibet Butler is a Plains wetland that is a small cypress dome located within the Tibet-Butler Preserve (**Figures B-5 and B-6**). This cypress wetland is an established DMIT long-term wetlands monitoring program site. Monitoring transects were setup in 2018, and the 5-year monitoring event was conducted in 2023.

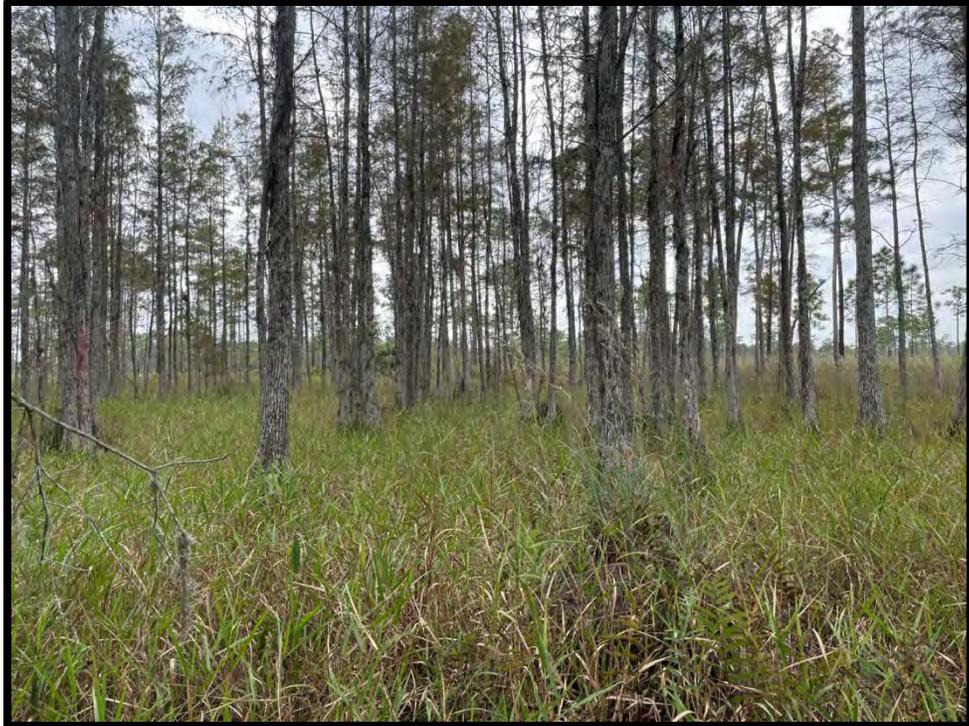
**Figure B-10.** Center of Walker Ranch – WR11 (DMIT-190), November 2023.

Walker Ranch – WR11 is a Plains wetland and cypress dome located within the Disney Wilderness Preserve, which is owned and maintained by The Nature Conservancy (TNC) (**Figures B-9, B-10, and B-11**). The assessment conducted in November 2023 was consistent with those made in previous years, and the wetland was determined to be Not Stressed. Prescribed burns are regularly used on the adjacent pine flatwoods by TNC to maintain the native community.

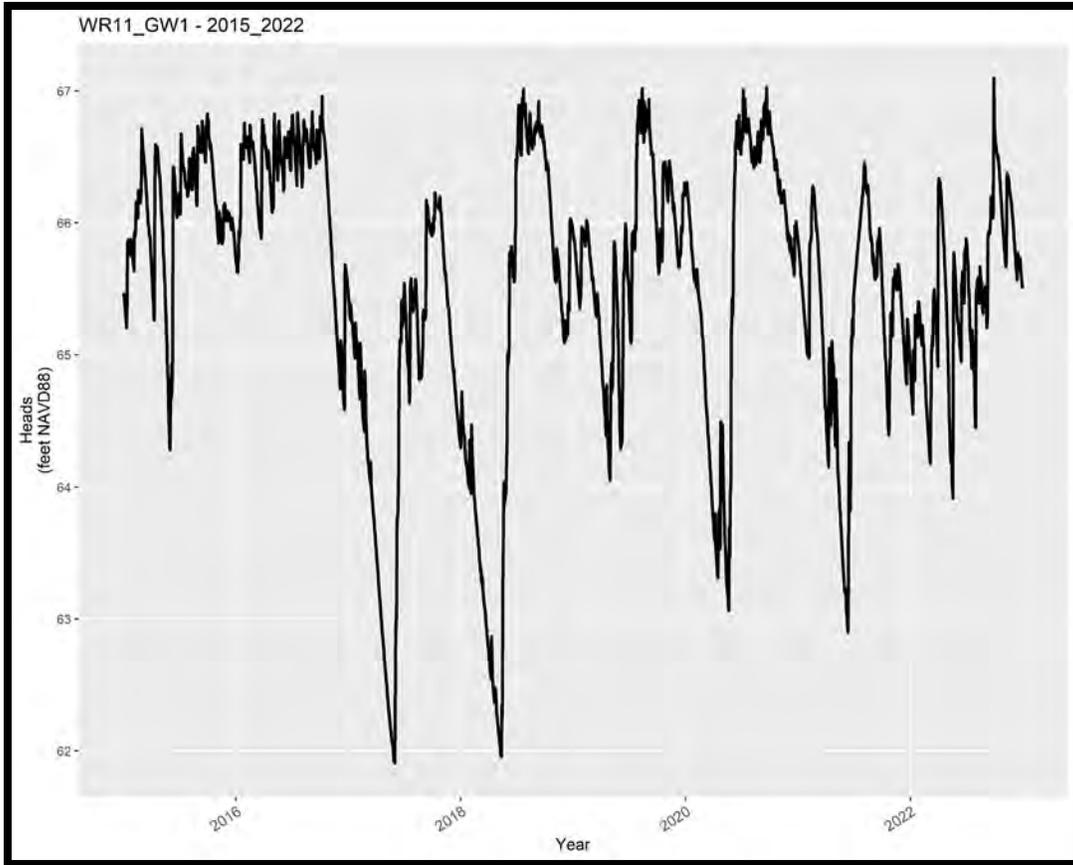
**Figure B-12.** Selected period-of-record (2015-2022) water level data for Walker Ranch – WR11 (DMIT-190).

Monitoring of this wetland system is conducted by the SFWMD as part of their regional hydrologic monitoring network (**Figure B-12**). The evaluation included pedestrian transects throughout the entire system. This wetland is included in the DMIT long-term wetlands monitoring program. Monitoring transects were established in 2019, and the 5-year DMIT monitoring event was conducted in 2024.

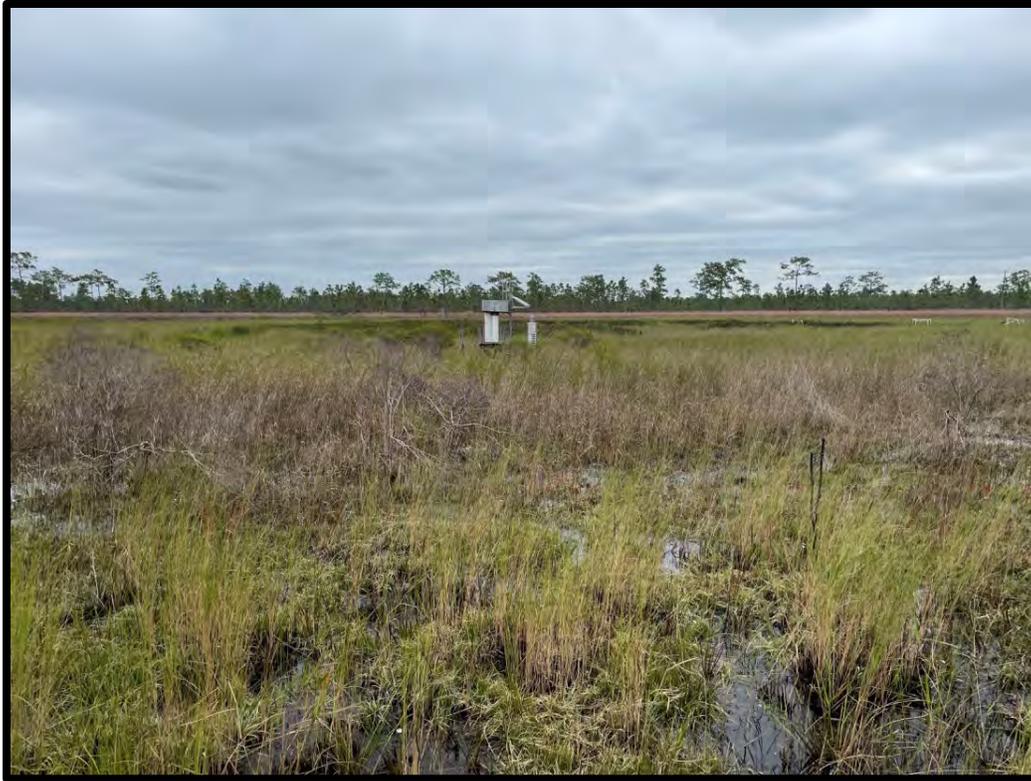
**Figure B-13.** View of center of Walker Ranch – WR9 (DMIT-191), November 2023.

Observations of stress made in November 2023 by conducting pedestrian transects throughout the entire wetland were consistent with previous assessments, and the marsh was determined to be Not Stressed. The adjacent pine flatwoods is maintained in its native state through the use of frequent prescribed burns. Monitoring of this wetland system is conducted by the SFWMD as part of their regional hydrologic monitoring network (**Figure B-16**).

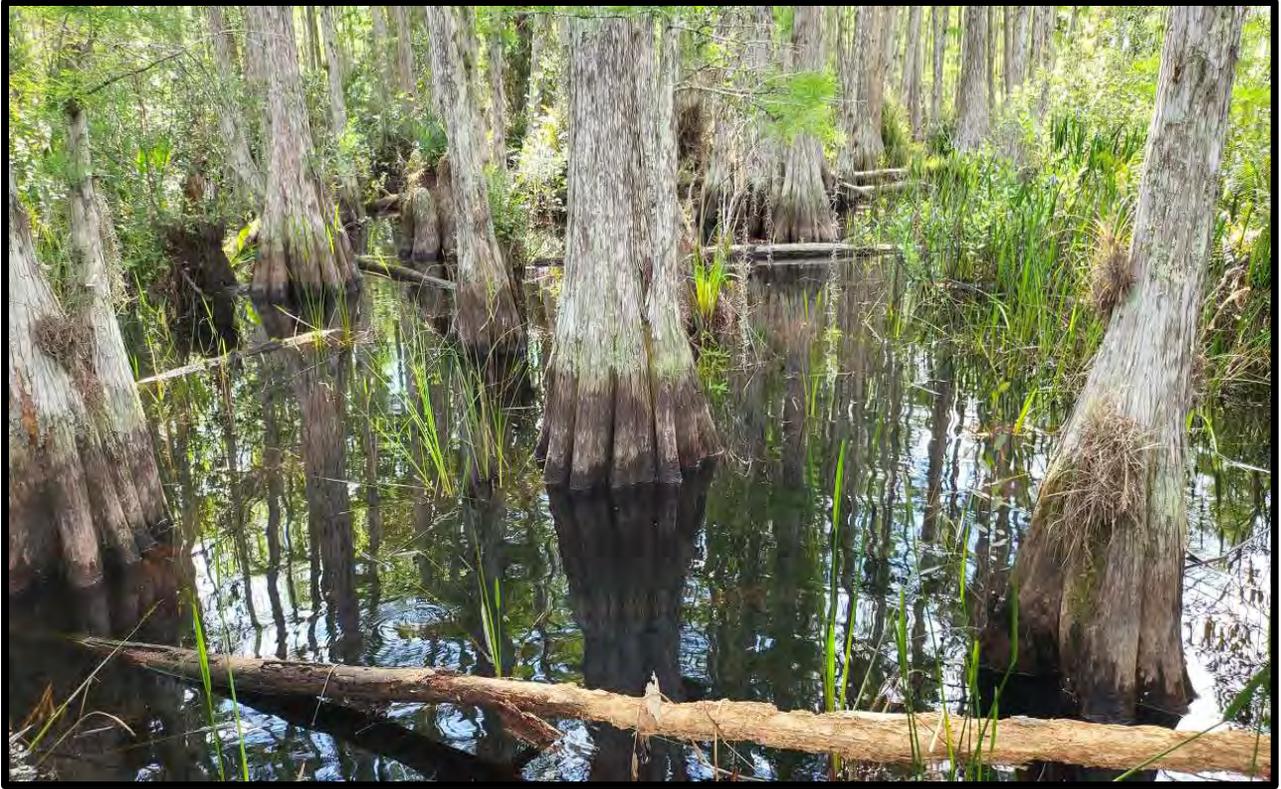
**Figure B-18.** Tree fall on northern portion of Split Oak (SF-WT), February 2023.

This Plains wetland was assessed in February 2023, and it was determined to be Stressed. It was determined by the SFWMD to be Not Stressed in 2008; however, an assessment of the site in May 2018 during the annual compliance review for the STOPR monitoring sites indicated that the site was Stressed. Indicators of hydrologic stress observed in the system include leaning trees, rotting cypress knees, tree fall, the presence of soil fissures within central portion of the cypress dome, exposed tree roots, and evidence of oxidation of the muck layer of the soil (**Figures B-18 and B-19**). It should be noted that new indicators of stress were not found in the 2023 assessment, and water levels were extremely low from 2017 through 2021 (**Figure B-20**). Access to this site is off Clapp Simms Duda Road (**Figure B-17**).

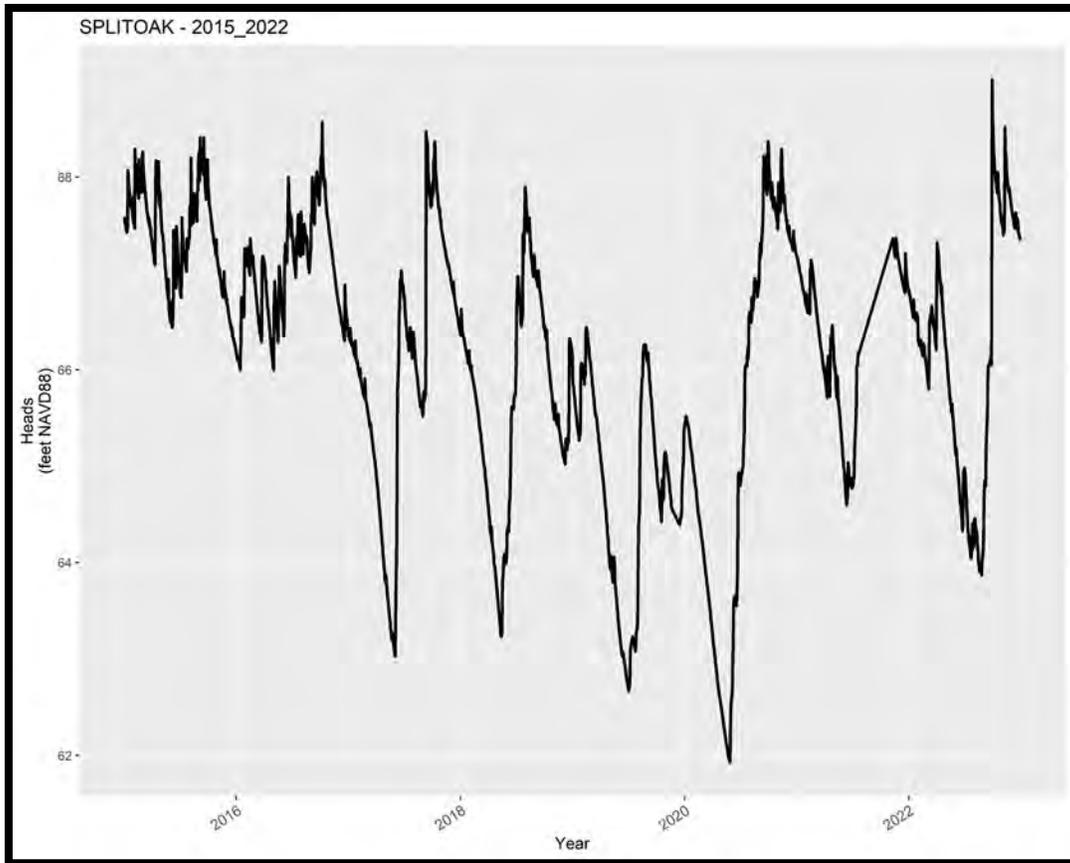
**Figure B-20.** Selected period-of-record (2015-2022) water level data for Split Oak (SF-WT).

Monitoring of this wetland system is conducted by the St. Cloud, TOHO Water Authority, Orange County, Polk County, and Reedy Creek Improvement District (STOPR) as part of the wetland monitoring program required by their Water Use Permit (WUP). This system is a cypress strand located within a large area of preservation lands owned jointly between the Florida Fish and Wildlife Conservation Commission (FWC) and Osceola and Orange Counties (**Figure B-17**). The counties and FWC regularly use prescribed burns on the adjacent pine flatwoods to maintain the native community.

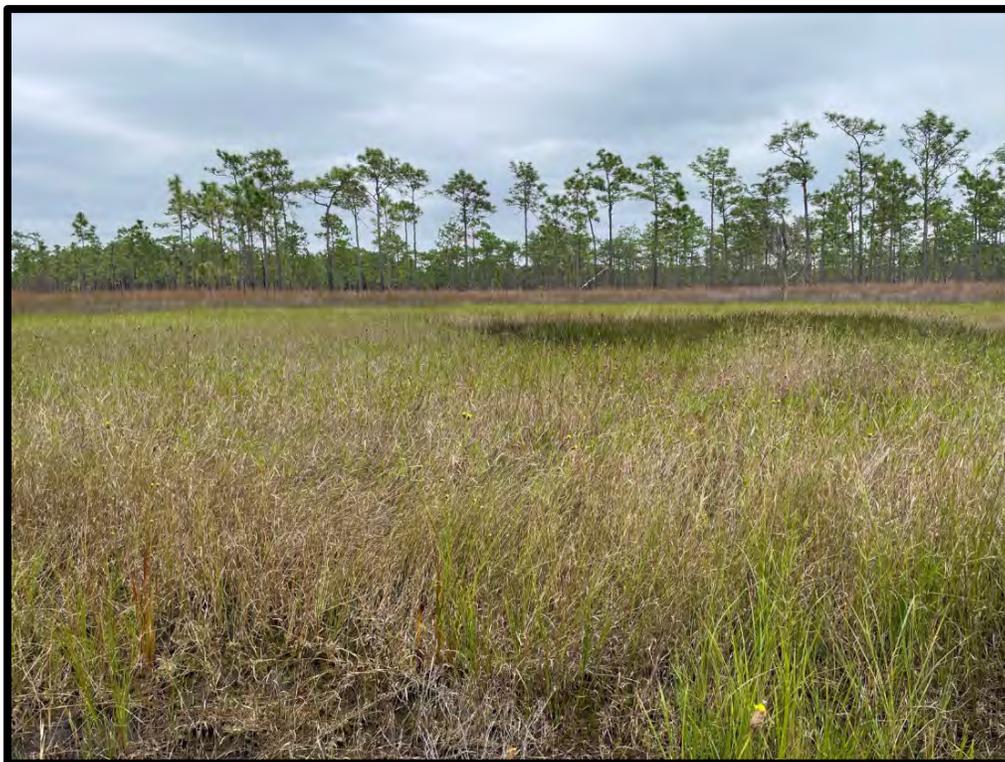
Figure B-22. Center of Walker Ranch – WR6 (SF-XX), November 2023.

Walker Ranch – WR6 is a Plains wetland that is located within the Disney Wilderness Preserve, which is owned and maintained by TNC (**Figures B-21, B-22, B-23, and B-24**). Observations of stress made in November 2023 were consistent with those made in the prior evaluations; the marsh was determined to be Not Stressed.

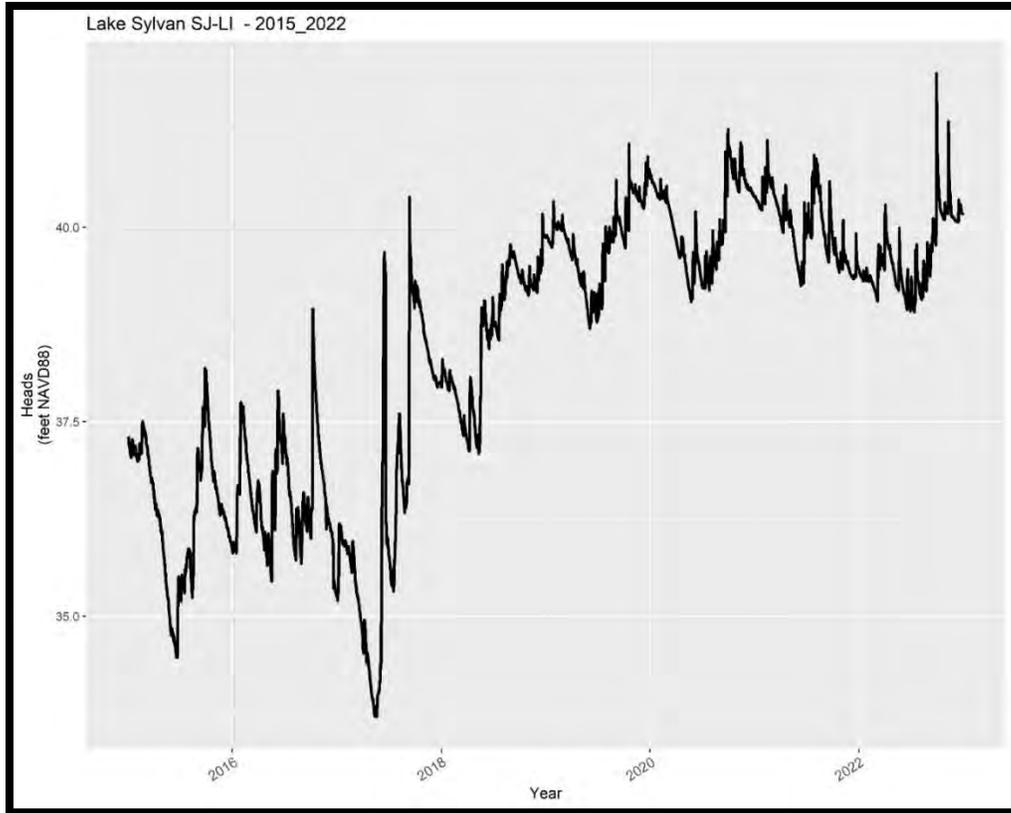
**Figure B-27.** Selected period-of-record (2015-2022) water level data for Lake Sylvan (DMIT-59).

Although recent water levels have been much higher compared to past levels (**Figure B-27**), the assessment conducted in support of the analysis conducted for the 2025 CFWI RWSP determined that the lake was Stressed. Since the lake was determined to be Not Stressed during the evaluation conducted for the 2015 CFWI RWSP analysis, the lake has been visited multiple times. Monitoring of this wetland system is conducted by Seminole County as part of the wetland monitoring program established by their Consumptive Use Permit. Indicators of hydrologic stress observed during low water periods within the system include the presence of soil fissures within exposed lower reaches of marsh areas, encroachment of pines and invasive species into the wetland areas, exposed tree roots, and the absence of regeneration of wetland tree species along the wetland boundaries (**Figure B-28**).

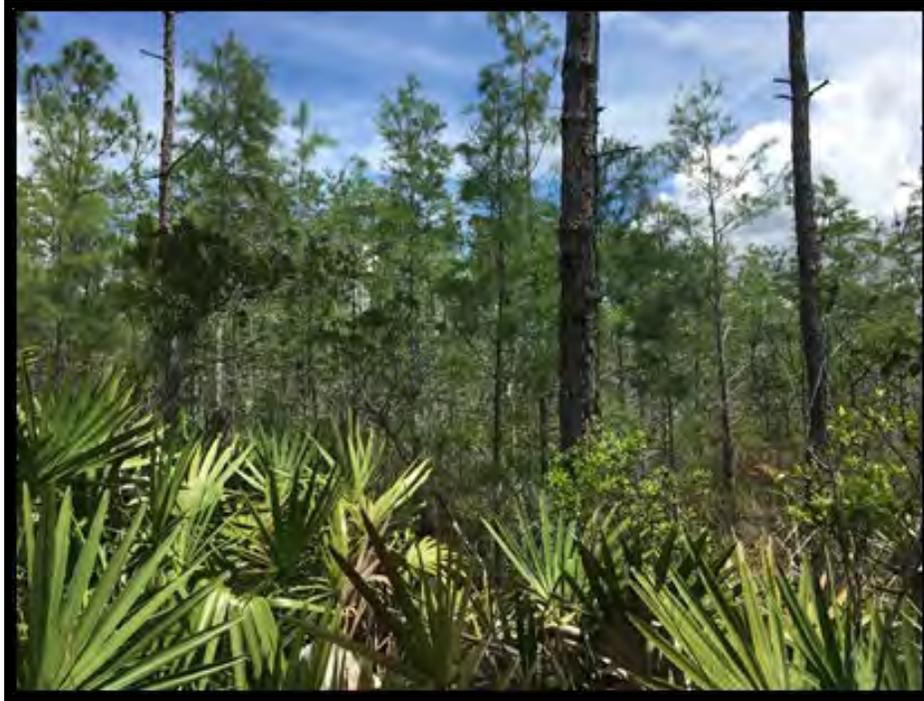
**Figure B-30.** City of Cocoa, Well 9T (SJ-LL or SJ-0127), May 2018. New photos were not taken during the most recent assessment.

This large cypress wetland is surrounded by improved pasture (**Figure B-29**). Historically, the system extended further to the south, but it has been bisected by Cocoa Water Plant Road. There are some small areas of intact upland vegetation around the perimeter of the system; however, along much of the wetland, the improved pasture extends to or beyond the wetland edge (**Figure B-30**).

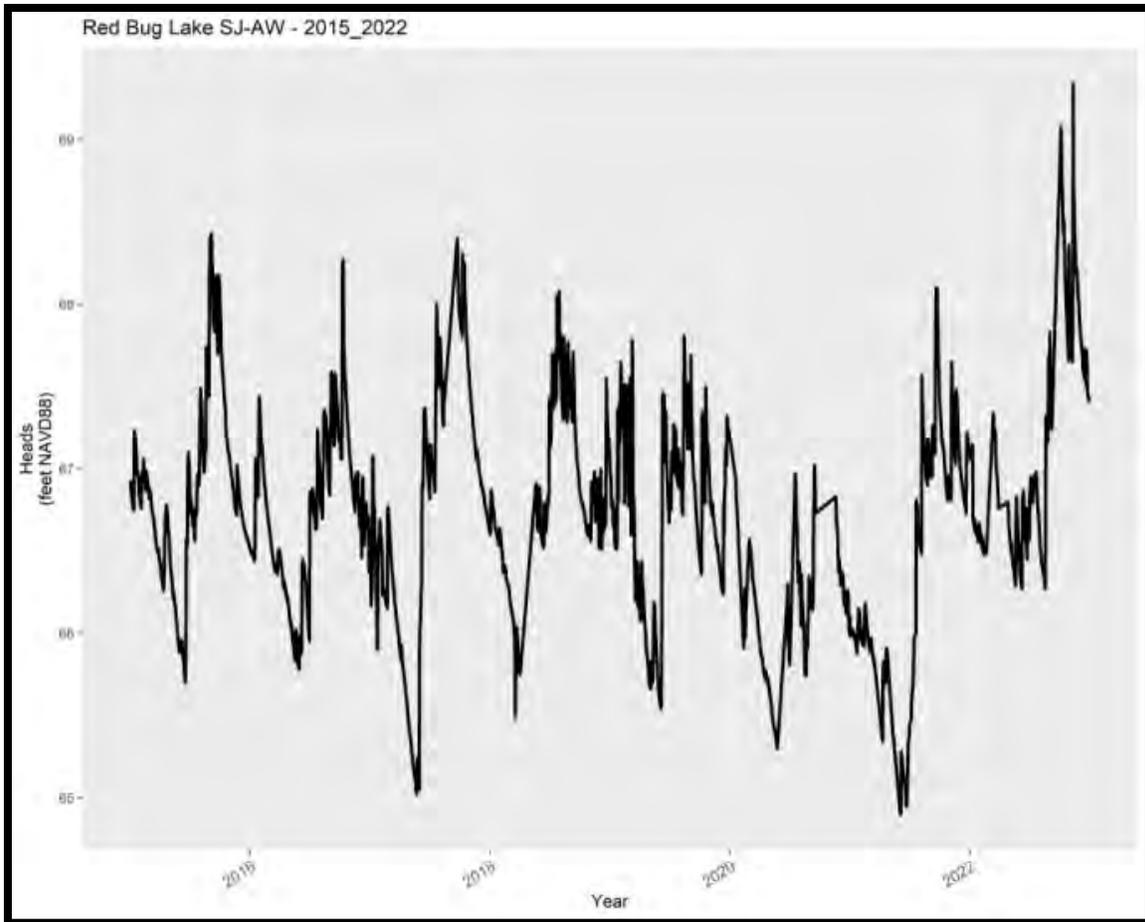
**Figure B-35.** Selected period-of-record (2015-2022) water level data for Red Bug Lake (SJ-AW).

Monitoring of this wetland system is conducted by Orlando Utilities Commission (OUC) as part of the wetland monitoring program established by their CUP. Based on review of aerial photographs, there appears to be a historic, significant reduction in the upper lake level, supported by site evaluations conducted by SJRWMD staff. Zonation of the marsh areas has remained consistent for the last several decades; however, periods of inundation within the marsh areas appear to be reducing in frequency and duration. The reduced hydroperiod may be an ongoing result of the historic reduction in lake level or a more recent change in hydrologic condition (**Figure B-35**). Dry conditions within the marsh zones have led to the encroachment of woody species.

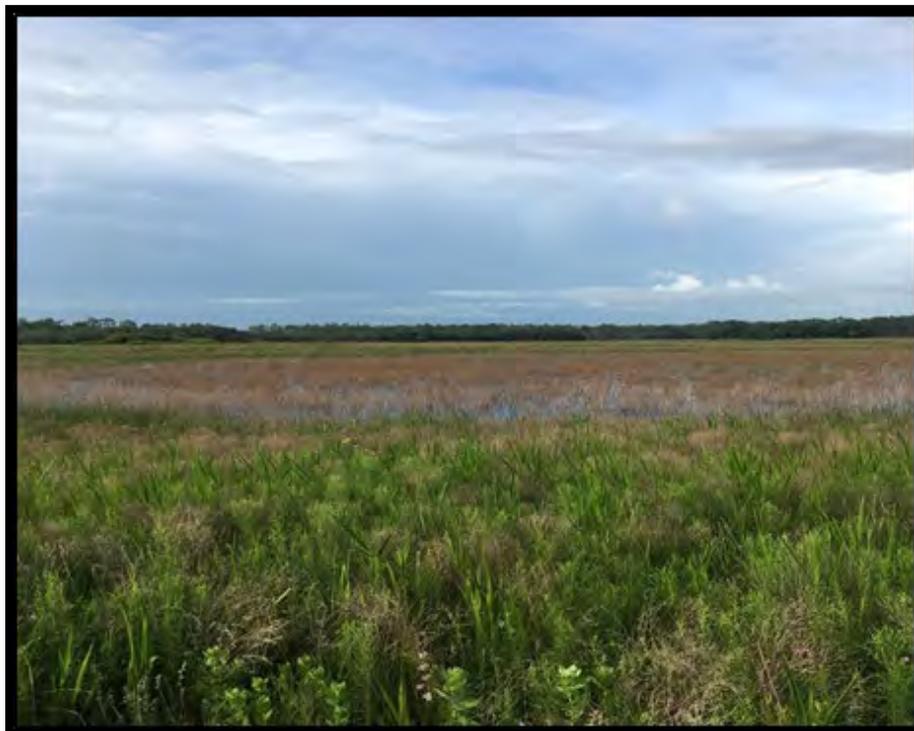
**Figure B-43.** Hopkins Prairie (SJ-LD), June 2018. New photos were not taken during the most recent assessment.

The wetland system consists of an elongated freshwater marsh dominated by herbaceous grasses and sedges (**Figure B-43**). At low water levels, several pockets of open water generally persist in the eastern portion of the system. Monitoring of this wetland system is conducted by SJRWMD as part of their regional hydrologic monitoring network, and water levels since 2018 have been higher than the earlier years included in the period of record selected for the analysis in support of the 2025 CFWI RWSP (**Figure B-44**). The system is accessed via Forest Road 86 off of U.S. Highway 19.

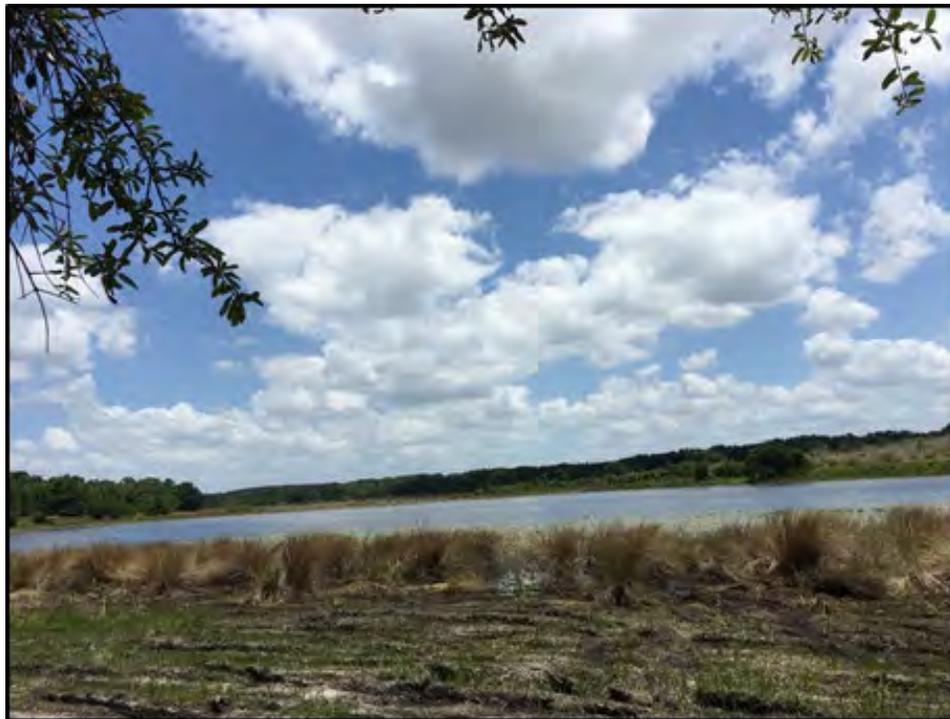
Figure B-46. Lake Avalon (SJ-LE), May 2018. New photos were not taken during the most recent assessment.

This xeric lake is bounded by agricultural properties to the south, single family residential properties to the southwest, and a new residential development to the north (**Figure B-45**). The system is predominantly characterized by open water, with a narrow littoral edge of herbaceous wetland species (**Figure B-46**). The northeast portion of the system is dominated by a shallow herbaceous freshwater marsh with scattered wetland hardwoods. Monitoring of this wetland system is conducted by the SJRWMD as part of their regional hydrologic monitoring network, and water levels have been increasing in recent years (**Figure B-47**). Access to this wetland is along Marsh Road; however, the new development may limit historic access to the open water portion of the system.

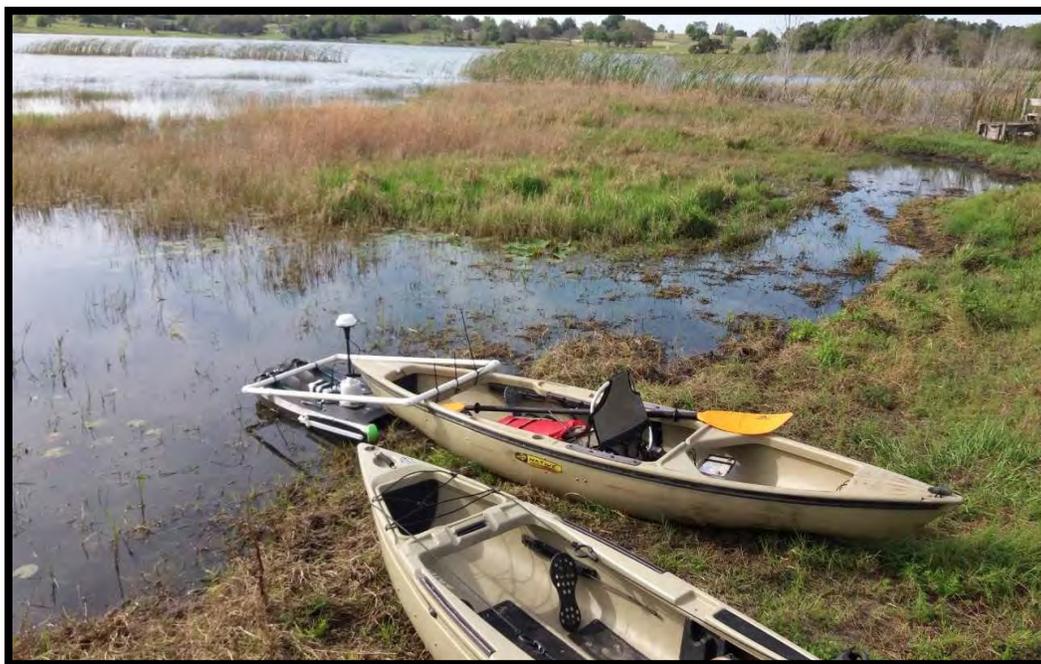
**Figure B-49.** Lake Apshawa (SL-LF), March 2019. New photos were not taken during the most recent assessment.

This xeric lake has a very steep grade from the upland community to the wetlands, bounded by single family residential properties (**Figure B-48**). The system is predominantly characterized by open water, with a narrow littoral edge of herbaceous wetland species (**Figure B-49**). The bulk of the residential parcels are maintained to the water's edge.

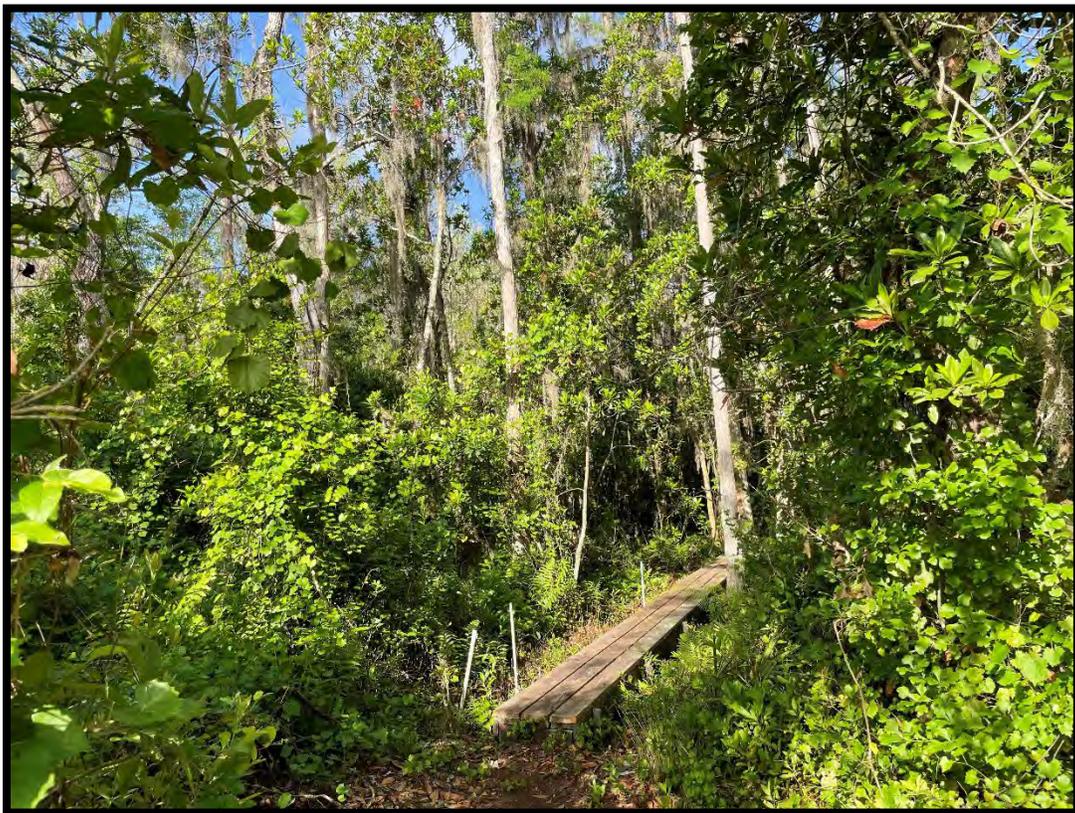
**Figure B-60.** Alston Bay (DMIT-1), April 2023.

The wetland is accessed from Deems Road and through a locked SWFWMD gate (**Figure B-63**). This preserve is typically very wet, so getting to the site with an ORV/ATV/side-by-side is recommended. The April 2023 assessment, which was conducted from the east side of the wetland, determined that the wetland was Not Stressed. It was also determined to be Not Stressed during the 2018 assessment.

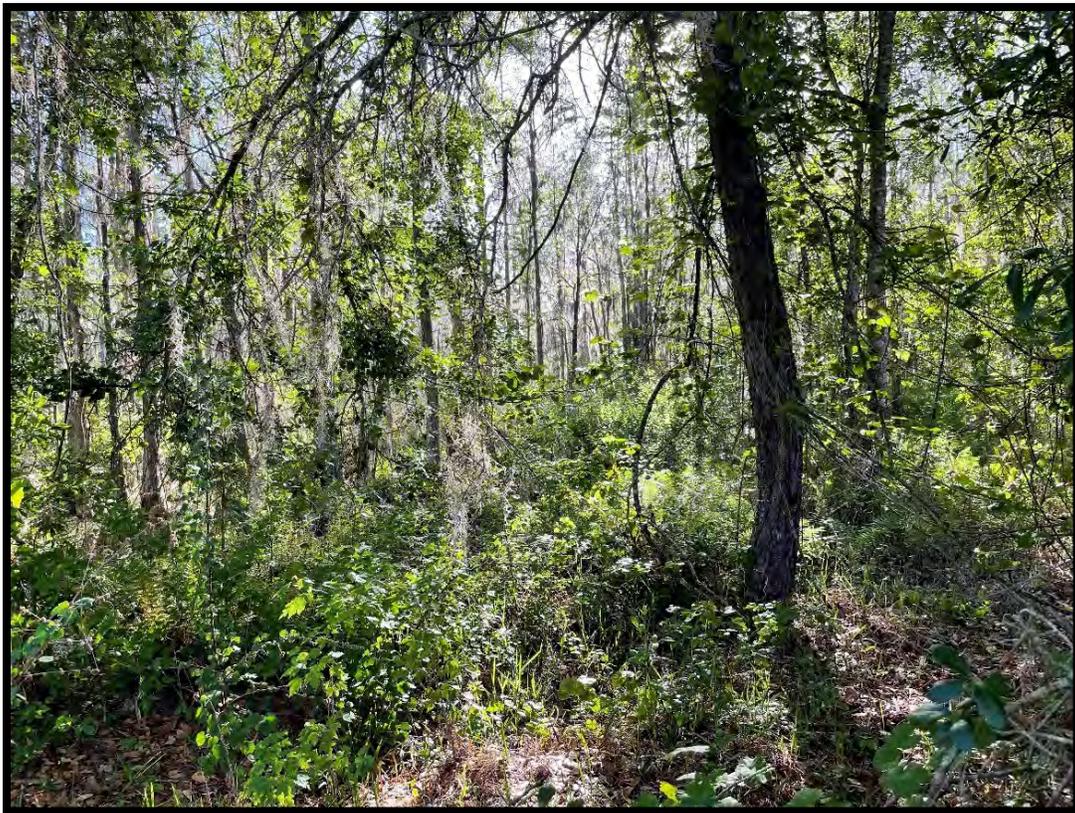
**Figure B-65.** NE Lakeland Wellfield G (DMIT-11), March 2023.

NE Lakeland Wellfield G is a Plains wetland and groundwater-dominated, cypress wetland located on the City of Lakeland's Northeast Wellfield (**Figures B-65, B-66, and B-67**). The wetland is located on property owned by the City of Lakeland and is accessed from Old Polk City Road through a locked gate (**Figure B-68**). It is included in the DMIT long-term wetlands monitoring program, and arrangements for escorted fieldwork must be made in advance with the city. Monitoring transects were established in 2016, and the 5-year DMIT monitoring event was conducted in 2021.

During the March 2023 assessment, which was conducted on the west side of the wetland (**Figure B-68**), this wetland was determined to be Not Stressed. It was also Not Stressed during the 2018 assessment. For the analysis of water level data for the period of record selected in support of the 2020 CFWI RWSP, this site was determined not to be representative of groundwater-dominated wetlands in the CFWI Planning Area, mainly because the period of record included both a stressed and unstressed period; therefore, it was included in the Class 2 wetlands dataset. However, there were enough unstressed years in the period of record of water level data selected for the analysis in support of the 2025 RWSP (**Figure B-69**), so this wetland could be included in the Class 1 wetlands dataset.

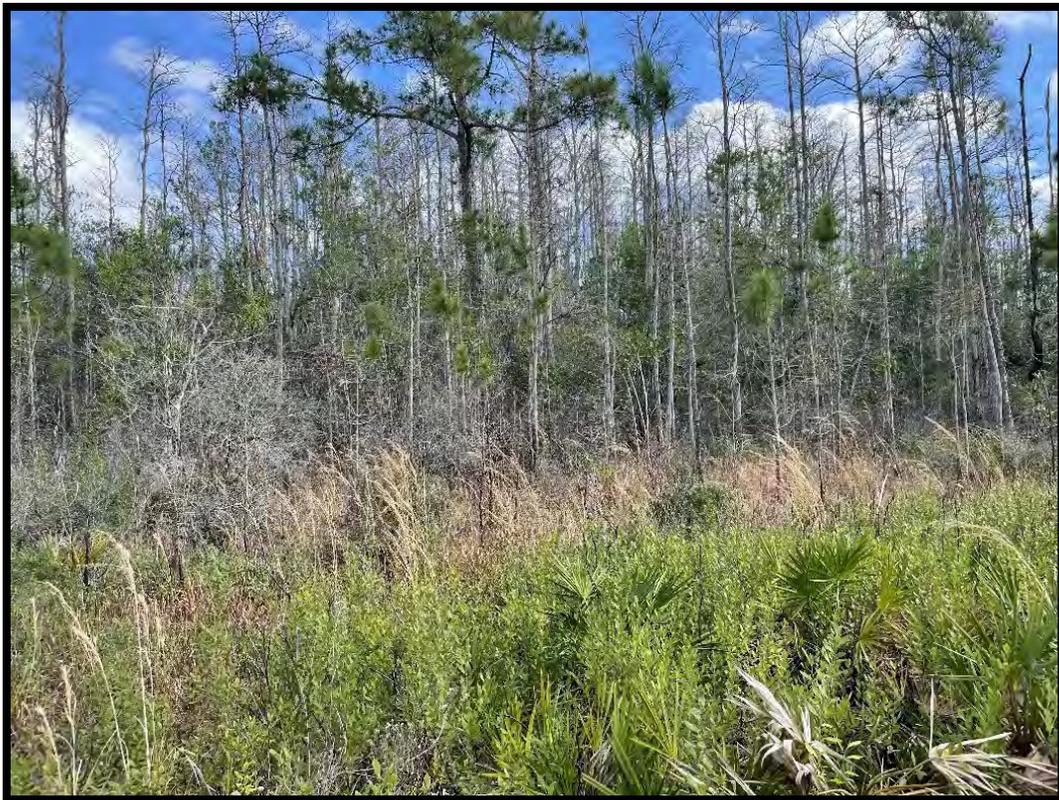
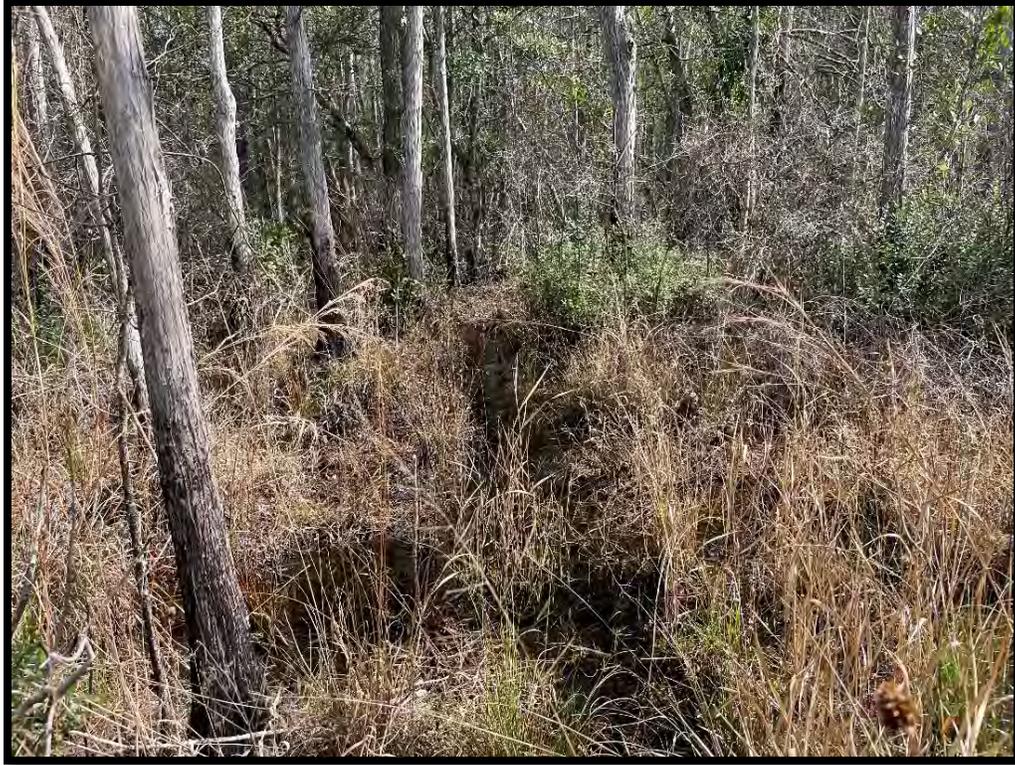
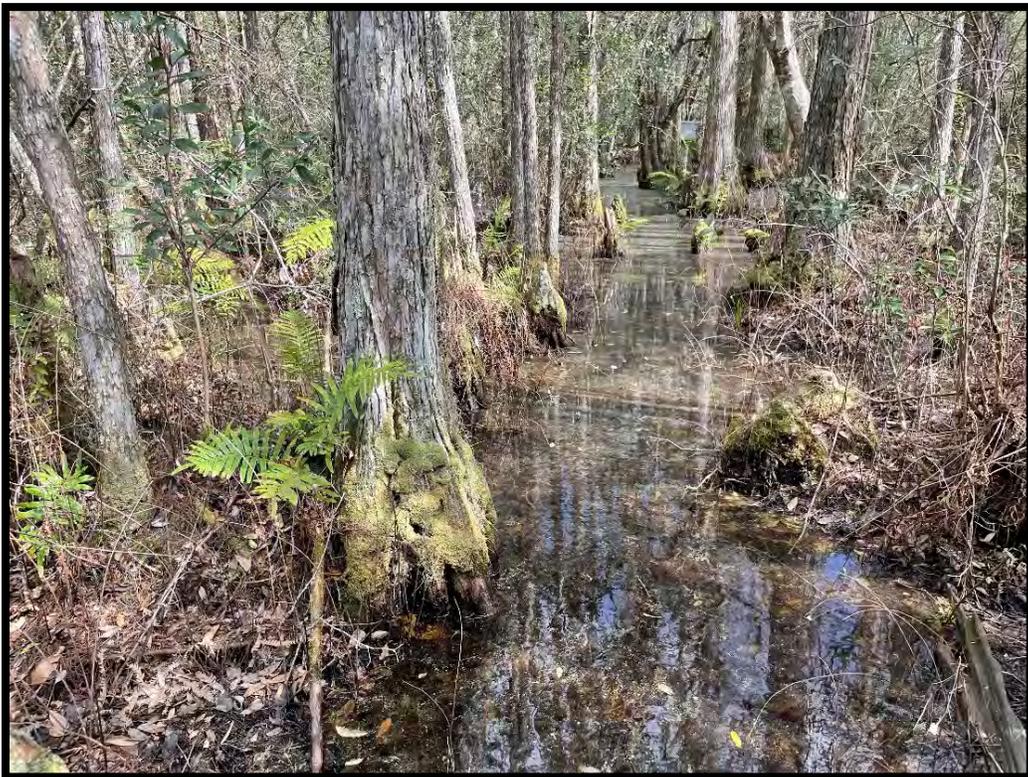
Green Swamp 4 is a groundwater-dominated, cypress Plains wetland located on the SWFWMD's Green Swamp Wilderness Preserve East Tract (**Figure B-80, B-81, and B-82**). The wetland is accessed from State Road 471, turning east on Main Grade (unpaved) and through a locked SWFWMD gate (**Figure B-83**). From Main Grade turn north (left) on Powder Grade then right on Island Pond Road.

During the February 2023 assessment, which was conducted on the southwest side of the wetland (**Figure B-83**), Green Swamp 4 was determined to be Not Stressed. It was also determined to be Not Stressed during 2018. This wetland is included in the DMIT long-term wetlands monitoring program; monitoring transects were established in 2016, and the 5-year DMIT monitoring event was conducted in 2021.

**Figure B-80.** Green Swamp 4 (DMIT-28), February 2023.

**Figure B-81.** Green Swamp 4 (DMIT-28), February 2023.

**Figure B-82.** Green Swamp 4 (DMIT-28), February 2023.

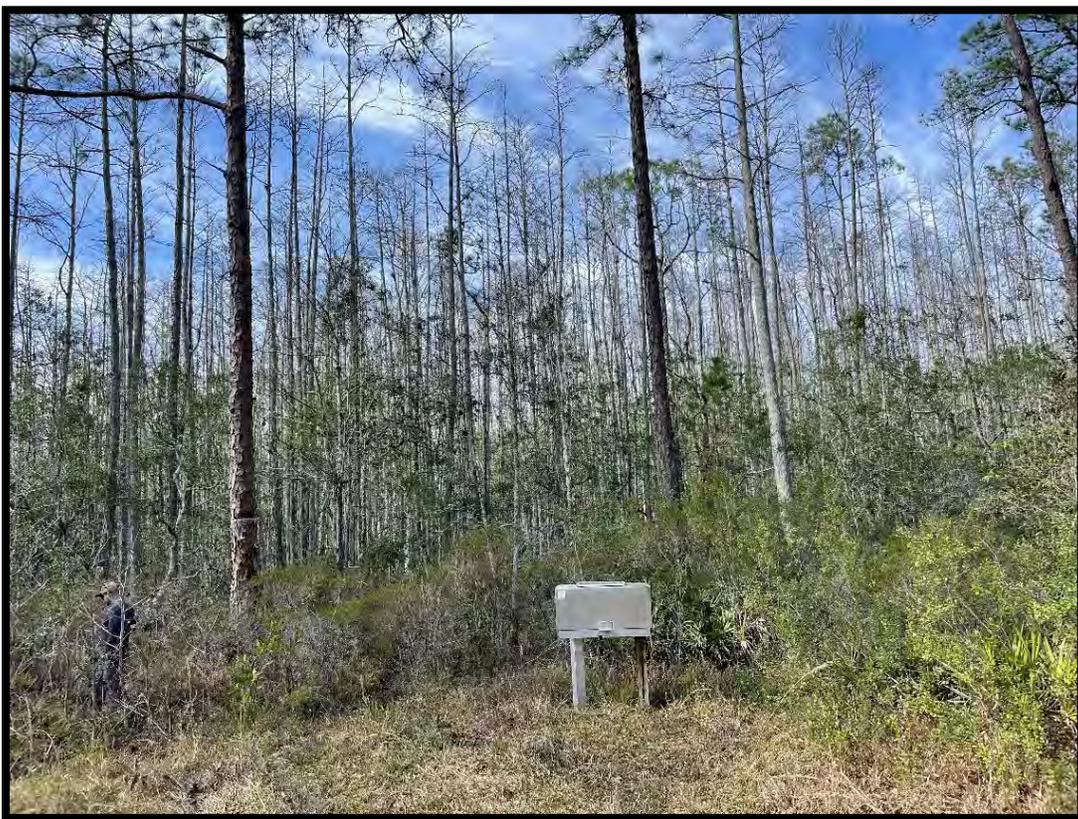
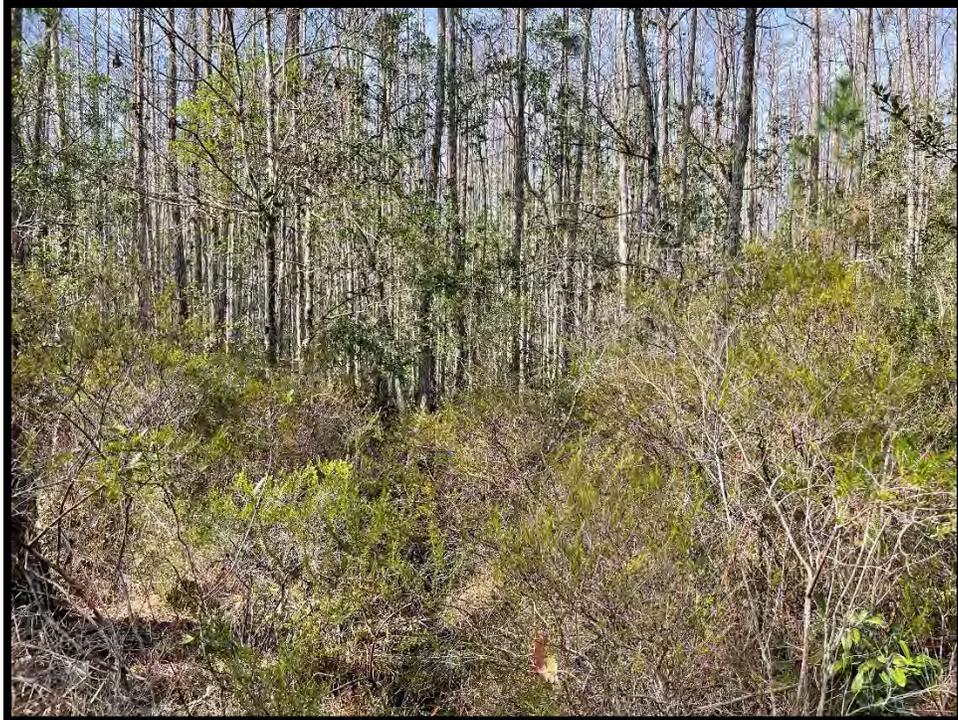
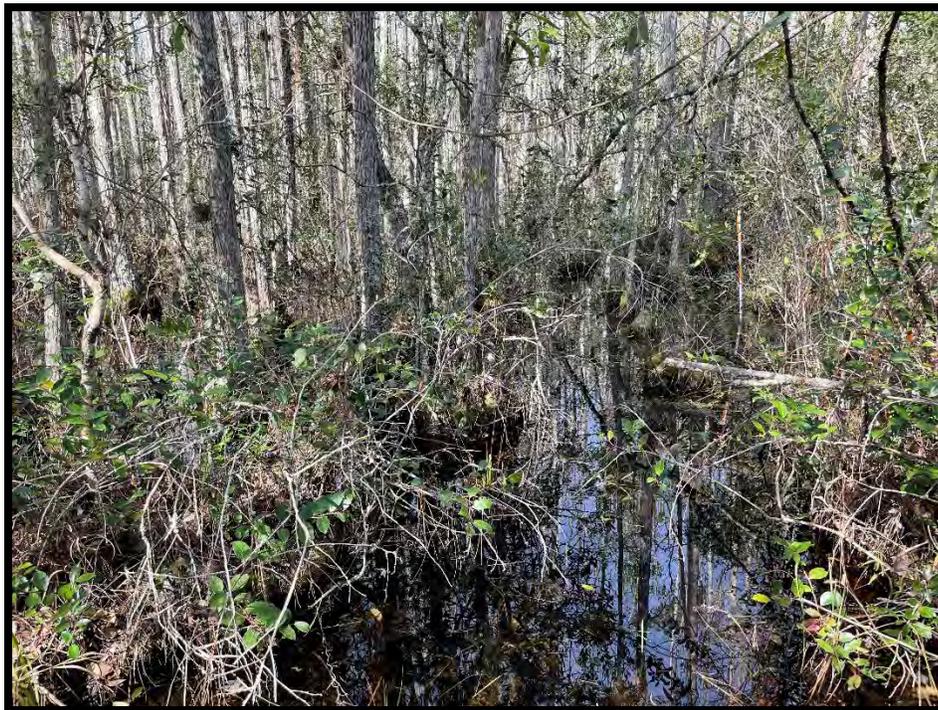
Green Swamp 7 is a small, groundwater-dominated, cypress wetland located in Northwest Polk County (**Figures B-85, B-86, and B-87**). This Plains wetland is within the SWFWMD's Green Swamp Wilderness Preserve East Tract. The wetland is accessible via the locked Smith Place Road entrance gate off of Rock Ridge Road (**Figure B-88**). It is included in the DMIT long-term wetlands monitoring program. Monitoring transects were established in 2016, and the 5-year DMIT monitoring event was conducted in 2021.

In January 2023, as well as in 2018, this wetland was determined to be Not Stressed. Since the wetland is small in size, the entire wetland was assessed. A review of a 1970s aerial photograph (**Figure B-89**) compared with the 2017 aerial indicates that, although the wetland appears to be unchanged, the surrounding uplands were historically converted to improved pasture. Currently, the uplands are restored to pine flatwoods. There are no known hydrologic alterations to the wetland.

**Figure B-85.** Green Swamp 7 (DMIT-29), January 2023.

**Figure B-86.** Green Swamp 7 (DMIT-29), January 2023.

**Figure B-87.** Interior of Green Swamp 7 (DMIT-29), January 2023.
