# Central Florida Water Initiative

## ASSESSMENT OF EFFECTS OF GROUNDWATER WITHDRAWALS ON GROUNDWATER-DOMINATED WETLANDS IN THE CENTRAL FLORIDA WATER INITIATIVE PLANNING AREA

January 2025

FINAL REPORT APPENDICES

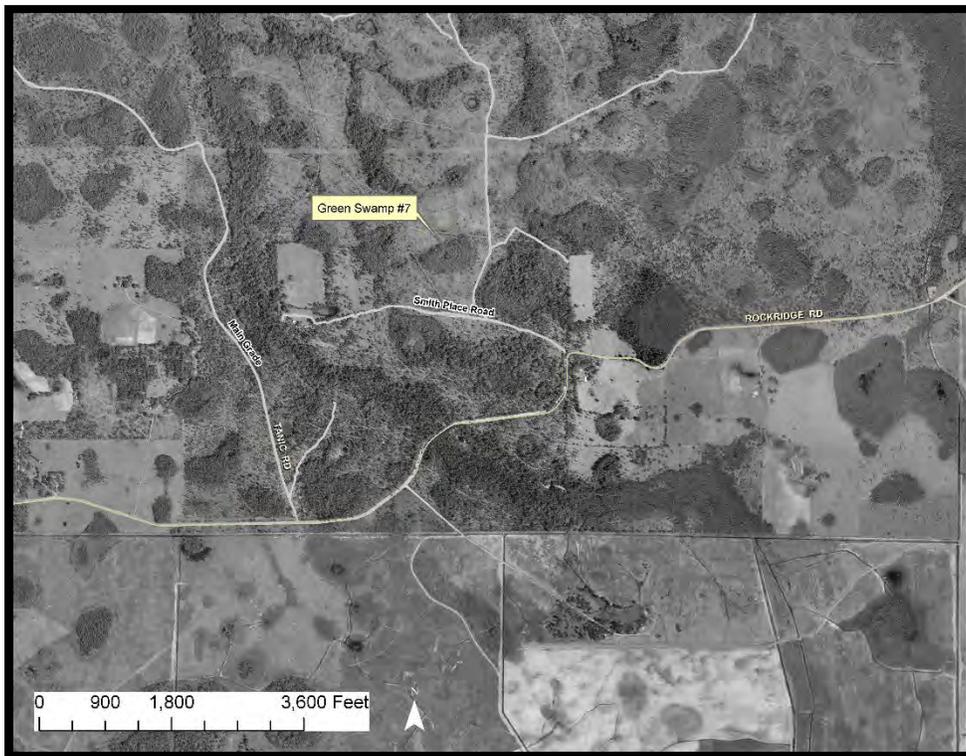
In January 2023, as well as in 2018, this wetland was determined to be Not Stressed. Since the wetland is small in size, the entire wetland was assessed. A review of a 1970s aerial photograph (**Figure B-89**) compared with the 2017 aerial indicates that, although the wetland appears to be unchanged, the surrounding uplands were historically converted to improved pasture. Currently, the uplands are restored to pine flatwoods. There are no known hydrologic alterations to the wetland.

**Figure B-89.** Green Swamp 7 (DMIT-29), circa 1970 aerial photograph.

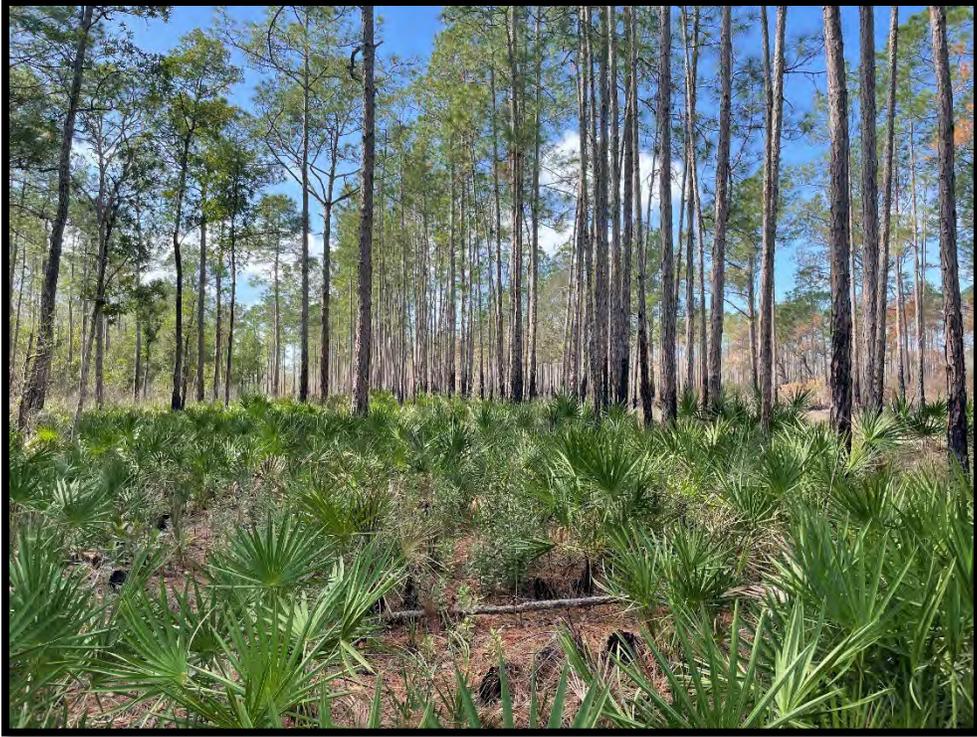
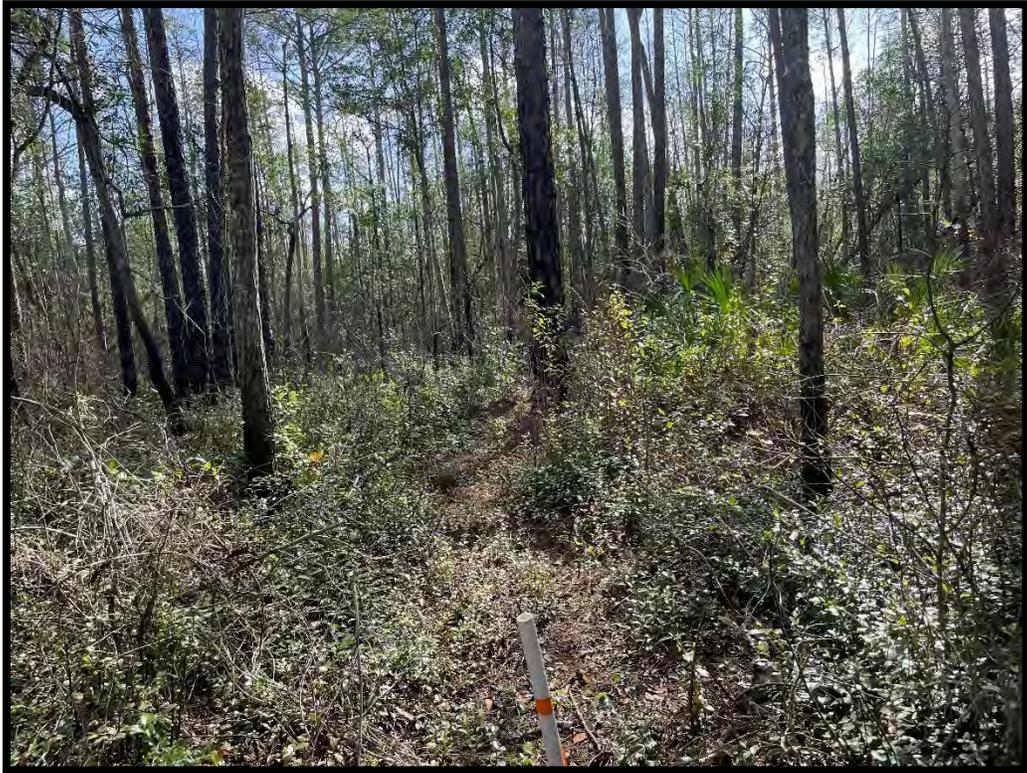
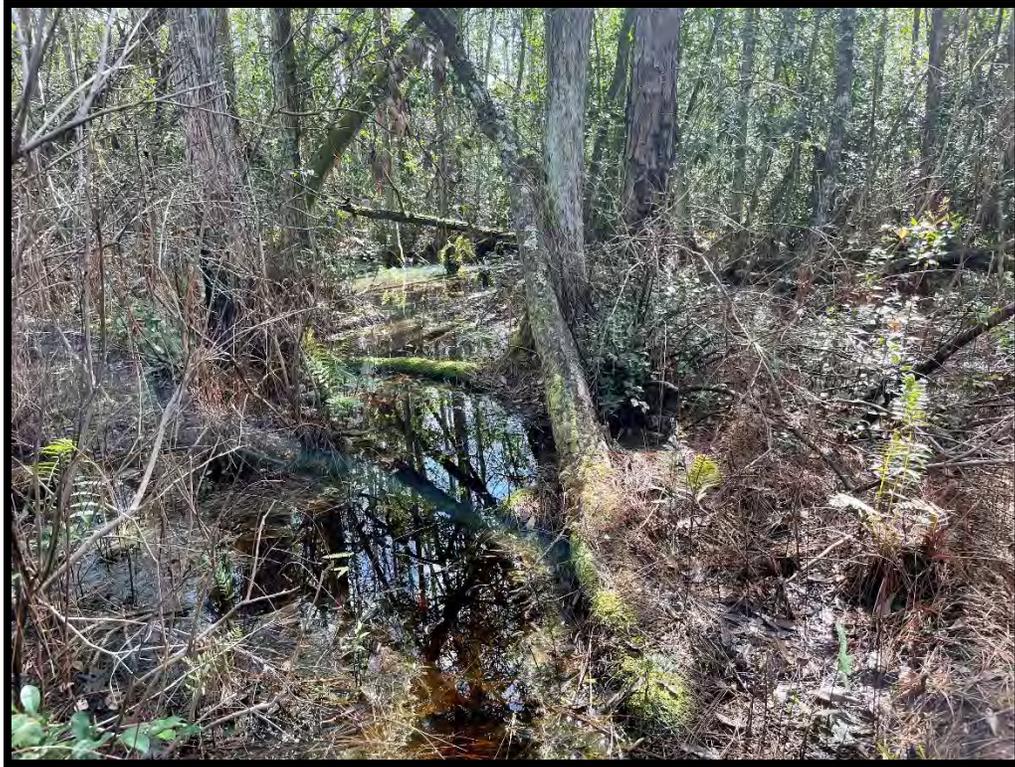
Green Swamp Bay is a bayhead wetland located in a Plains setting in Southwest Lake County on the SWFWMD’s Green Swamp Wilderness Preserve East Tract (**Figures B-91, B-92, and B-93**). The wetland is accessed from State Road 471, turning east on Main Grade (unpaved) and through a locked SWFWMD gate (**Figure B-94**). From Main Grade, turn north on Tanic Grade then east on Three Run Grade. The wetland is on the east side of Three Run Grade, approximately three miles from Tanic Grade.

The wetland was determined to be Not Stressed during the February 2023 assessment, as well as during the 2018 assessment. Both assessments were conducted on the west side of the wetland (**Figure B-94**). Green Swamp Bay is included in the DMIT long-term wetlands monitoring program. Monitoring transects were established in 2016, and the 5-year DMIT monitoring event was conducted in 2021.

**Figure B-91.** Green Swamp Bay (DMIT-30), February 2023.

**Figure B-92.** Green Swamp Bay (DMIT-30), February 2023.

**Figure B-93.** Green Swamp Bay (DMIT-30), February 2023.

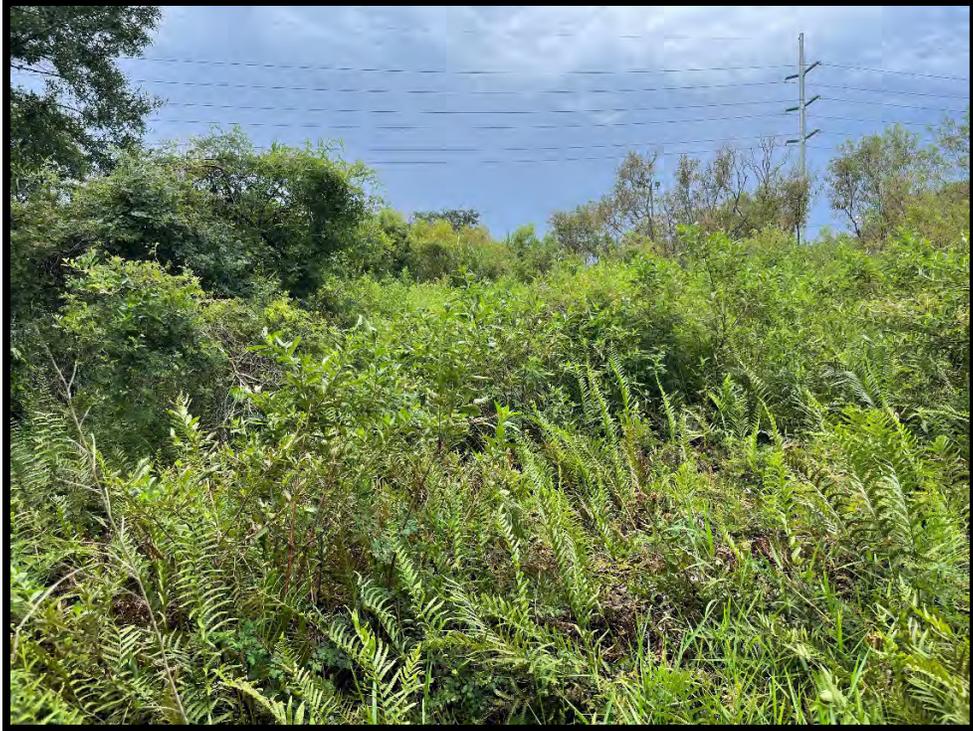
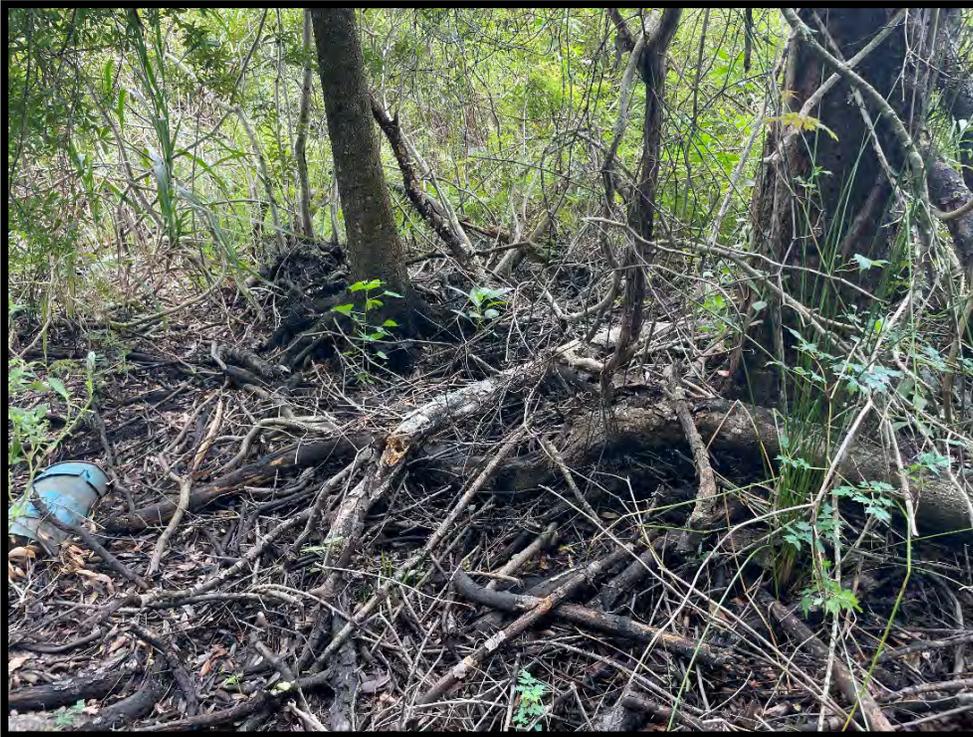
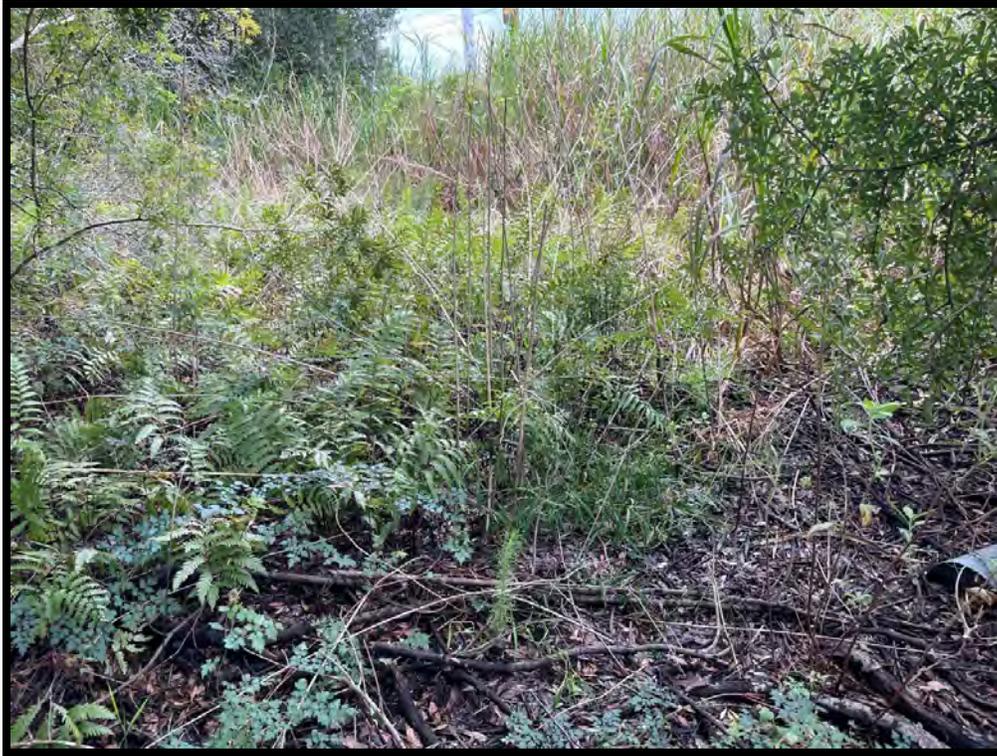
This wetland is a Ridge wetland and a groundwater-dominated marsh located in the Lake Wales Ridge Wildlife and Environmental Area (WEA), Mountain Lake Cutoff Tract, which is owned and managed by the FWC (**Figure B-96, B-97, and B-98**). The wetland is located within the city limits of Lake Wales and is accessed from north end of the tract through a locked gate on East Mountain Lake Cutoff Road, just east of U.S. Highway 27 (**Figure B-99**). Although this wetland is contiguous with the remaining FWC property to the north, it is surrounded by City of Lake Wales facilities (a school and a park) on the east and west sides, and a residential subdivision on the south side, and is bisected by a Duke Energy powerline and easement (**Figure B-99**).

This site, along with Lake Wales Ridge WEA 2, a Class 2 wetland described in Appendix D, is included in the DMIT long-term wetlands monitoring program, and transects will be established in 2025. During both the 2018 and August 2023 assessments, which were conducted on the east side of the wetland (**Figure B-99**), this wetland was determined to be Stressed. The SA water levels for this wetland are monitored at a SWFWMD Regional Observation and Monitor-Well Program (ROMP) well located east of the wetland (**Figure B-100**).

**Figure B-96.** Lake Wales Ridge WEA 1 (DMIT-67), August 2023.

**Figure B-97.** Lake Wales Ridge WEA 1 (DMIT-67), August 2023.

**Figure B-98.** Lake Wales Ridge WEA 1 (DMIT-67), August 2023.

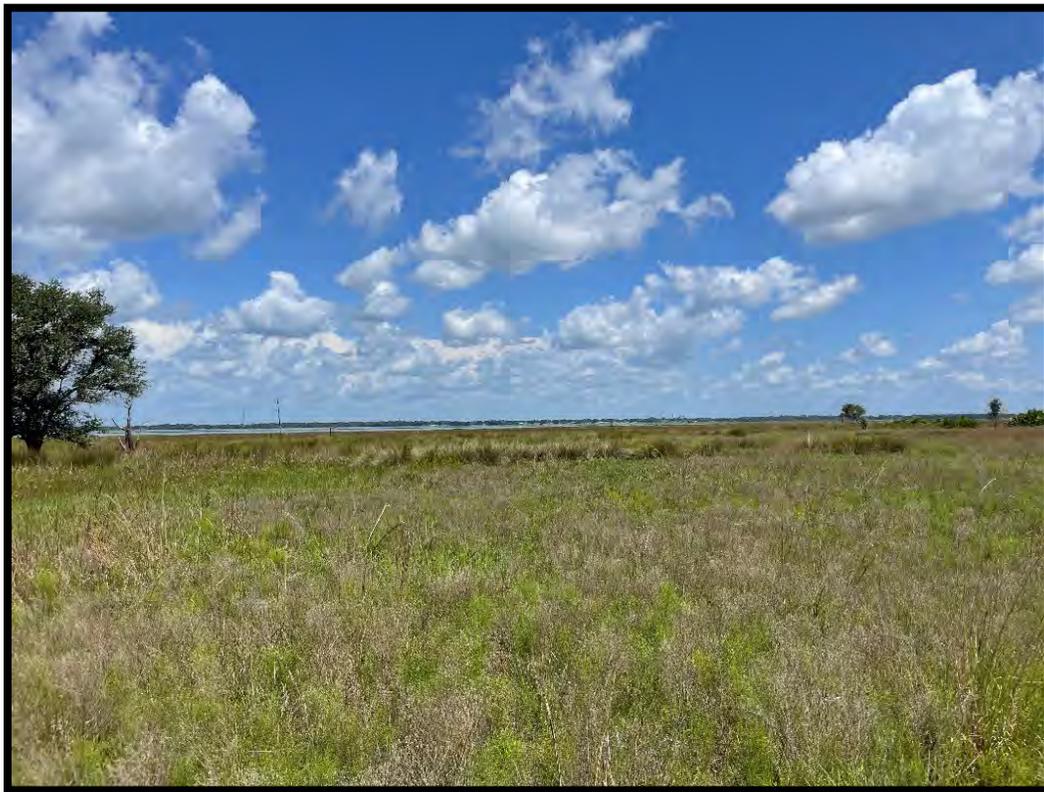
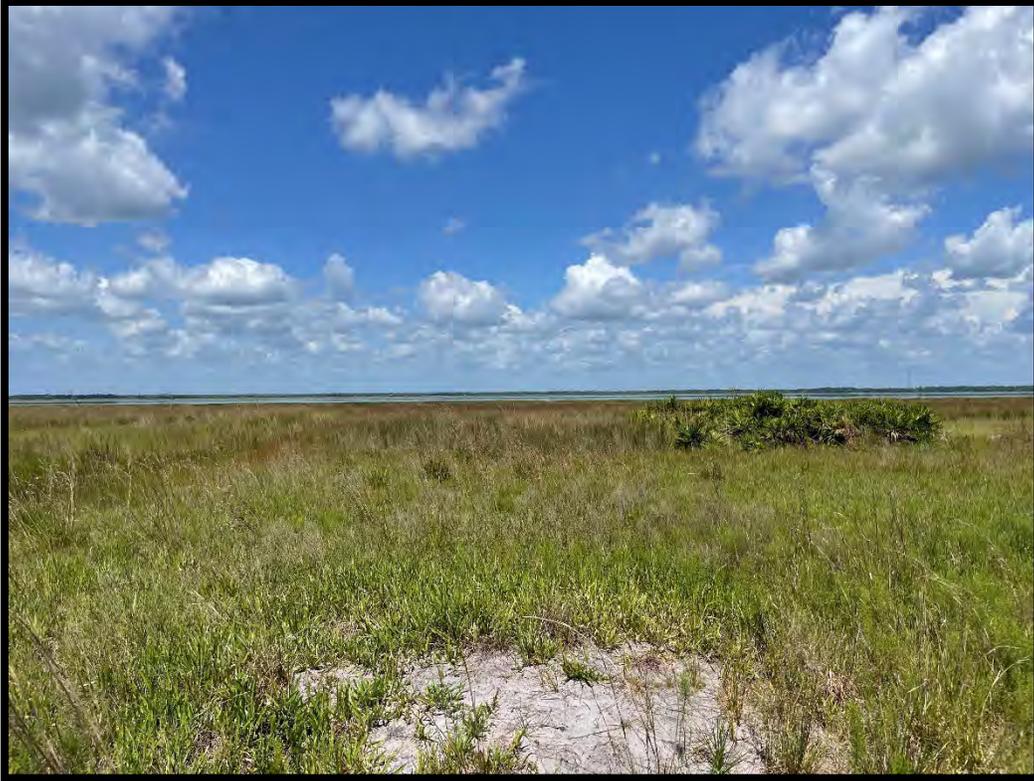
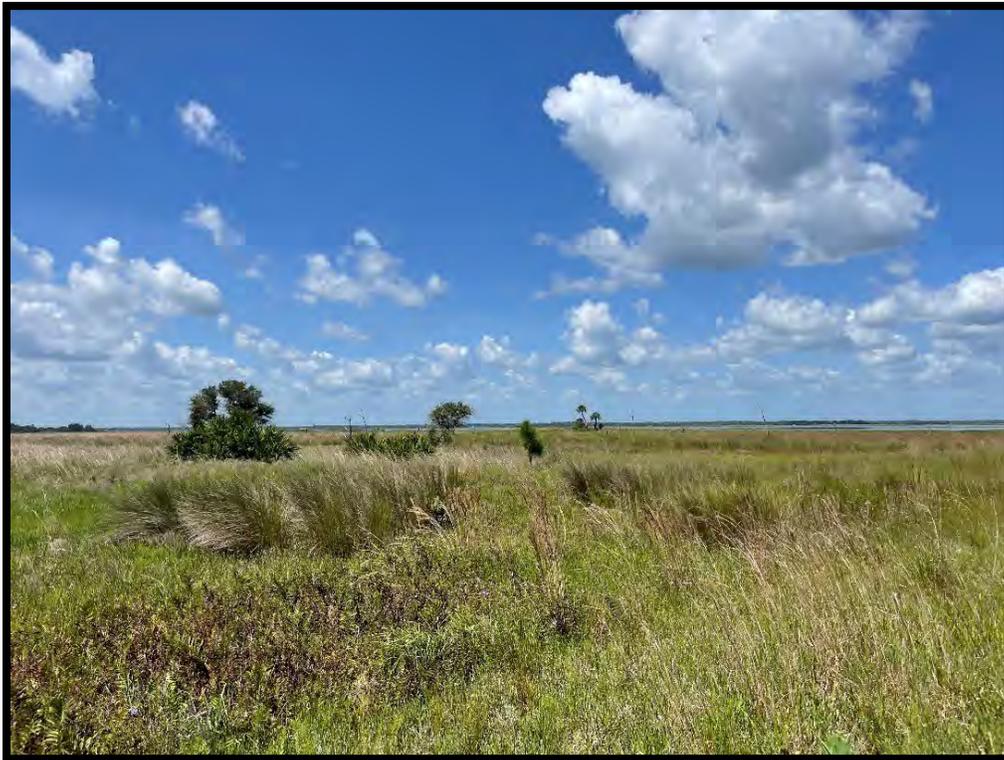
**Figure B-101.** Crooked Lake Prairie (DMIT-136), July 2023.

**Figure B-102.** Crooked Lake Prairie (DMIT-136), July 2023.

**Figure B-103.** Crooked Lake Prairie (DMIT-136), July 2023.

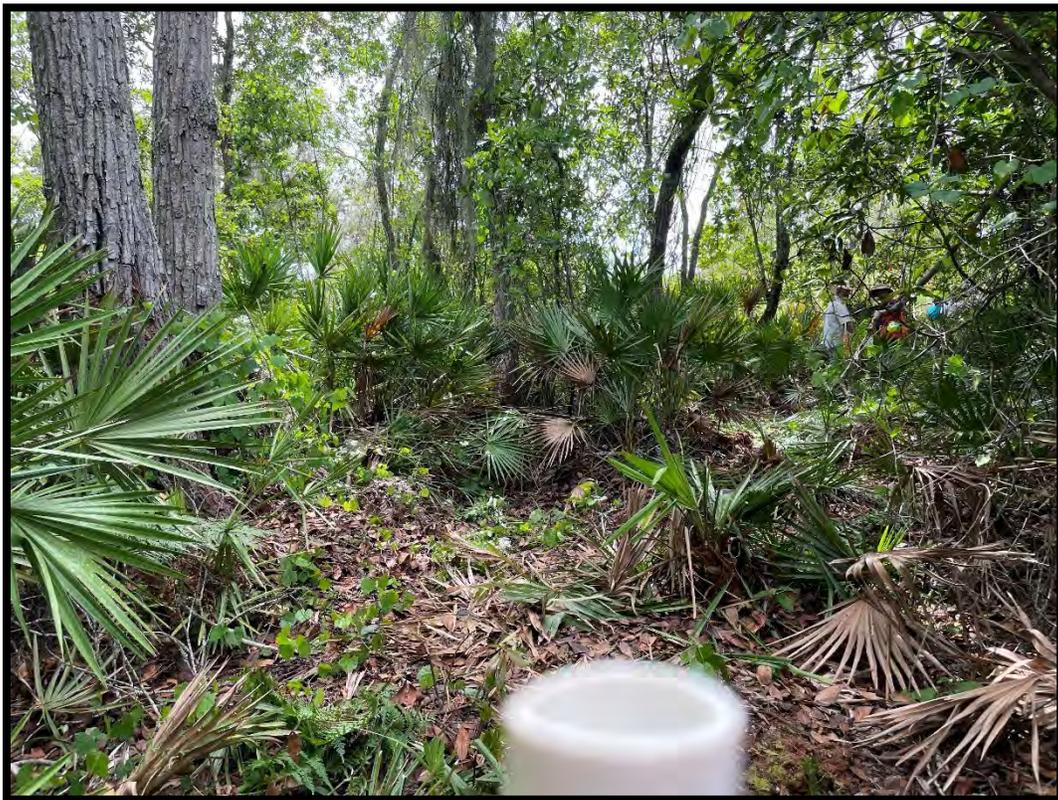
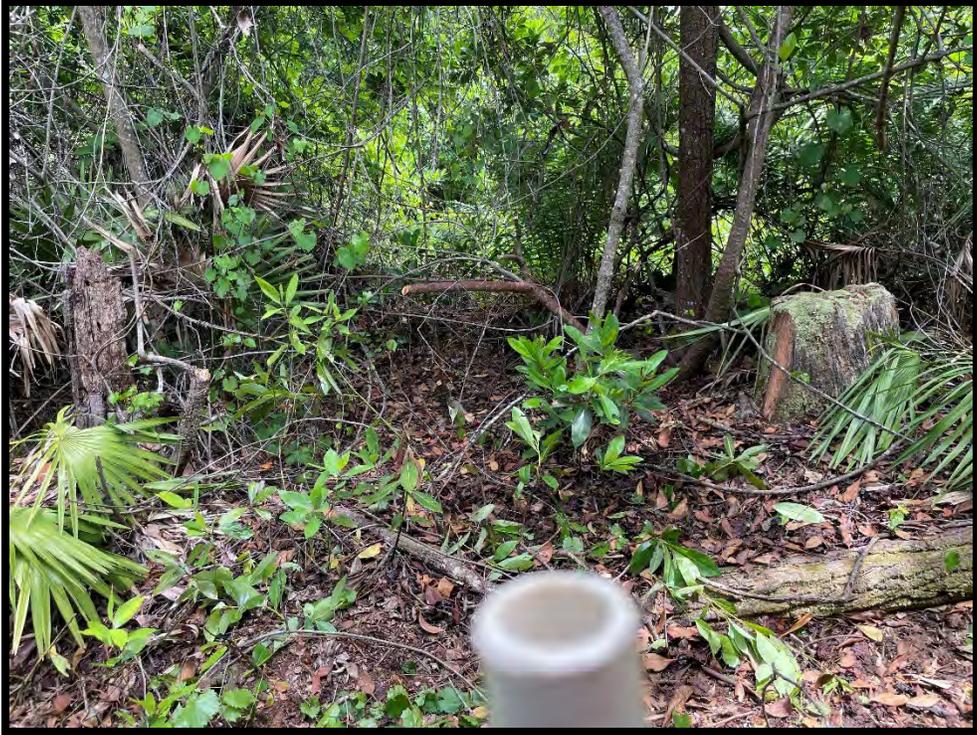
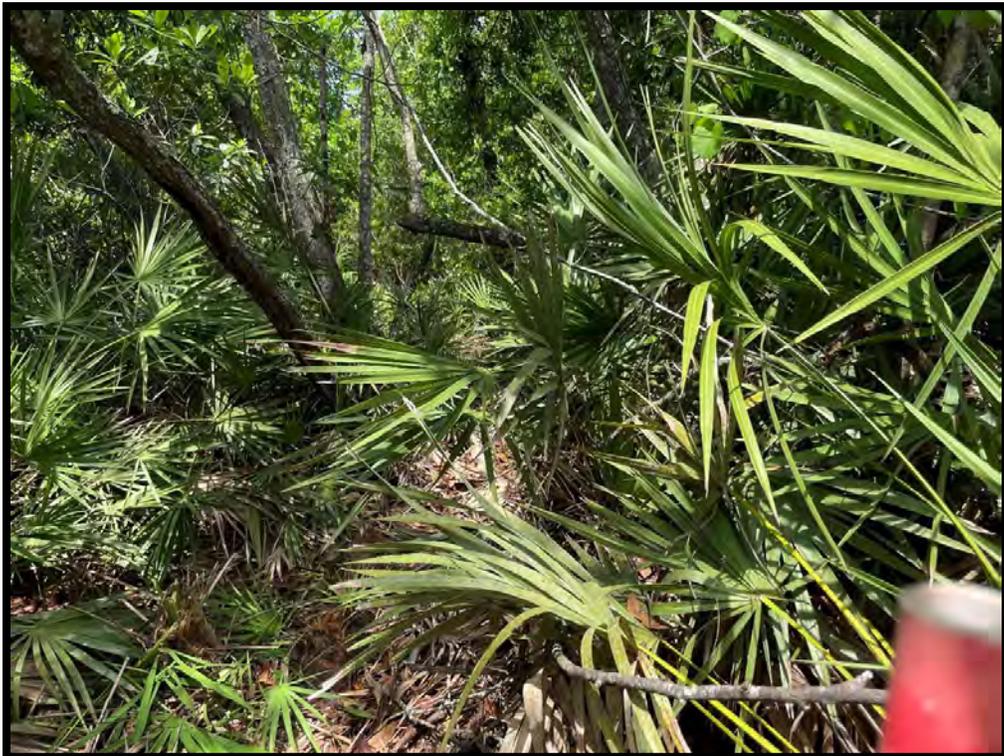
This wetland was determined to be Not Stressed in April 2022. During the September 2018 assessment, it was also determined to be Not Stressed.

**Figure B-106.** Saddle Blanket Scrub 2 (DMIT-154), April 2022.

**Figure B-107.** Saddle Blanket Scrub 2 (DMIT-154), April 2022.

**Figure B-108.** Saddle Blanket Scrub 2 (DMIT-154), April 2022.

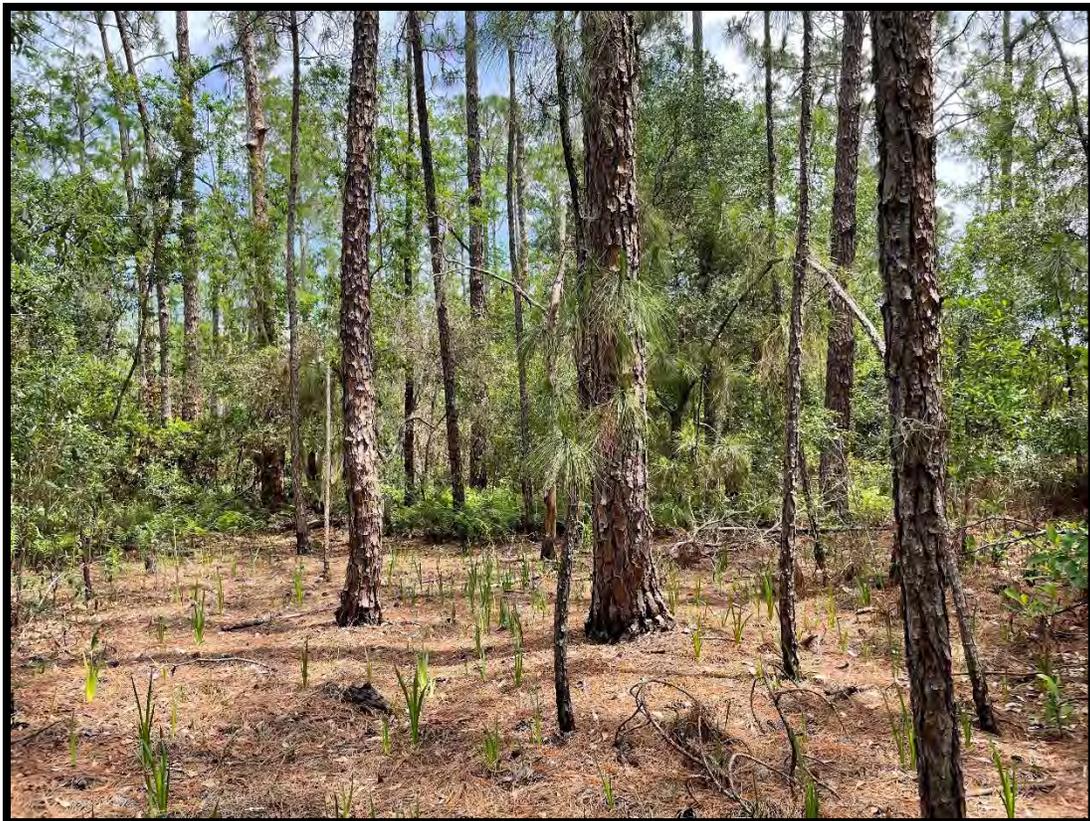
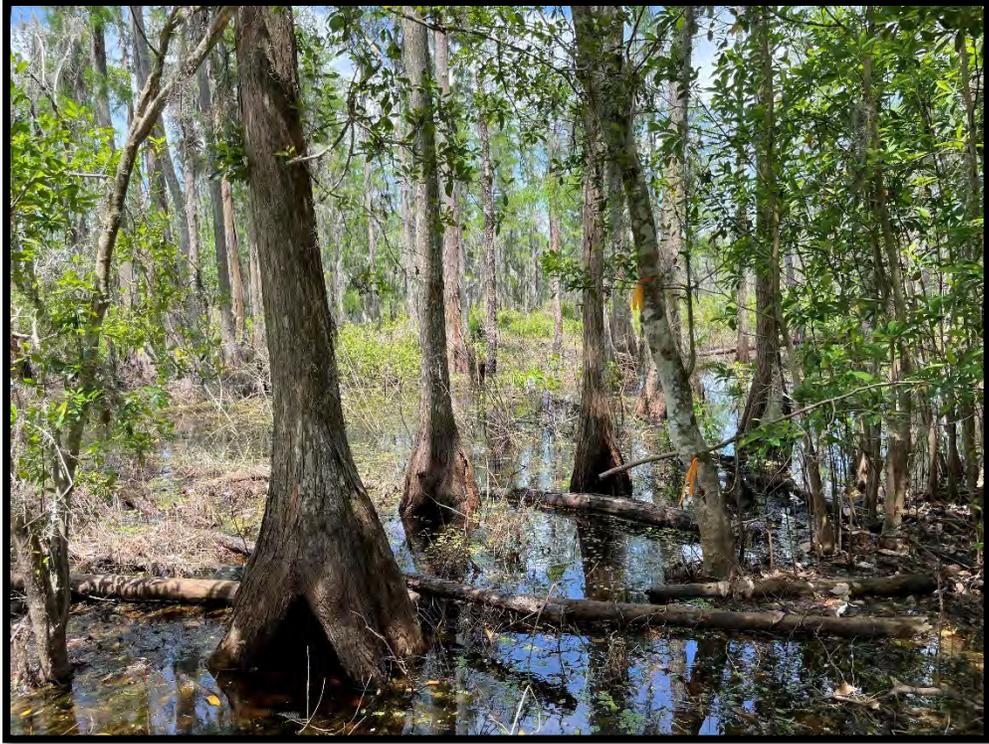
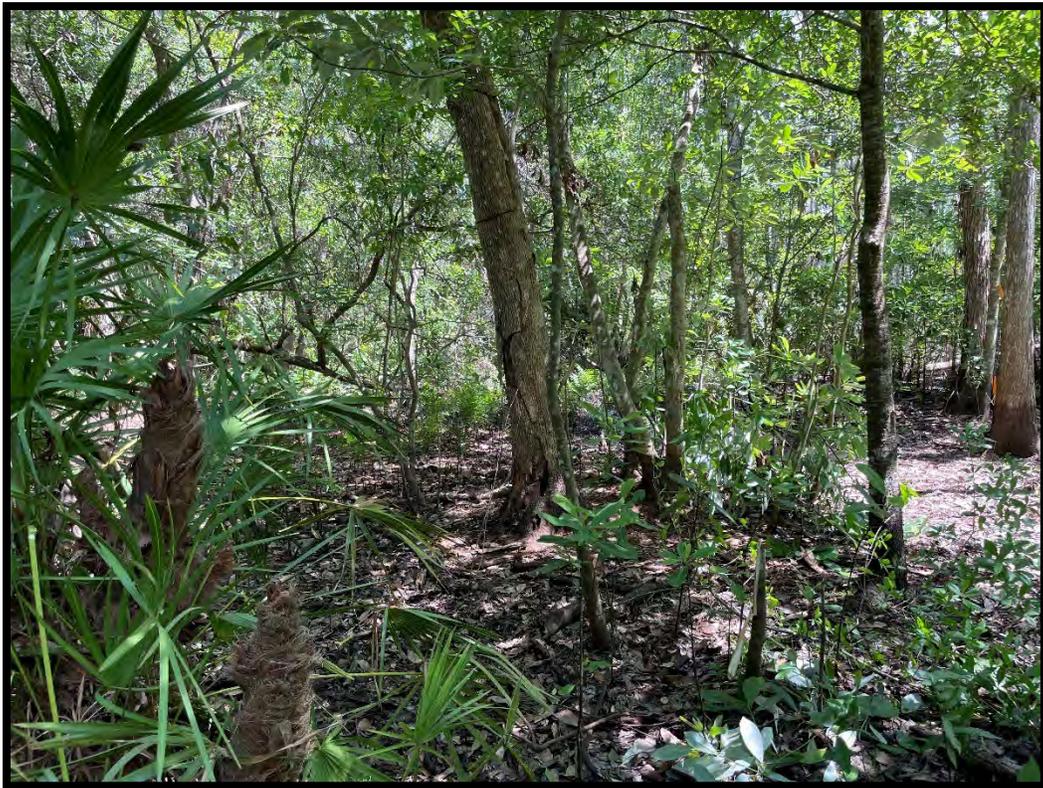
This groundwater-dominated wetland is included in the DMIT long-term wetlands monitoring program and was assessed as Not Stressed in April 2023. It was also determined to be Not Stressed in 2018. Monitoring transects were established in 2023.

**Figure B-111.** Van Fleet 2 (DMIT-161), April 2023.

**Figure B-112.** Van Fleet 2 (DMIT-161), April 2023.

**Figure B-113.** Van Fleet 2 (DMIT-161), April 2023.

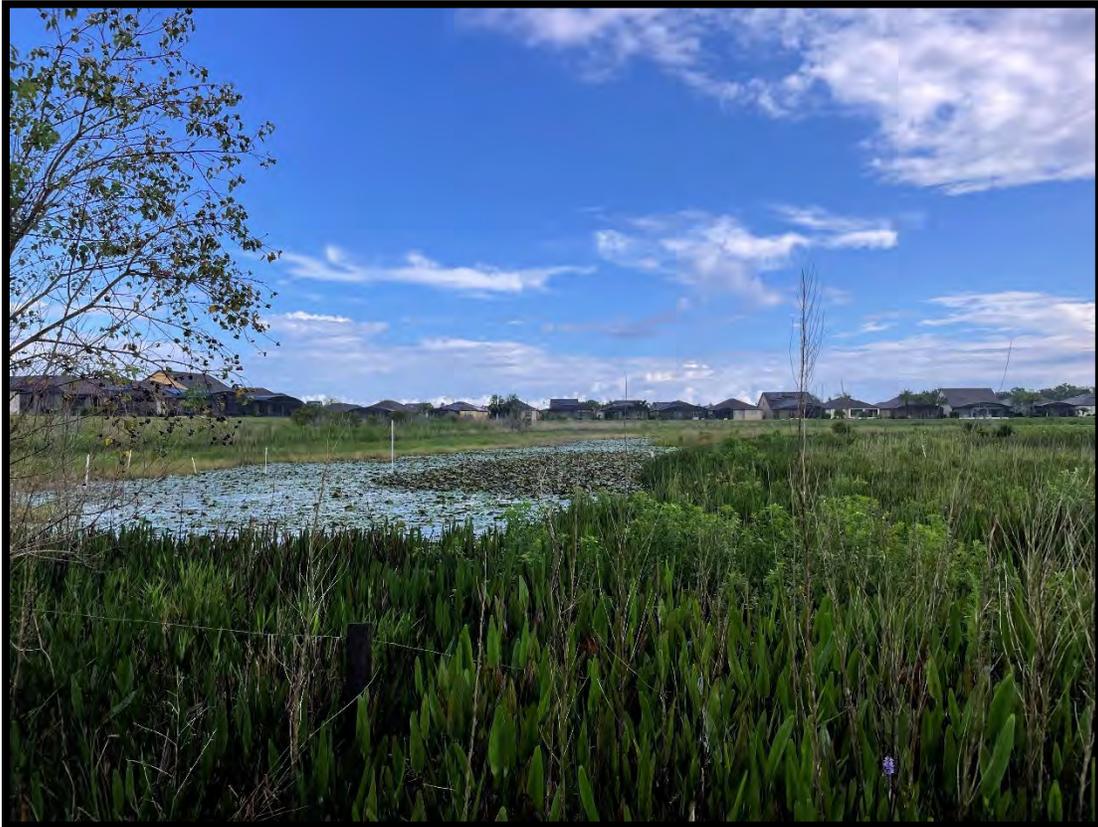
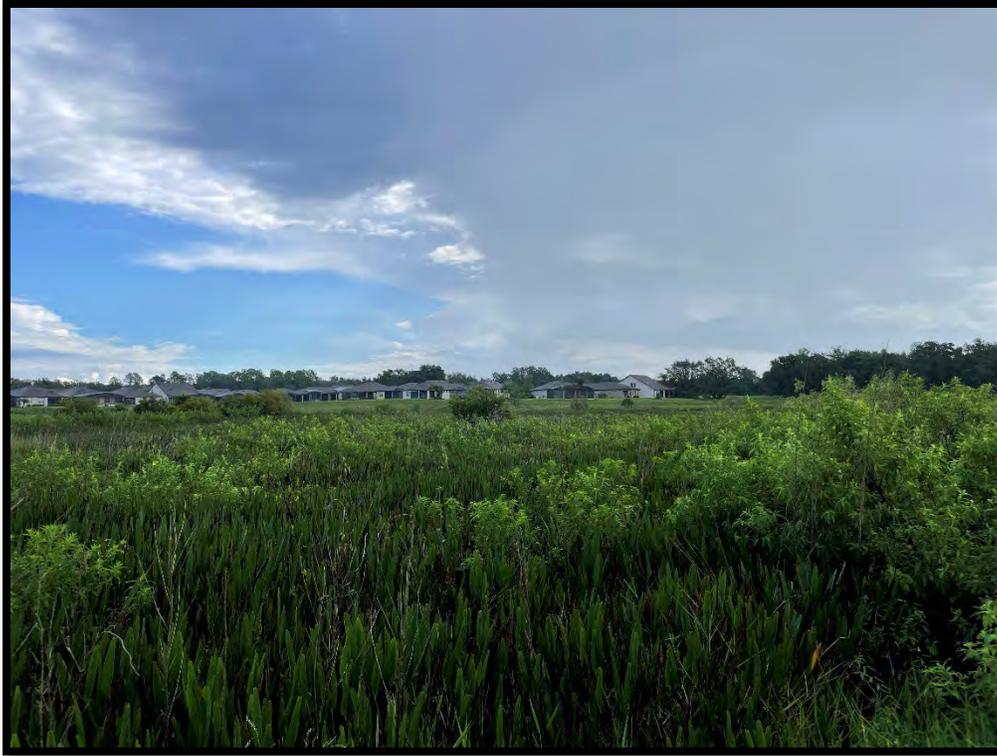
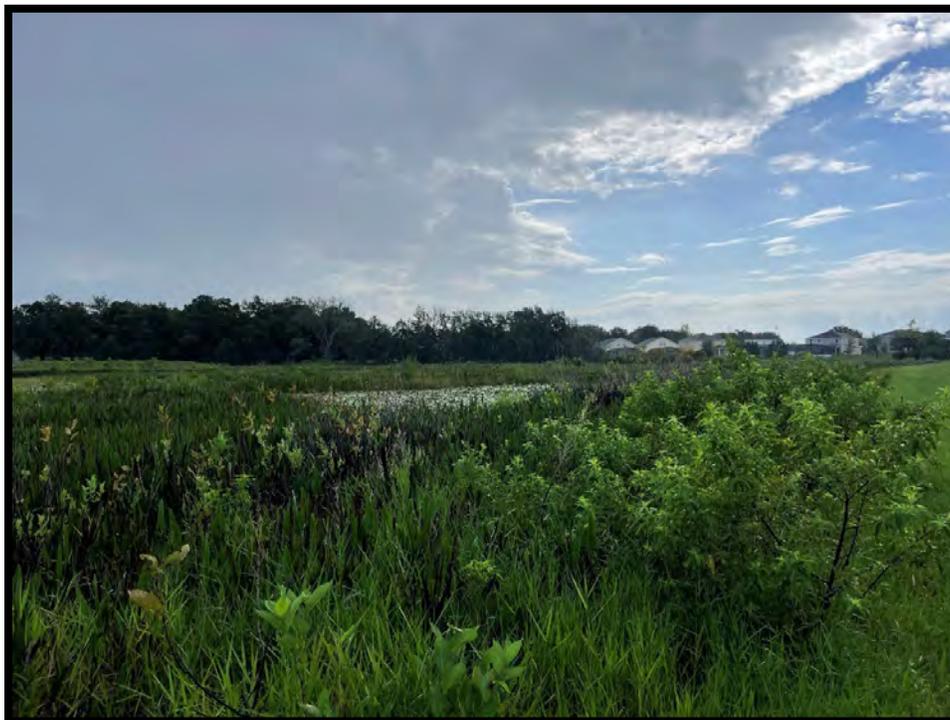
Davenport P1 is a large marsh located in a Plains setting that is located in an area of rapid residential development. The south and eastern boundaries of this wetland are rimmed with houses (**Figures B-116, B-117, B-118, and B-119**). The wetland is accessed from Andalusia Loop off of North Boulevard, east of U.S. Highway 27 (**Figure B-119**).

**Figure B-116.** Davenport P1 (SW-AF), August 2023.

**Figure B-117.** Davenport P1 (SW-AF), August 2023.

**Figure B-118.** Davenport P1 (SW-AF), August 2023.

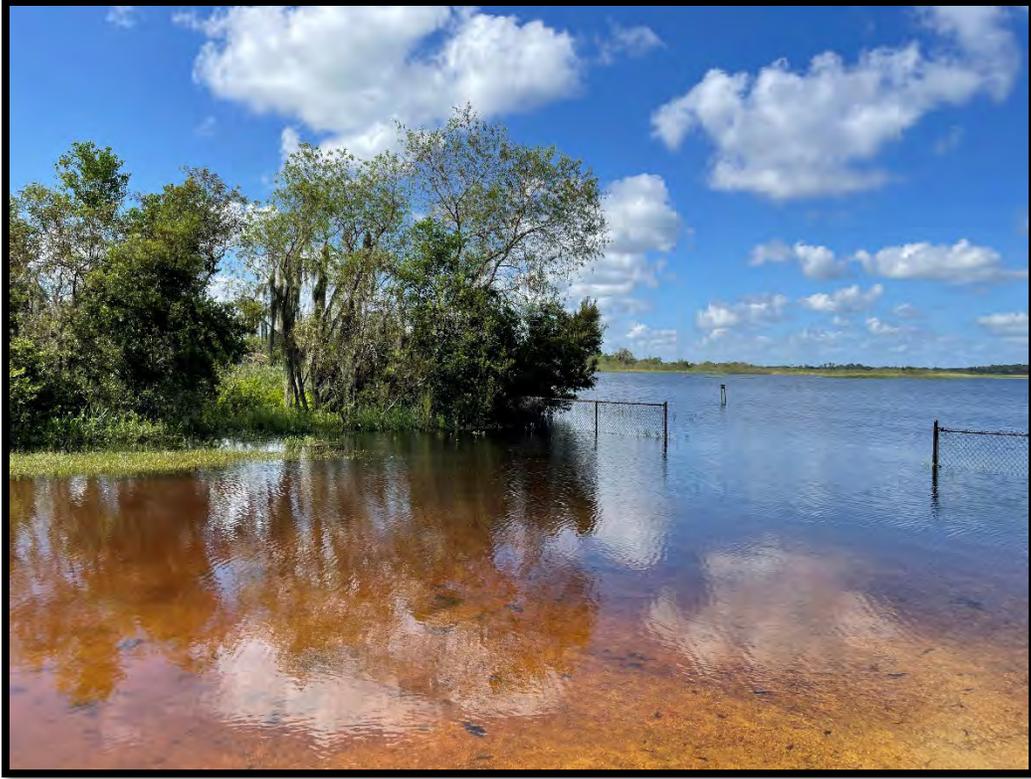
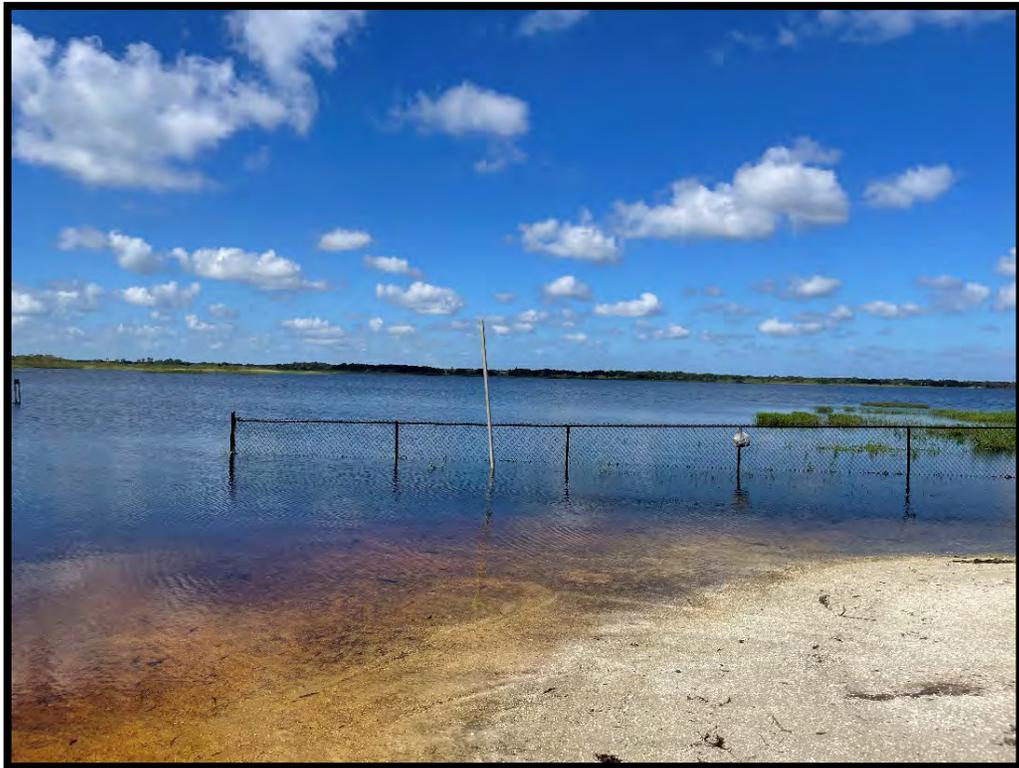
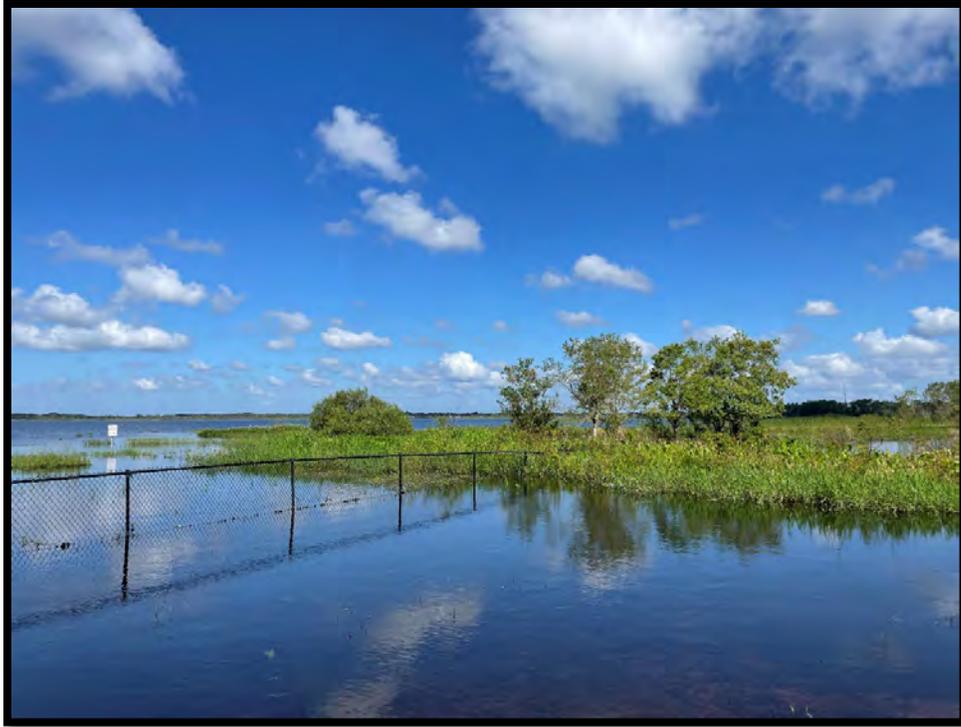
**Figure B-121.** Lake Garfield (SW-JJ), September 2022.

**Figure B-122.** Lake Garfield (SW-JJ), September 2022.

**Figure B-123.** Lake Garfield (SW-JJ), September 2022.

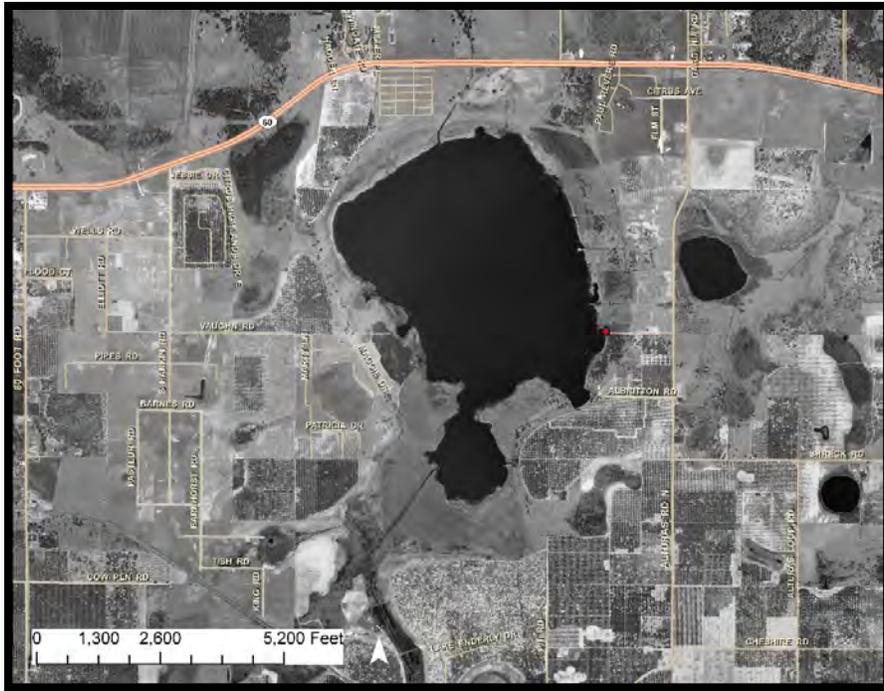
Historic aerial photography shows that the adjacent land use has been, and is currently, predominantly agriculture (**Figures B-124 and B-125**). The outfall for the lake is an excavated channel connecting to the Peace Creek Canal and has existed since before 1941. Based on a review of LiDAR, historic aerial photography, and on-site inspections, the water levels in the lake may have staged higher prior to excavation of the outfall channel.

Figure B-125. Lake Garfield (SW-JJ), circa 1970 aerial photograph.

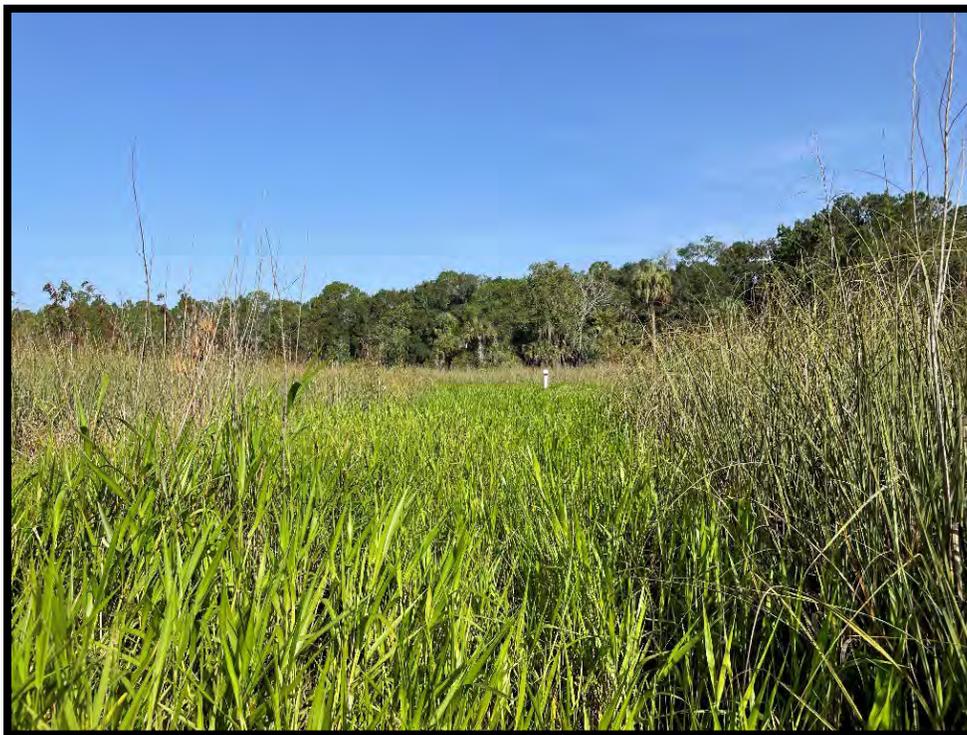
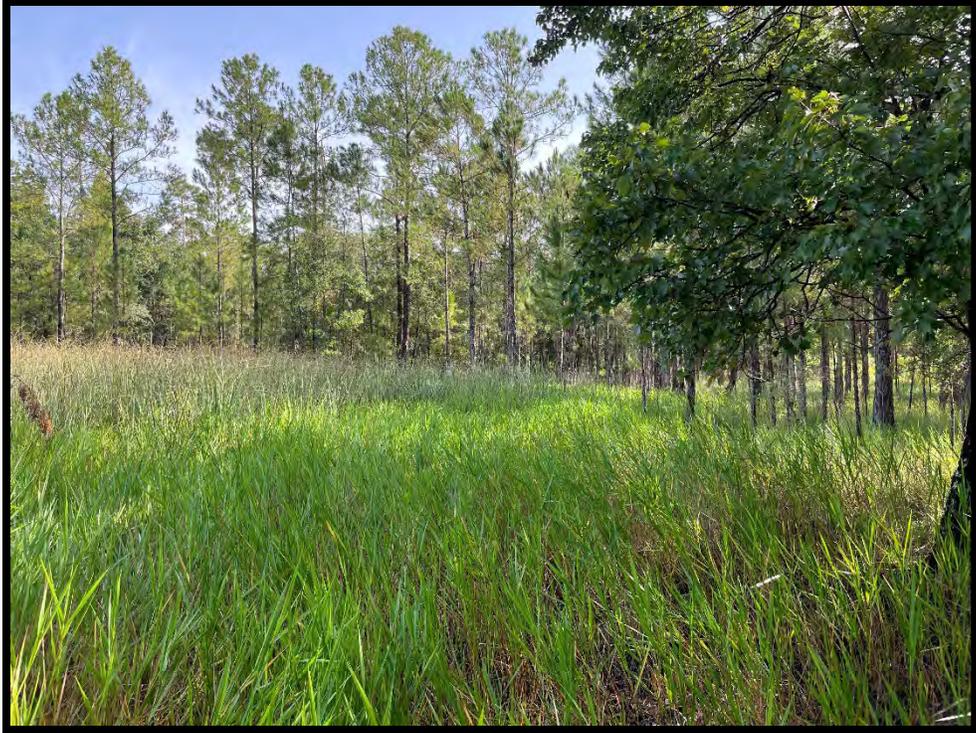
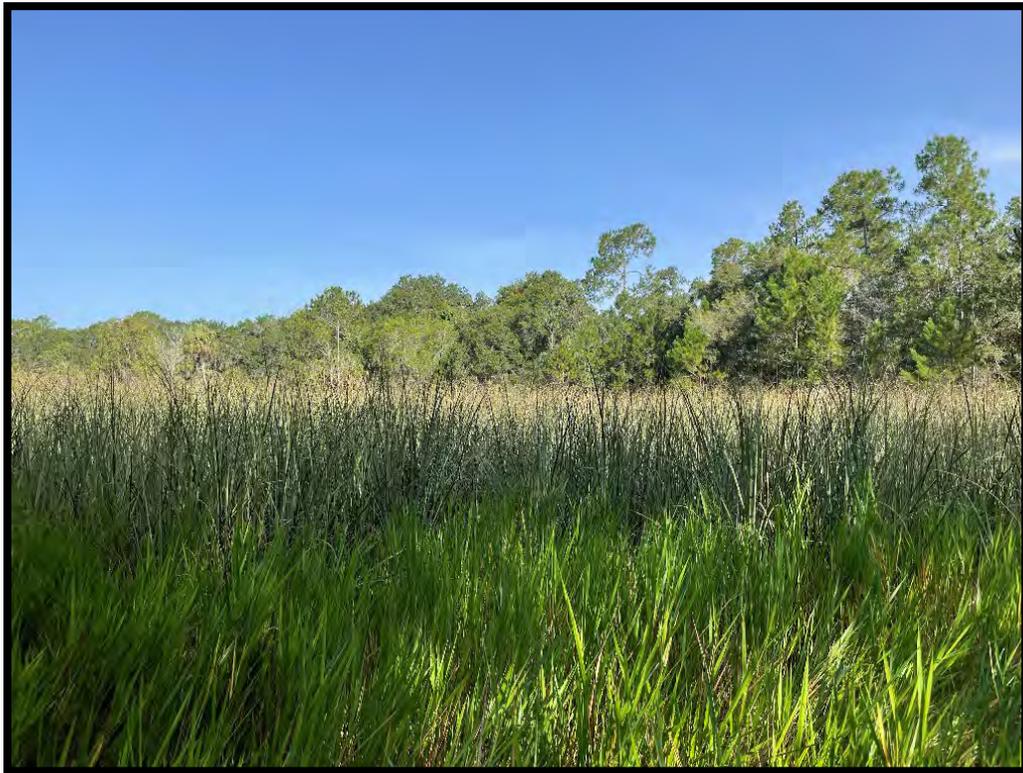
This groundwater-dominated marsh is also within Tampa Bay Water's Cypress Creek Wellfield, which is authorized to withdraw groundwater under WUP No. 200011771.001. Groundwater pumping at the wellfield began in 1976. Pumping quantities peaked in 2001 and this wetland was hydrologically affected; impacts included reduced hydroperiods and water levels. From 2001 through 2003, groundwater withdrawals at the wellfield were substantially reduced and reduced pumping has been maintained to date. The reduced pumping rate is still approximately 15 million gallons per day average; however, pumping quantities are generally less in this area of the wellfield. **Figure B-131** includes the water level data for the selected period of record for the analysis in support of the 2025 RWSP.

The SWFWMD has conducted annual vegetation assessments of the wetland since 2005 using the WAP. While many trees have been lost in the middle area of the wetland due to past over pumping (**Figures B-127, B-128, and B-129**), both the SWFWMD and Tampa Bay Water have determined that this wetland is recovered.

**Figure B-127.** Cypress Creek 190 East Marsh (SW-LF), July 2022.

**Figure B-128.** Cypress Creek 190 East Marsh (SW-LF), July 2022.

**Figure B-129.** Cypress Creek 190 East Marsh (SW-LF), July 2022.

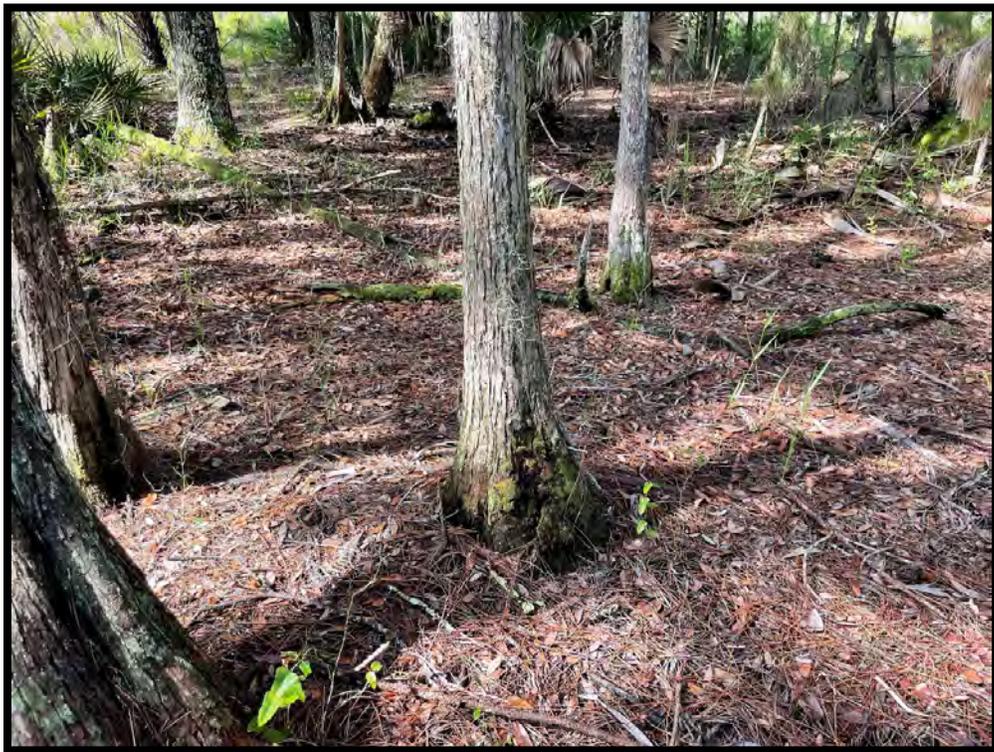
Groundwater pumping at the wellfield began in 1976. Pumping quantities peaked in 2001, and this wetland was impacted by groundwater withdrawals. The impacts included reduced hydroperiod and water levels. From 2001 to 2003 groundwater withdrawals at the wellfield were substantially reduced, and reduced pumping has been maintained to date. However, groundwater pumping still averages approximately 15 million gallons per day.

Since 1980, the SWFWMD has recorded SA water levels in the wetland twice each month (**Figure B-136**). Annual vegetation assessments of the wetland using the WAP have also been conducted since 2005. During the original assessment, as well as during the assessments conducted in 2018 and July 2022, this wetland was determined to be Stressed. Since the wetland is small in size, the entire wetland was assessed.

**Figure B-132.** Cypress Creek 223 B W46 (SW-LG), July 2022.
