# Central Florida Water Initiative

## ASSESSMENT OF EFFECTS OF GROUNDWATER WITHDRAWALS ON GROUNDWATER-DOMINATED WETLANDS IN THE CENTRAL FLORIDA WATER INITIATIVE PLANNING AREA

January 2025

FINAL REPORT APPENDICES

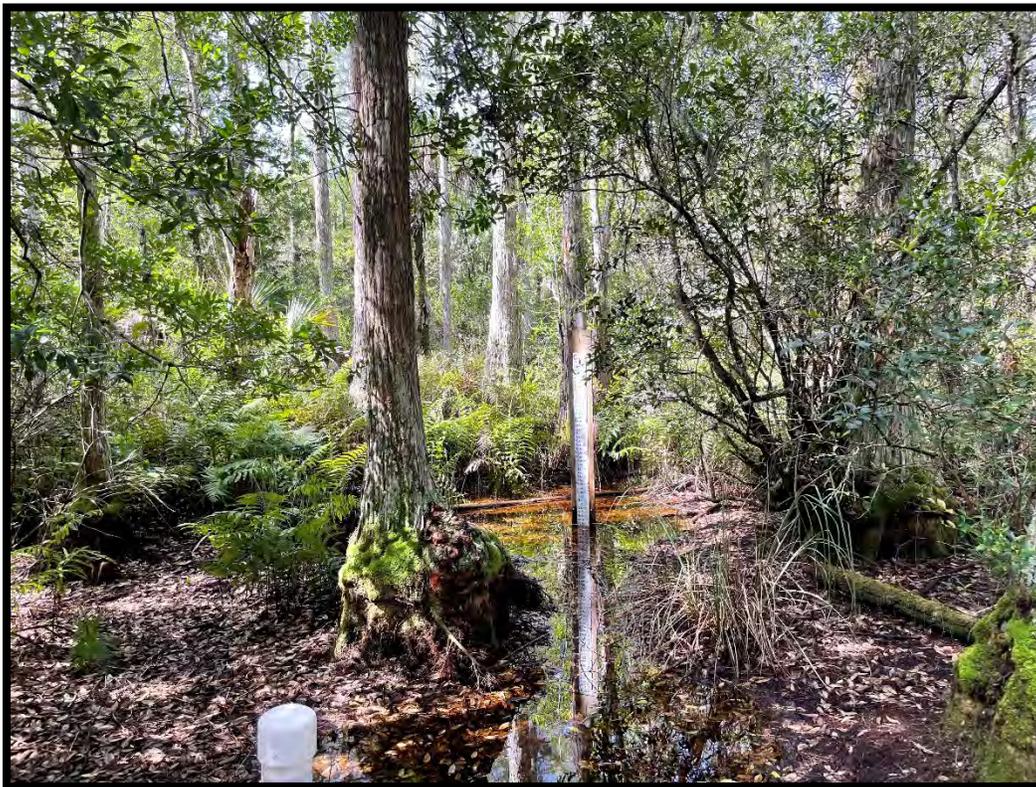
**Figure B-137.** Cypress Creek 211 W33 (SW-LH), July 2022.

This Plains wetland was originally determined to be Stressed for the 2015 CFWI RWSP analysis. However, in July 2022, as well as in 2018, the wetland was determined to be Not Stressed.

Groundwater pumping at the wellfield, which began in 1976, has been reduced in recent years, and as indicated by the review of water level monitoring data, with the exception of the early 2017 drought, the SA levels have increased in recent years (**Figure B-141**). The wetland was hydrologically impacted, e.g., reduced hydroperiod and water levels, as a result of pumping that peaked in 2001. From 2001 to 2003 groundwater withdrawals at the wellfield were substantially reduced, and reduced pumping has been maintained to date.

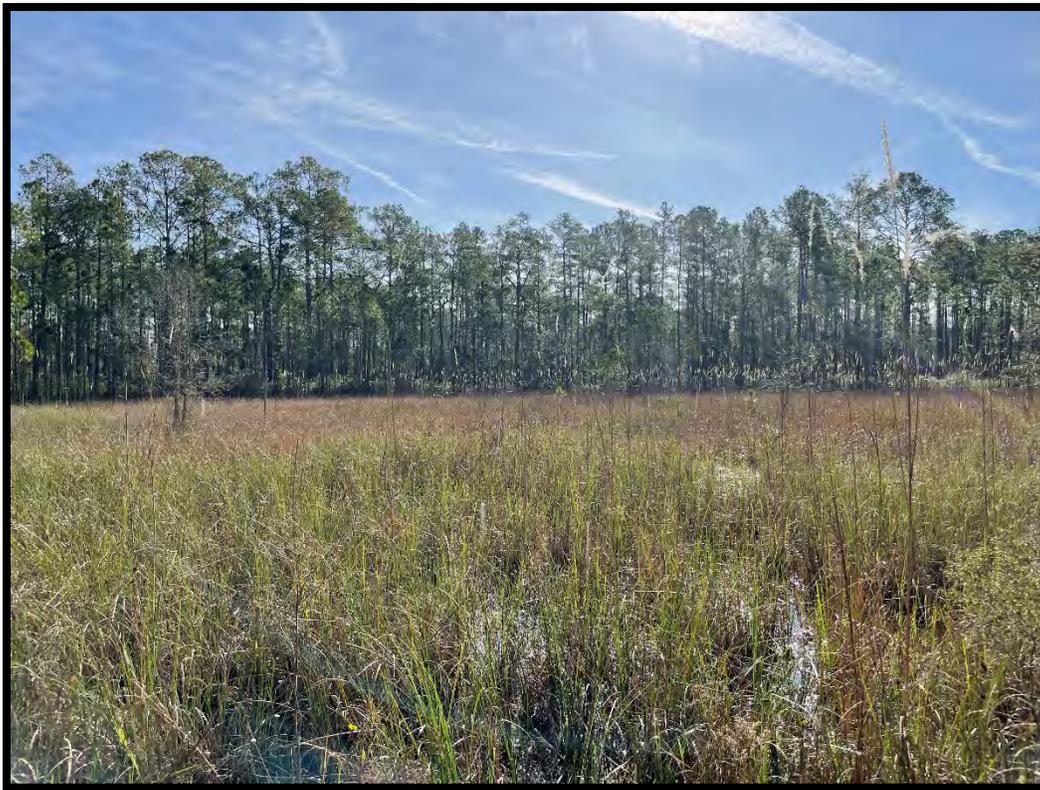
**Figure B-142.** Green Swamp Marsh 304 (SW-LI), January 2023.

Green Swamp Marsh 304 is a groundwater-dominated marsh located in South Sumter County on the SWFWMD's Green Swamp Wilderness Preserve East Tract (**Figures B-142, B-143, and B-144**). It is accessed from State Road 471 through a locked SWFWMD gate, turning east on Main Grade, an unpaved, lime rock road (**Figure B-145**). An unimproved trail, approximately 1,000 feet east of Levee Road and on the south side of Main Grade, leads to the marsh.

This Plains wetland was determined to be Not Stressed in January 2023. The 2018 assessment also determined it to be Not Stressed. Since the wetland is an open marsh and small in size, the entire wetland was assessed. The SWFWMD has recorded SA water levels in the wetland daily since 2006, which vary depending on rainfall (**Figure B-146**). Using the WAP, the SWFWMD has also conducted annual vegetation assessments of the wetland since 2005. Sometime between 1970 and 1984, a borrow pit was excavated and a road constructed on the west side of the wetland (**Figures B-147 and B-148**). Otherwise, there do not appear to be any historic changes to the wetland or adjacent uplands. There are no known hydrologic alterations to the wetland or known significant groundwater withdrawals in the vicinity. The nearest public supply wellfield (City of Lakeland Northeast Wellfield) is approximately 14 miles away.

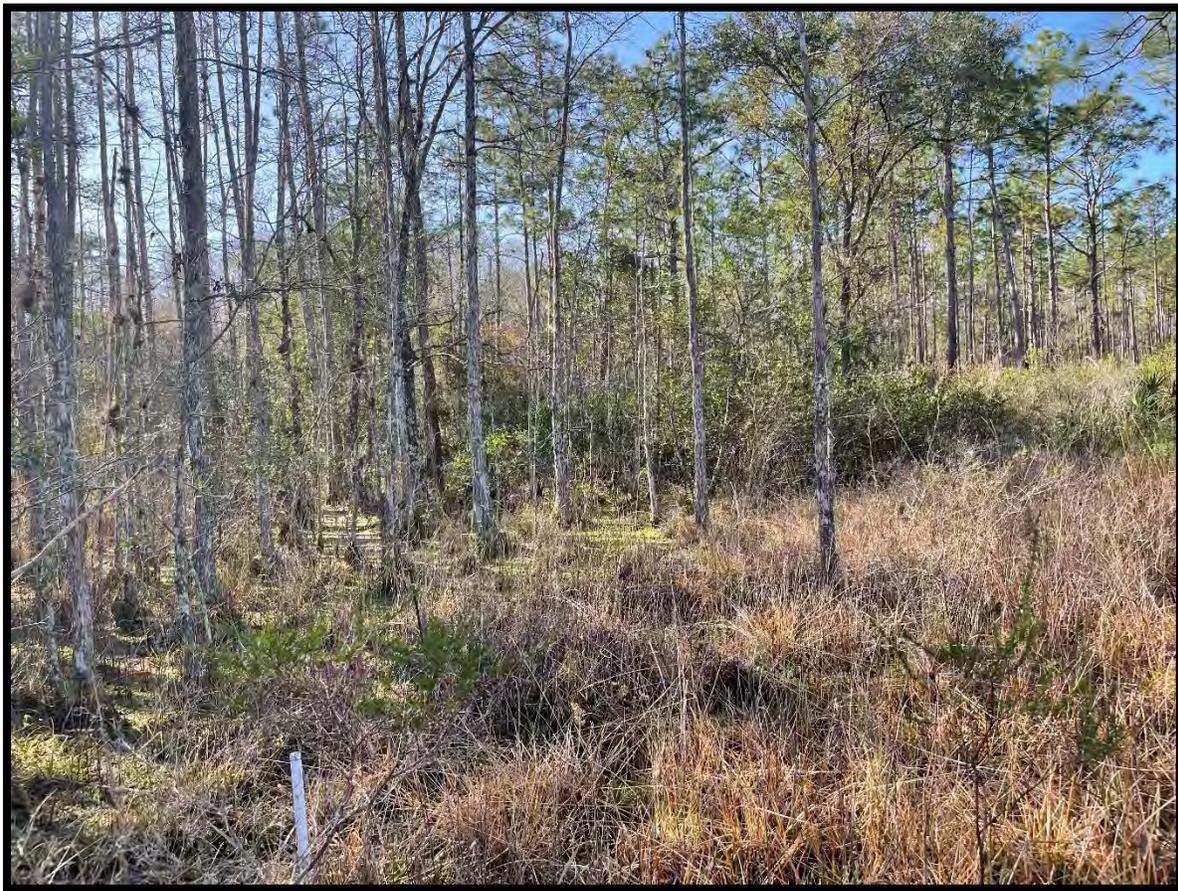
**Figure B-149.** Green Swamp 6, 303 (SW-LJ), February 2023.

Green Swamp 6, 303 is a groundwater-dominated, cypress wetland located in South Sumter County within the Green Swamp Wilderness Preserve East Tract, owned by the SWFWMD (**Figures B-149, B-150, and B-151**). This Plains wetland was determined to be Not Stressed in February 2023; the 2018 assessment also indicated it to be Not Stressed. The wetland is accessed from State Road 471, turning east on Main Grade (unpaved) and through a locked SWFWMD gate (**Figure B-152**). From Main Grade turn north on Tanic Grade and east on Three Run Grade. The February 2023 assessment was conducted from the west side of the wetland (**Figure B-152**).

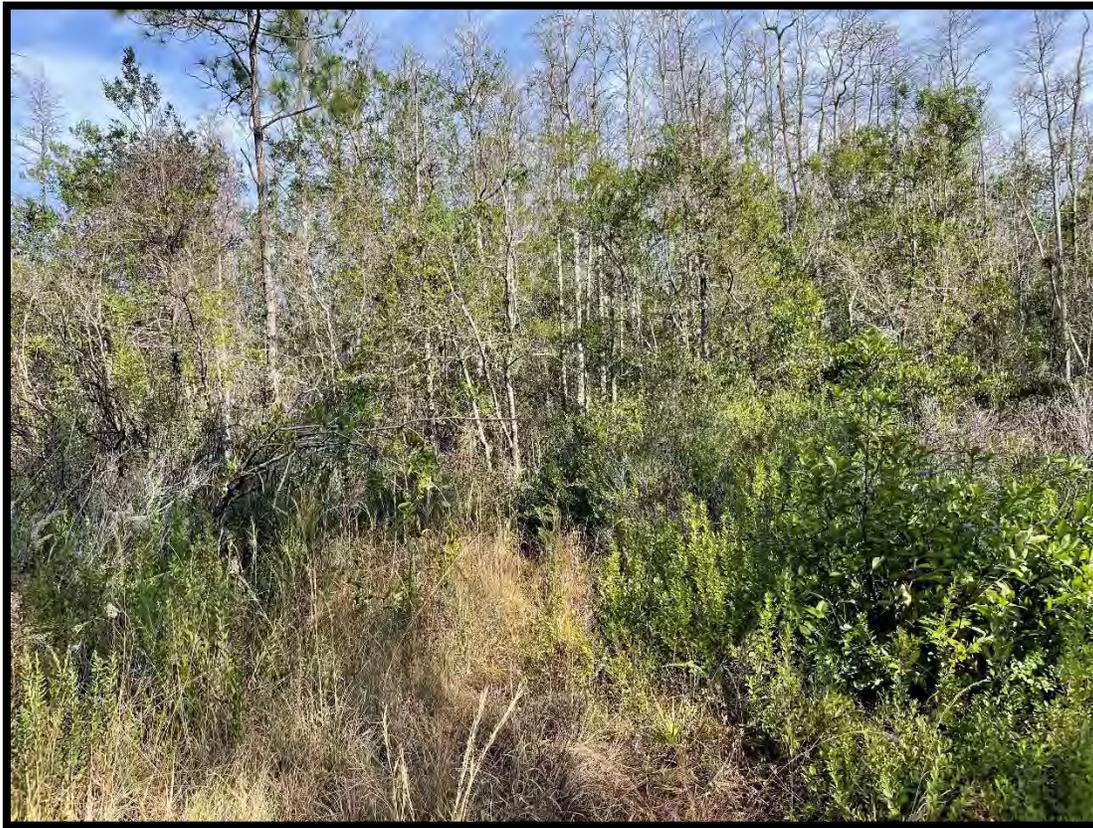
**Figure B-154.** Green Swamp 1, 298 (SW-LM), January 2023.

Green Swamp 1, 298 is located in a Plains setting within the Green Swamp Wilderness Preserve, which is owned and managed by the SWFWMD, and in Southwest Lake County (**Figures B-154, B-155, and B-156**). This cypress wetland was determined to be Not Stressed during both the January 2023 and 2018 assessments. The wetland is accessed from Rock Ridge Road through a locked SWFWMD gate on Tanic Road/Main Grade (unpaved lime rock road) (**Figure B-157**). A fire lane is on the east side of Main Grade approximately 5 miles north of Rock Ridge Road. The wetland is located on the north side of the fire lane, approximately 1,000 feet east of Main Grade. The 2023 assessment was conducted from the south side of the wetland (**Figure B-157**).

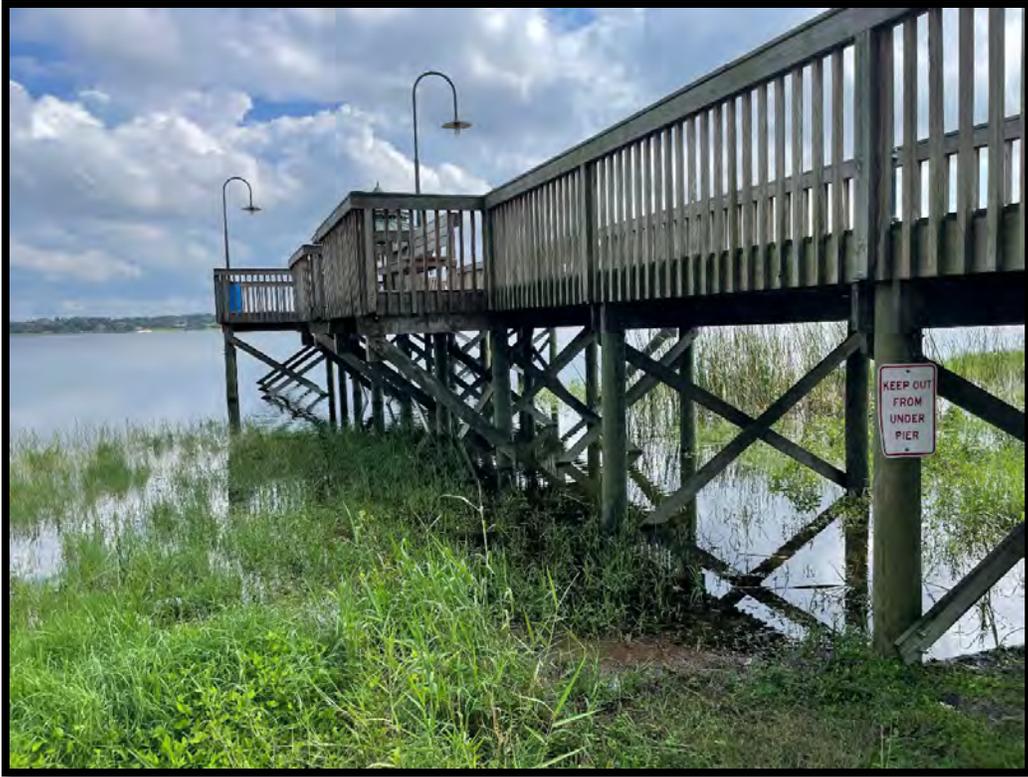
**Figure B-160.** Lake Wales (SW-MM), November 2022.

Lake Wales (also known as Lake Wailes) is a 300-acre Ridge lake located in the heart of the City of Lake Wales, with a mean depth of 10 ft. (**Figure B-159**). The lake's shoreline is completely developed, and it is surrounded by a multi-use paved trail and part of Lake Wailes Park. The November 2022 assessment was conducted along the northwest portion of the lake on and around the park's gazebo and dock (**Figures B-160, B-161, and B-162**).

During the November 2022 assessment, the lake was determined to be Not Stressed; it was also determined to be Not Stressed during the 2018 assessment. Except for mid-2022, water levels in the lake have been trending higher in the recent past (**Figure B-163**). In addition to the stable water levels for many years, a review of historical aerials and the multiple field inspections have indicated that the lake is not hydrologically stressed.

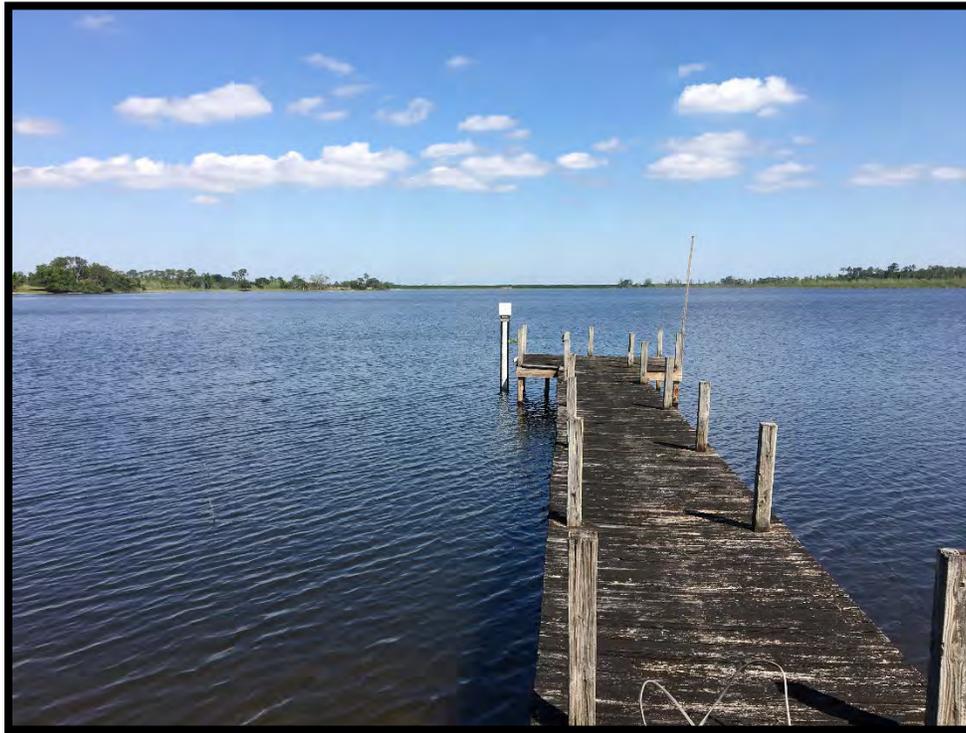
**Figure B-164.** Big Gum Lake (SW-QA), April 2018.

Big Gum Lake is an approximately 200-acre Ridge lake located in Polk County. It was determined to be Not Stressed during the August 2023 assessment. The stress status of the lake resulting from the 2018 assessment was also Not Stressed. Much of the shoreline of the lake is natural with some residential development and citrus groves (**Figures B-164, B-165, B-166, B-167, and B-168**). The lake typically is accessed at the location of the SWFWMD staff gauge, a private residence off Mammoth Grove Road. Access to the staff gauge location in August 2023 was not possible because of a new locked gate. Therefore, the assessment was conducted from the road, and obtaining updated photos was not possible (and the 2018 photos are included below).

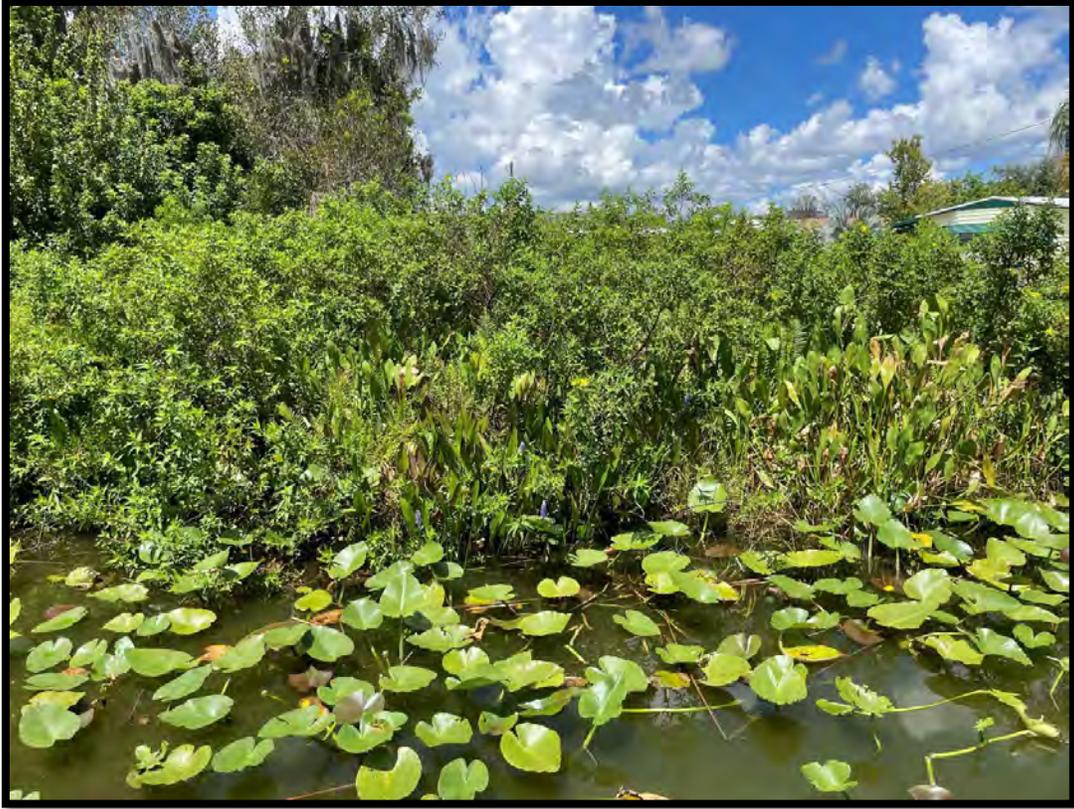
**Figure B-170.** Bonnet Lake (SW-QB), August 2022.

Bonnet Lake is a 268-acre Ridge lake in Highlands County; it has a maximum depth of about 10 ft. (**Figures B-170, B-171, and B-172**). Much of the surrounding land has been developed into mobile home and RV parks, as well as residential development. The lake was accessed from Lake Bonnet Village on the north side of the lake (**Figure B-173**). Even though it is not included in the CFWI Planning Area, it has been included in the Class 1 wetlands dataset since the original analysis in support of the 2015 CFWI RWSP demonstrated that it was representative of groundwater-dominated wetlands in the CFWI Planning Area.

During both the August 2022 and 2018 assessments, Bonnet Lake was determined to be Not Stressed. Water levels have been measured in the lake since 2004; and the data for the period of record selected for the analysis in support of the 2025 CFWI RWSP are shown in **Figure B-174**.

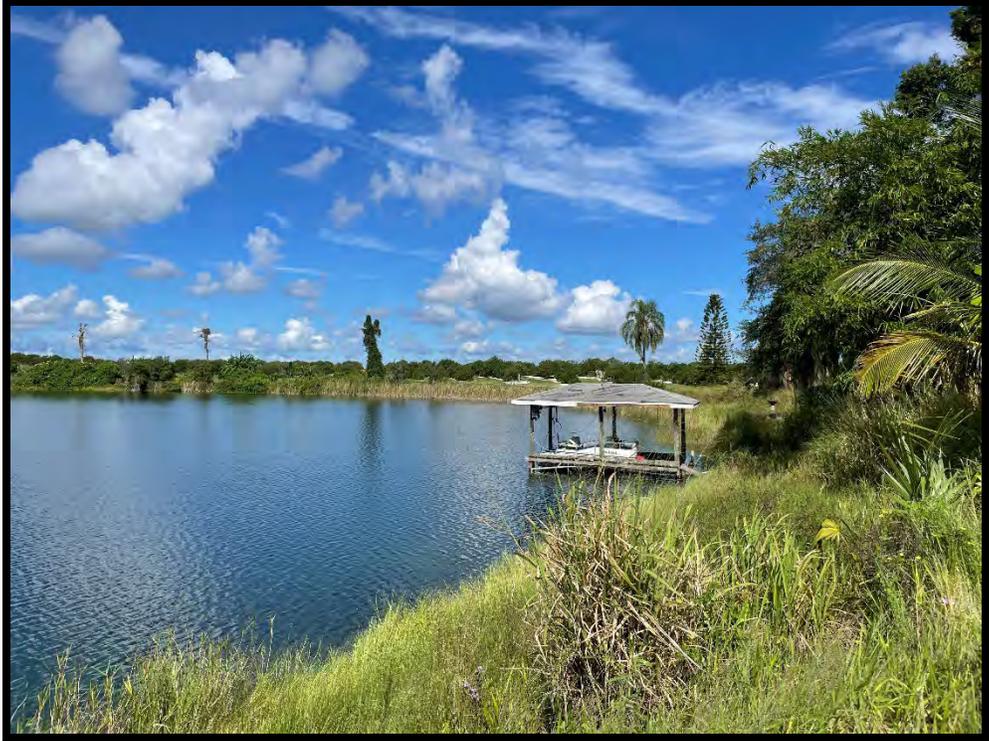
**Figure B-175.** Buck Lake (SW-QC), August 2022.

Buck Lake is a 10-acre Ridge lake in Highlands County, located about 4 miles south of Lake Placid on U.S. Highway 27 (**Figures B-175, B-176, and B-177**). This lake has been included in the Class 1 wetlands dataset since the original analysis in support of the 2015 CFWI RWSP even though it is not included in the CFWI Planning Area.

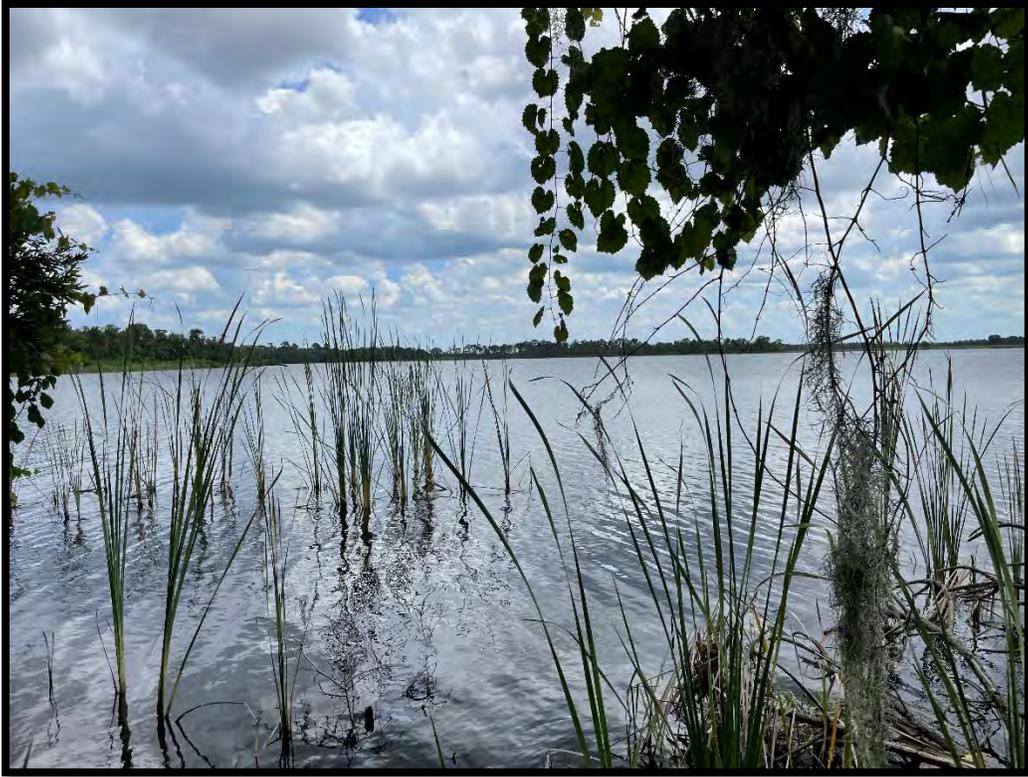
**Figure B-180.** Gator Lake (SW-QD), August 2023.

While the lake was determined to be Stressed during the 2018 assessment, the August 2023 assessment indicated that Gator Lake was Not Stressed. Evidence indicates that hydrologic stress, in the form of a shift in plant communities (e.g., upland plants invading wetlands) and slight soil subsidence and oxidation, has occurred historically along the lake shore on the site where the staff gauge is accessed (**Figures B-183 and B-184**). However, there was no change from April 2017 through August 2023, indicating stable conditions. A review of the historical aerials from the 1940s through the present indicated no change in the lake level. **Figure B-186** includes the period-of-record water level data used for the current analysis.

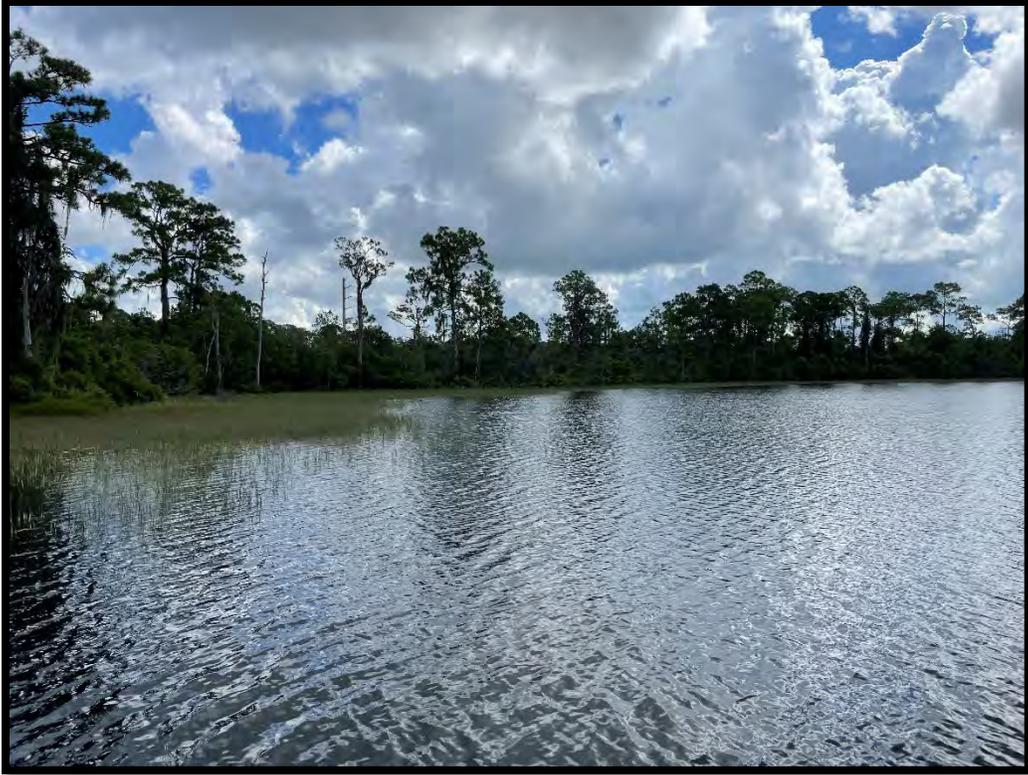
**Figure B-187.** Lake Annie (Highlands) (SW-QE), August 2022.

Lake Annie is a pristine, 90-acre sinkhole lake located in a Ridge setting at the northern end of Archbold Biological Station in Highlands County (**Figures B-187, B-188, B-189, and B-190**). While the lake is located in a Ridge physiographic province, it lies in a valley within the Lake Wales Ridge and is surrounded by flatwoods. This lake has been included in the Class 1 wetlands dataset since the original analysis in support of the 2015 CFWI RWSP even though it is not included in the CFWI Planning Area.

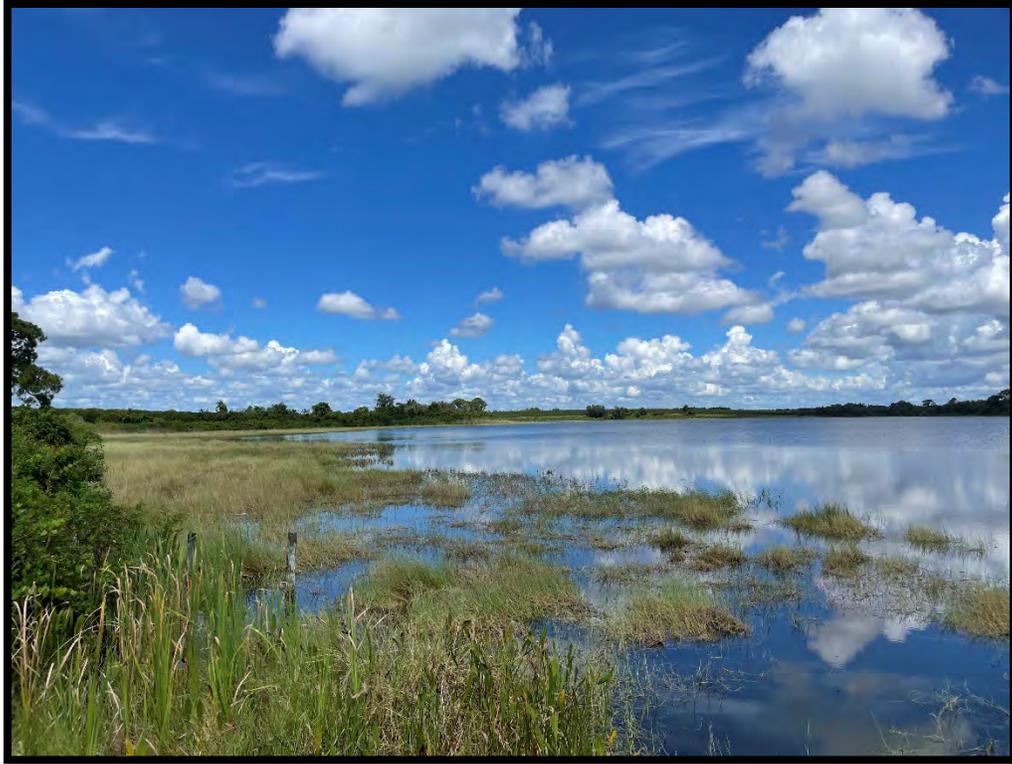
**Figure B-193.** Lake Apthorpe (SW-QF), August 2022.

Lake Apthorpe is a Ridge lake located in Highlands County (**Figures B-193, B-194, and B-195**). Even though it is not included in the CFWI Planning Area, this lake has been included in the Class 1 wetlands dataset since the original analysis in support of the 2015 CFWI RWSP was conducted. The August 2022 assessment was conducted at the public boat ramp and dock on the south side of the lake, which is accessed from U.S. Highway 27 and St. John Street (**Figure B-196**).

While most of the lands to the north, northeast, east, and southeast are undeveloped, lands to the south, west, and northwest consist of citrus groves. During both the August 2022 and 2018 assessments, Lake Apthorpe was determined to be Not Stressed. Water levels have been measured in the lake since 2003; they typically vary about two feet (**Figure B-197**).

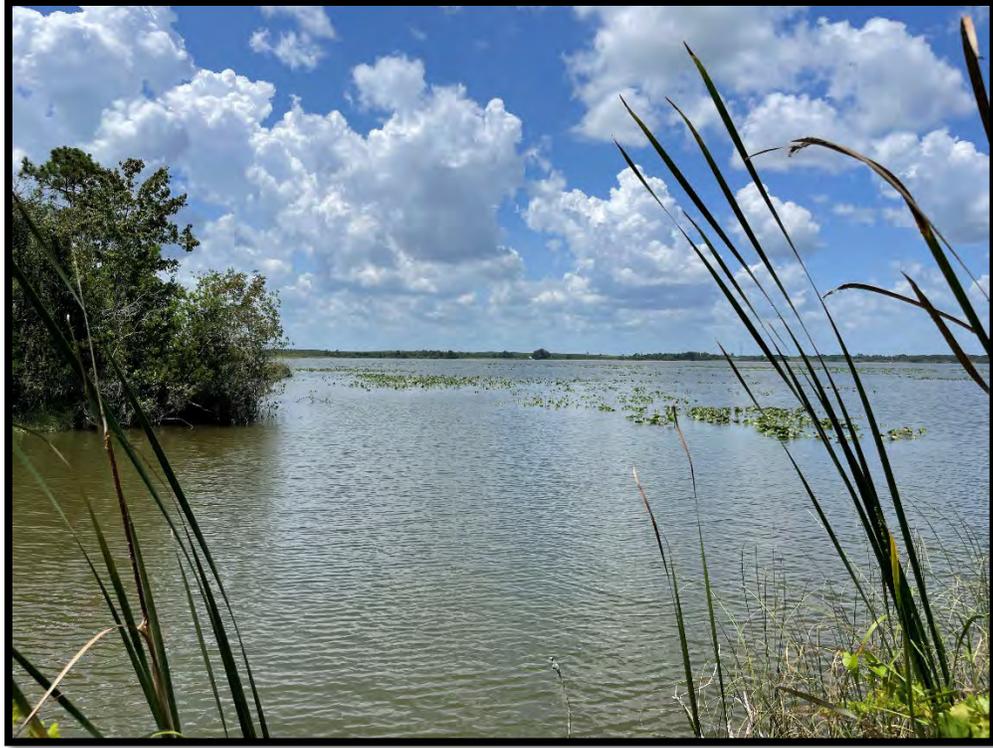
**Figure B-198.** Lake Leonore (SW-QH), July 2023.

Lake Leonore is 393-acre Ridge lake located near Babson Park in Polk County (**Figures B-198, B-199, and B-200**). The July 2023 assessment was conducted at the northeast corner of the lake along a dirt road off Murray Road (**Figure B-201**). There is a large swamp contiguous to the lake to the north, and the land surrounding the rest of the lake is in citrus.

At the assessment site, there is a large pump and piping indicating that water is withdrawn from the lake for agricultural purposes (**Figure B-200**). Lake Leonore was determined to be Not Stressed during both the July 2023 and 2018 assessments. Water levels have been measured in the lake since 2004, and water levels have shown an increasing trend since 2013 (**Figure B-202**).

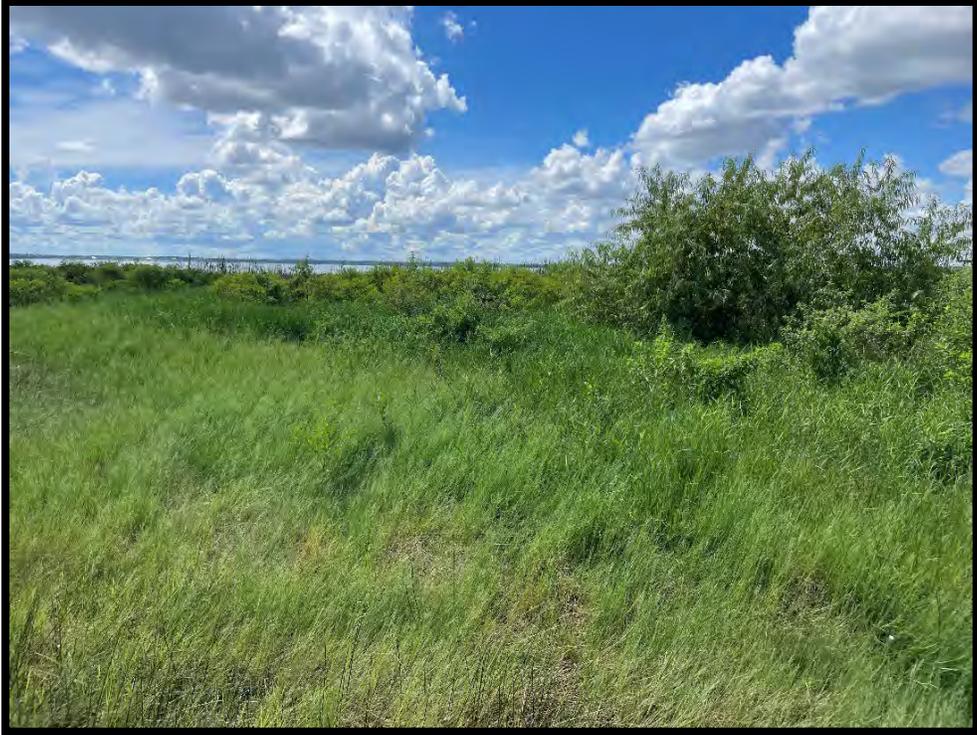
**Figure B-203.** Lake Placid (SW-QI), August 2022.

The August 2022 assessment was conducted at the public boat ramp located on the west side of the lake on Placid View Drive (**Figure B-206**). During both the August 2022 and 2018 assessments, Lake Placid was determined to be Not Stressed. Water levels have been measured in the lake since 2003 and have been on a decreasing trend in recent years (**Figure B-207**).

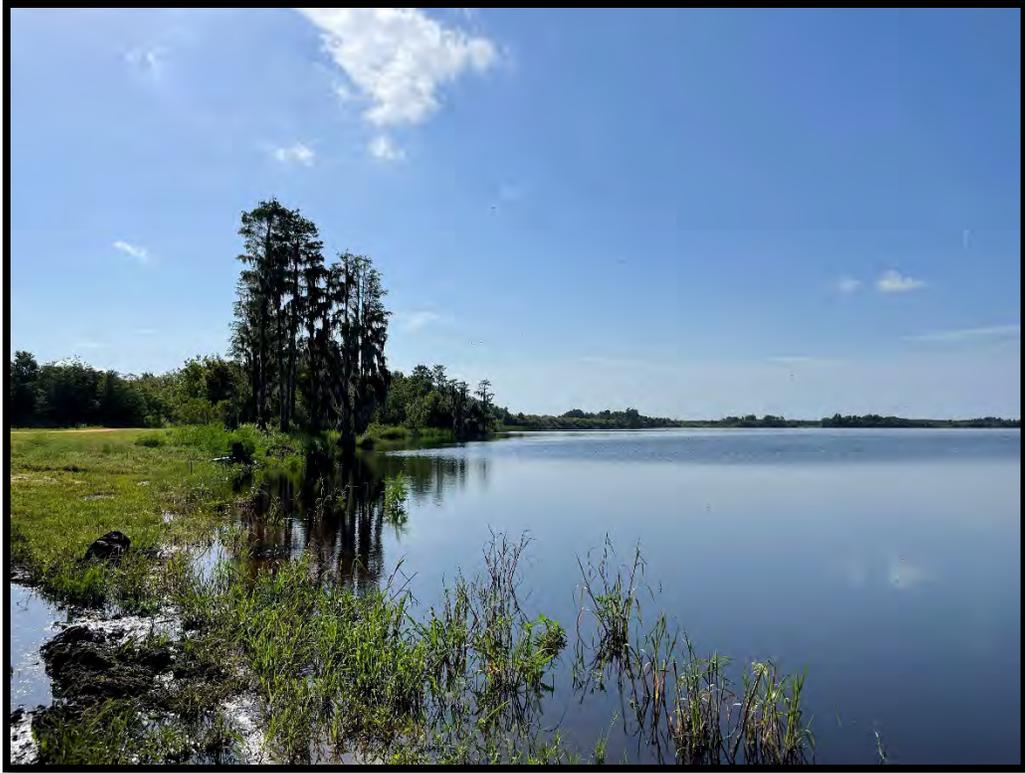
**Figure B-208.** Lake Streey (SW-QJ), July 2023.

Lake Streety is 324 acres in size and is a Ridge lake located in Polk County (**Figures B-208, B-209, and B-210**). The July 2023 assessment was conducted on the northern shoreline where Lake Streety Road runs along the shoreline; Lake Streety Road is accessible via U.S. Highway 27 (**Figure B-211**). This tannic lake is just north of Avon Park Cutoff Road in a rural area with relatively undisturbed shoreline and is surrounded by agricultural lands, most planted in citrus.

Lake Streety was determined to be Not Stressed during both the July 2023 and 2018 assessments. However, there is evidence of impacts due to historical surface water withdrawals. Lake Streety's water levels have been measured regularly since the early 1980s, and water levels are typically relatively stable (**Figure B-212**).

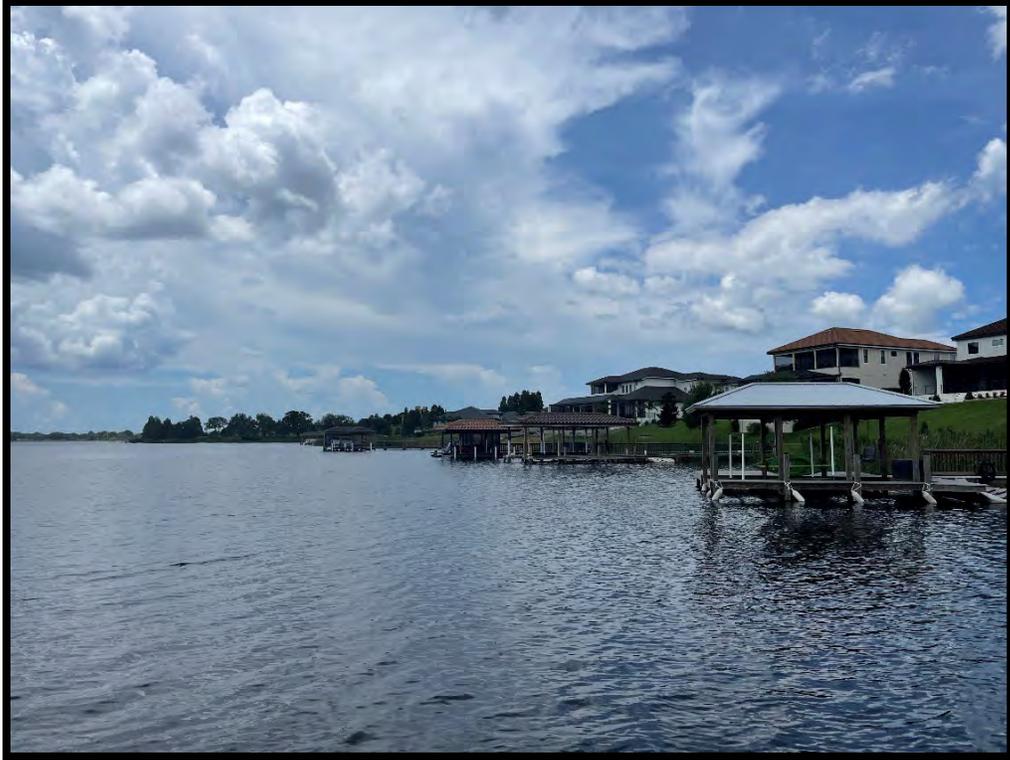
**Figure B-213.** Lake Van (SW-QK), July 2023.

Lake Van is a Ridge lake located in Polk County that is 595 acres in size (**Figures B-213, B-214, and B-215**). The July 2023 assessment was conducted on the eastern shoreline via a residential subdivision located on Adams Barn Road in the City of Auburndale (**Figure B-216**). The surrounding agricultural lands are being converted into residential development. Many more houses have been built along the lake shoreline as compared to the last assessment in April 2018, as well as a new boat ramp associated with the subdivision.

Water levels in Lake Van have been measured since 2003 and have been on an increasing trend during the 2015-2022 period of record used for the current analysis (**Figure B-217**). Lake Van was determined to be Not Stressed during both the July 2023 and April 2018 assessments.

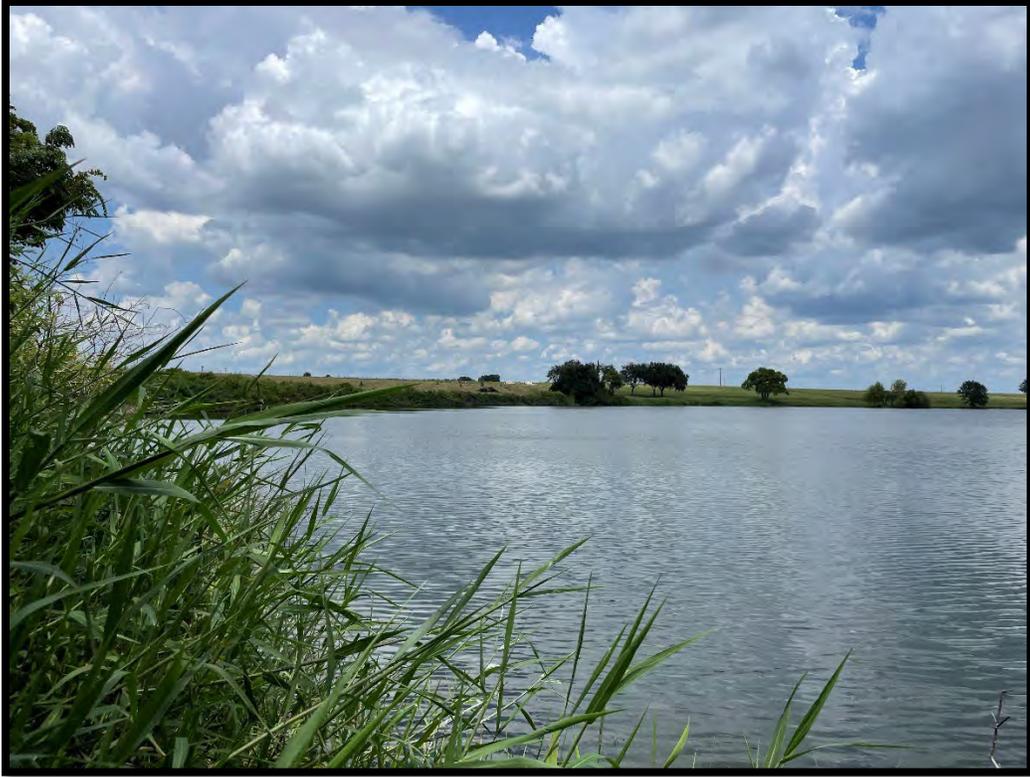
**Figure B-218.** Polecat Lake (SW-QM), August 2023.

Polecat Lake is an approximately 39-acre Ridge lake located in Polk County (**Figures B-218, B-219, and B-220**). The lake was accessed on the west side at the staff gauge location down a dirt path via Rocker Road for the August 2023 assessment (**Figure B-221**). The lake was determined to be Not Stressed in August 2023; it was also Not Stressed in 2018.

During the 2018 assessment, the lake was completely surrounded by citrus groves, and unlike the many other nearby lakes, the color of the water of Polecat Lake was pea green. However, in August 2023, the water was clear, and many of the groves had been cleared in preparation for residential development (**Figures B-218, B-219, and B-220**). Polecat Lake water levels have been measured since the mid-1980s, and water levels have remained relatively stable during the period of record included in the current analysis (**Figure B-222**).

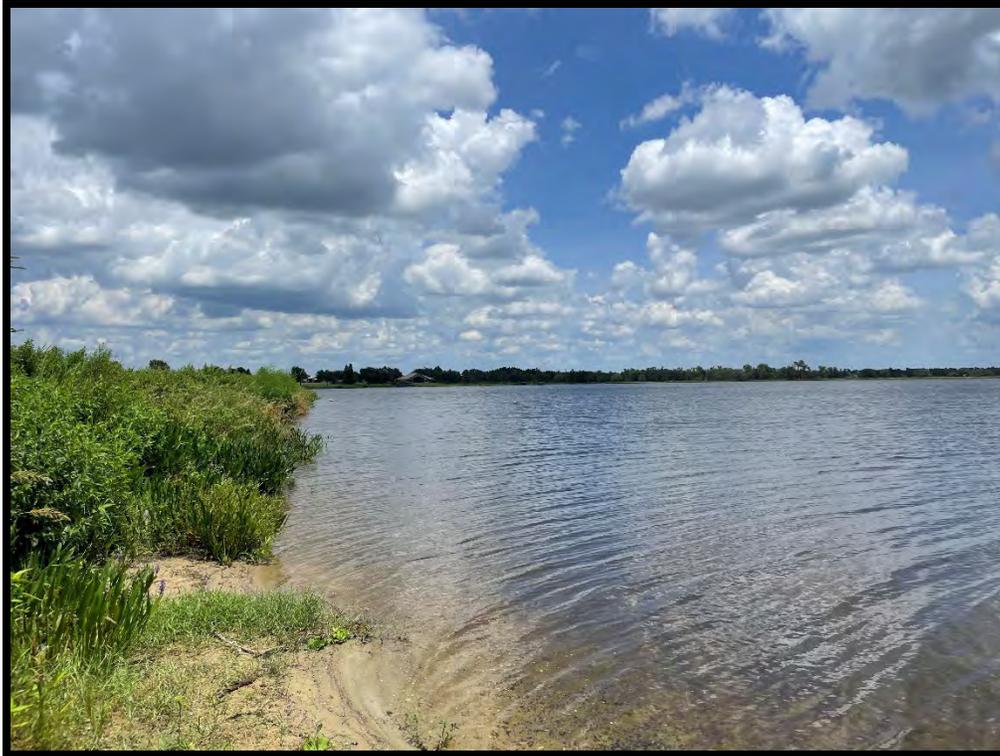
**Figure B-223.** Surveyors Lake (SW-QN), August 2023.

Surveyors Lake is a 284-acre Ridge lake in Polk County (**Figures B-223, B-224, and B-225**); its mean depth is 9 ft., with a maximum depth of 14 ft. The August 2023 assessment was conducted along the western shoreline at the public boat ramp at the end of Rocker Road (**Figure B-226**). This lake is in a rural area and completely surrounded by agricultural lands. It is connected to Gator Lake via a ditch to the northeast.

During both the August 2023 and 2018 assessments, Surveyors Lake was determined to be Not Stressed. Water level data have been collected from Surveyors Lake since 1984, and levels were relatively stable during the 2015-2022 period of record (**Figure B-227**).

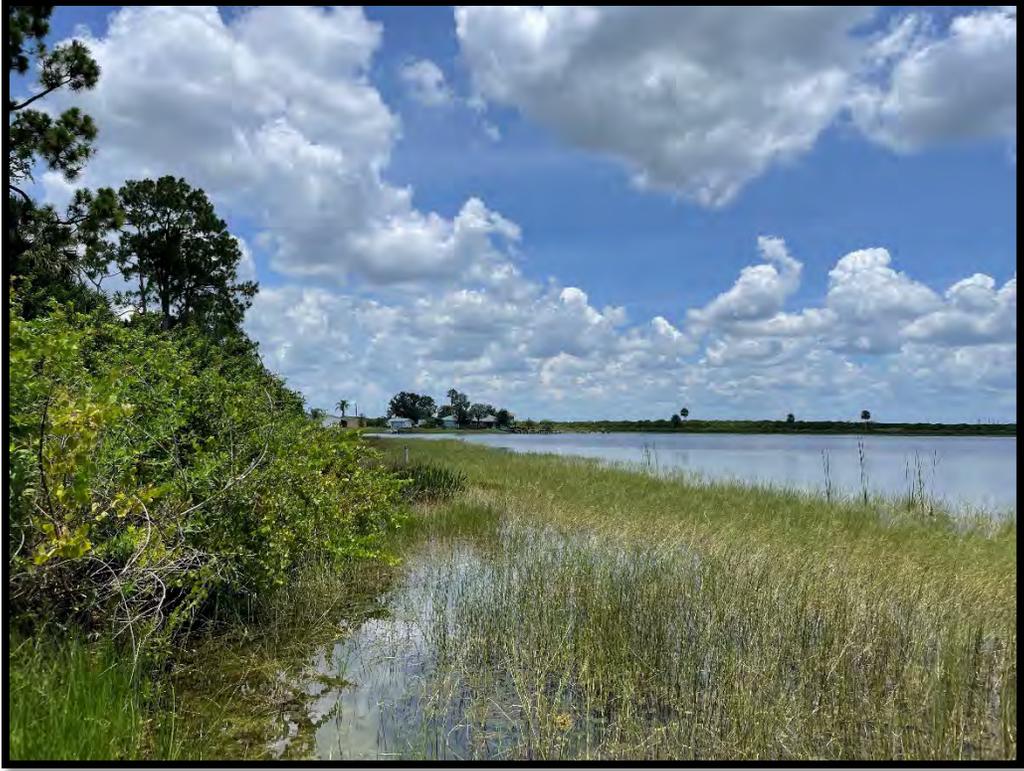
**Figure B-228.** Parks Lake (SW-QO), July 2023.

Parks Lake is a Ridge lake in Polk County that is 102 acres in size (**Figures B-228, B-229, and B-230**). The July 2023 assessment was conducted along the southwestern shoreline at the staff gauge behind a private residence located on a dirt road off Lake Park Road (**Figure B-231**). The lake is located in a rural area; the majority of the lake is surrounded by citrus groves.

Parks Lake was determined to be Not Stressed in July 2023, as well as during the 2018 assessment. Water level data for Parks Lake have been collected regularly since 1986, and the water level data for the period of record used for the current analysis is presented in **Figure B-232**.
