# Central Florida Water Initiative

### ENVIRONMENTAL MEASURES TEAM 2018 ASSESSMENT OF CLASS 1 WETLANDS

AUGUST 6, 2018

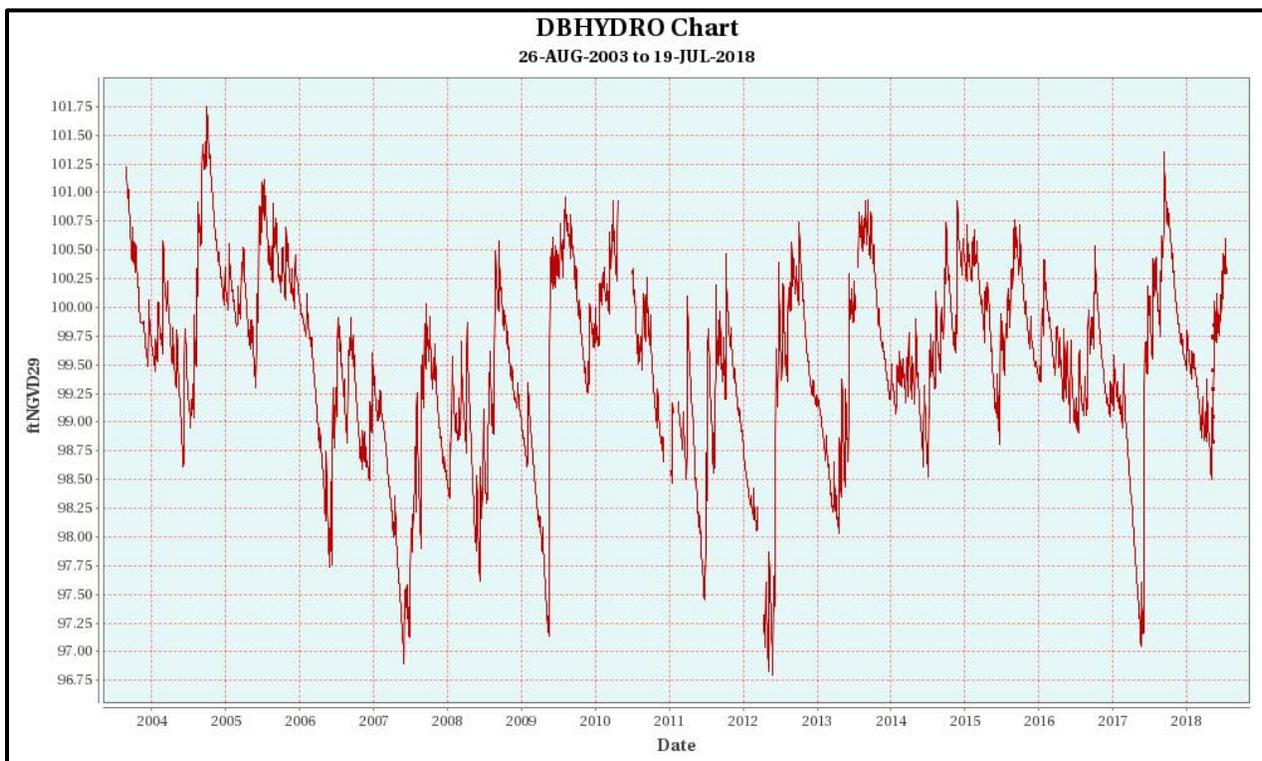
**Figure 2. Period-of-record water level data for Tibet Butler.  
NOTE: FINAL GRAPH WILL BE IN NAVD 88**

Tibet Butler is a Plain wetland that changed stress status from Stressed to Not Stressed. The review of the period-of-record staff gage data indicates that water levels appear to be on an increasing trend since 2012 (Figure 2). The field inspection indicated that this wetland is in recovery and not hydrologically stressed (Figure 3).

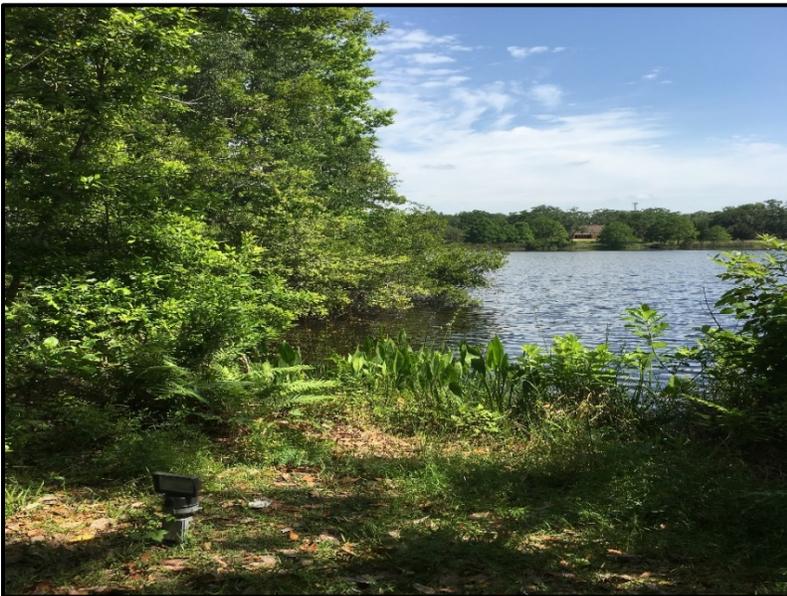
**Figure 4. Lake Gem, May 16, 2018.**

Lake Gem is Plain lake that changed stress status from Stressed to Not Stressed (Figure 4). Previous and current evaluations did not reveal ecological indicators of hydrologic stress. The original determination of Stressed appears to be based on the presence of a ditch along the western side of the lake which discharges offsite when the lake reaches higher water levels. However, the hydrology within the lake appears to be stable and consistent with expected regional hydrologic conditions (Figure 5).

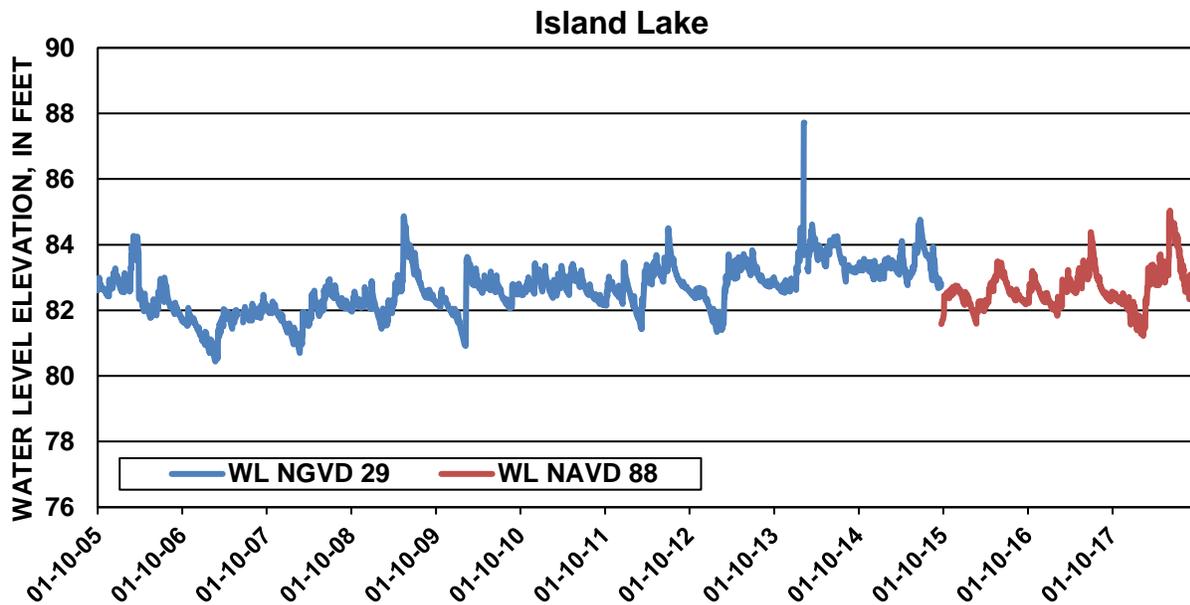
Figure 6. Period-of-record water level data for Island Lake.  
NOTE: FINAL GRAPH WILL BE IN NAVD 88

Island Lake is a Plain wetland that changed stress status from Stressed to Not Stressed. Previous and current evaluations did not reveal ecological indicators of hydrologic stress. The original determination of Stressed was based on the observation that islands within the marsh system appeared to expand over time based on review of historic aerials dating back to the 1950s. Water levels within the highly urbanized system appear to be stable and consistent with regional climactic conditions, and as indicated by the review of water level monitoring data, surficial aquifer levels have shown an overall increase since 2005 (Figure 6). With the exception of edge effects resulting from the adjacent developments, the marsh system is currently healthy (Figure 7).

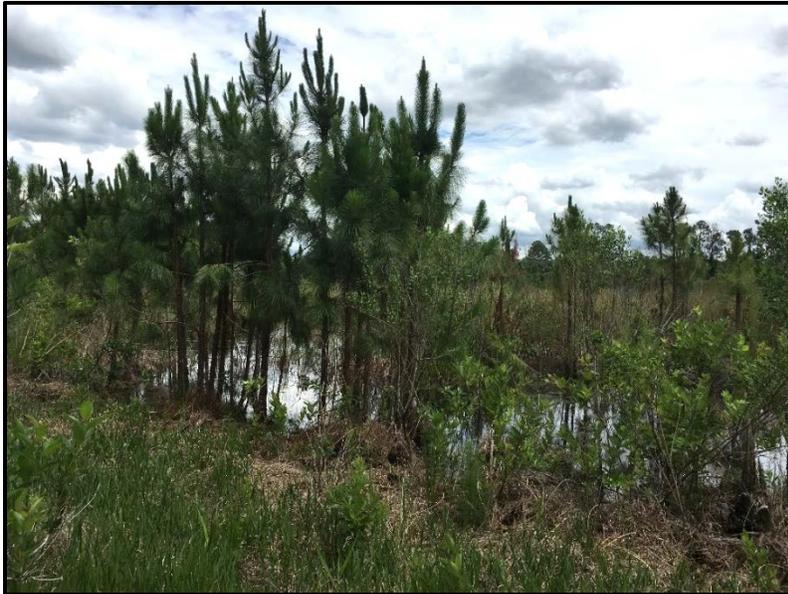
Figure 8. Lake Sylvan, May 29, 2018.

Lake Sylvan is a Plain lake that changed stress status from Not Stressed to Stressed. Since the EMT determined the lake to be Not Stressed during the original evaluation, the lake has been visited multiple times. Indicators of hydrologic stress observed during low water periods within the system include the presence of soil fissures within exposed lower reaches of marsh areas, encroachment of pines and invasive species into the wetland

areas, exposed tree roots, and the absence of regeneration of wetland tree species along the wetland boundaries (Figure 8). The review of water level monitoring data collected since 2005 has shown an overall downward trend in surficial aquifer levels for the system (Figure 9).

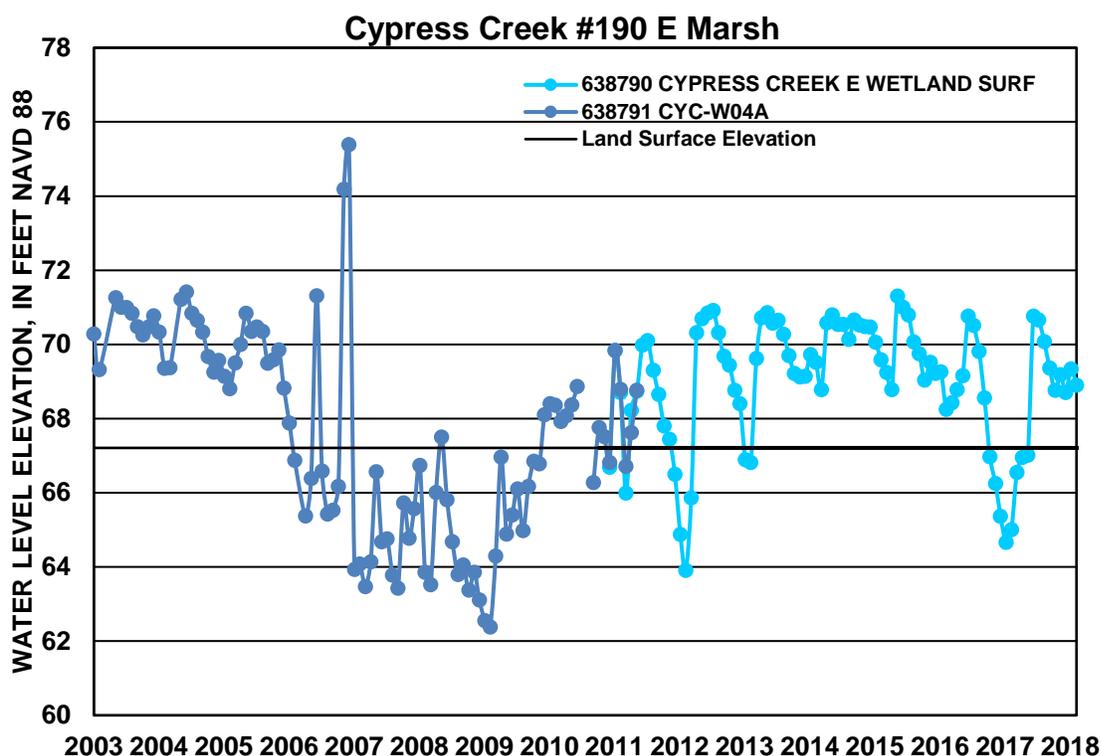
Figure 10. Period-of-record water level data for Cypress Creek #190 E Marsh.

Cypress Creek #190 E Marsh is a Plain wetland that changed stress status from Stressed to Not Stressed. This wetland is located in Tampa Bay Water's Cypress Creek Wellfield. Groundwater pumping at the wellfield has been reduced in recent years, and as indicated by the review of water level monitoring data, the surficial aquifer levels have increased since 2011 (Figure 10). The field inspection indicated that this wetland is not hydrologically stressed and is recovering (Figure 11).

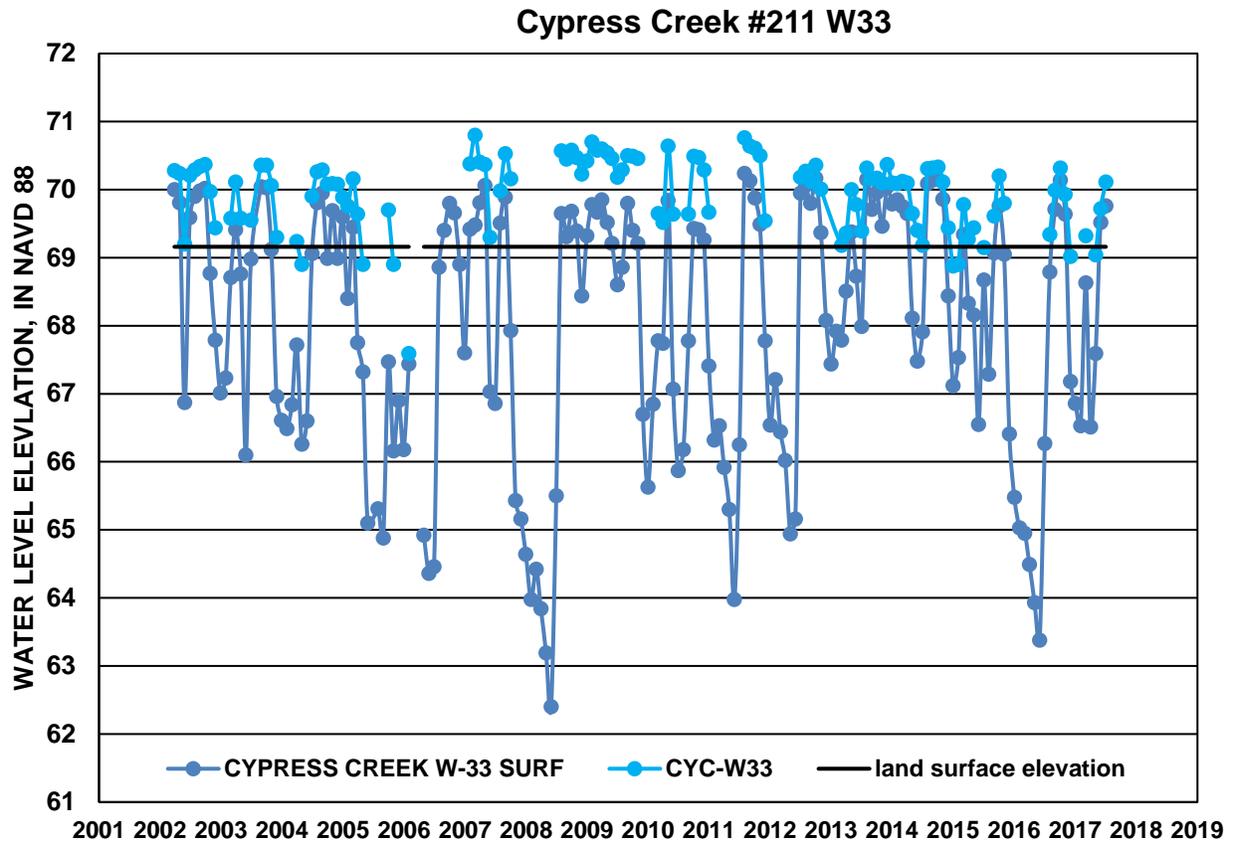
Figure 12. Period-of-record water level data for Cypress Creek #211 W33.

This wetland is a Plain wetland that changed stress status from Stressed to Not Stressed. Cypress Creek #211 W33 is located in Tampa Bay Water's Cypress Creek Wellfield. Groundwater pumping at the wellfield has been reduced in recent years, and as indicated by the review of water level monitoring data, with the exception of the early 2017 drought, the surficial aquifer levels have increased in recent years (Figure 12). The field inspection indicated that this wetland is not hydrologically stressed (Figure 13).

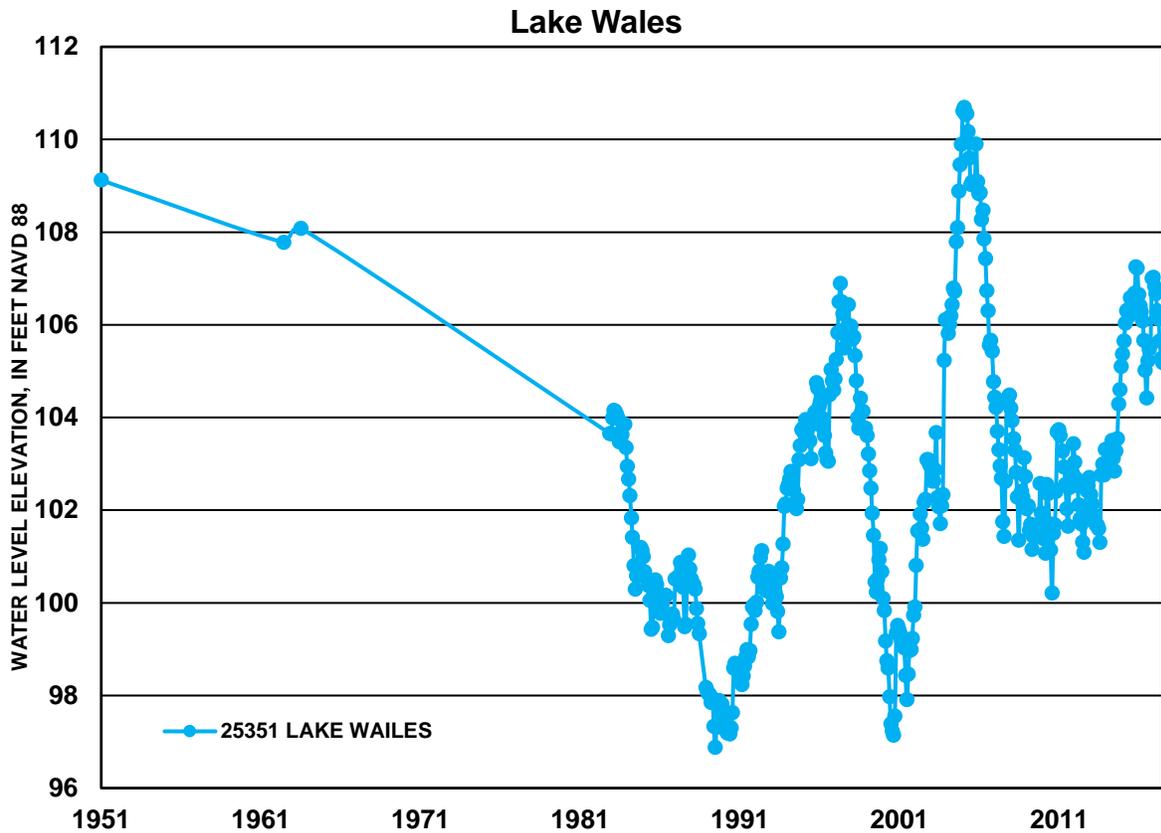
Figure 14. Period-of-record water level data for Lake Wales.

Lake Wales (also known as Lake Wailes) is a Ridge lake that changed stress status from Stressed to Not Stressed. The review of the period-of-record staff gage data indicates that lake levels have been stable since 2002, with levels after 2002 typically higher than before 2002 (Figure 14). In addition to the stable water levels for many years, a review of historical aerials and the field inspection indicated that the lake is not hydrologically stressed (Figure 15).

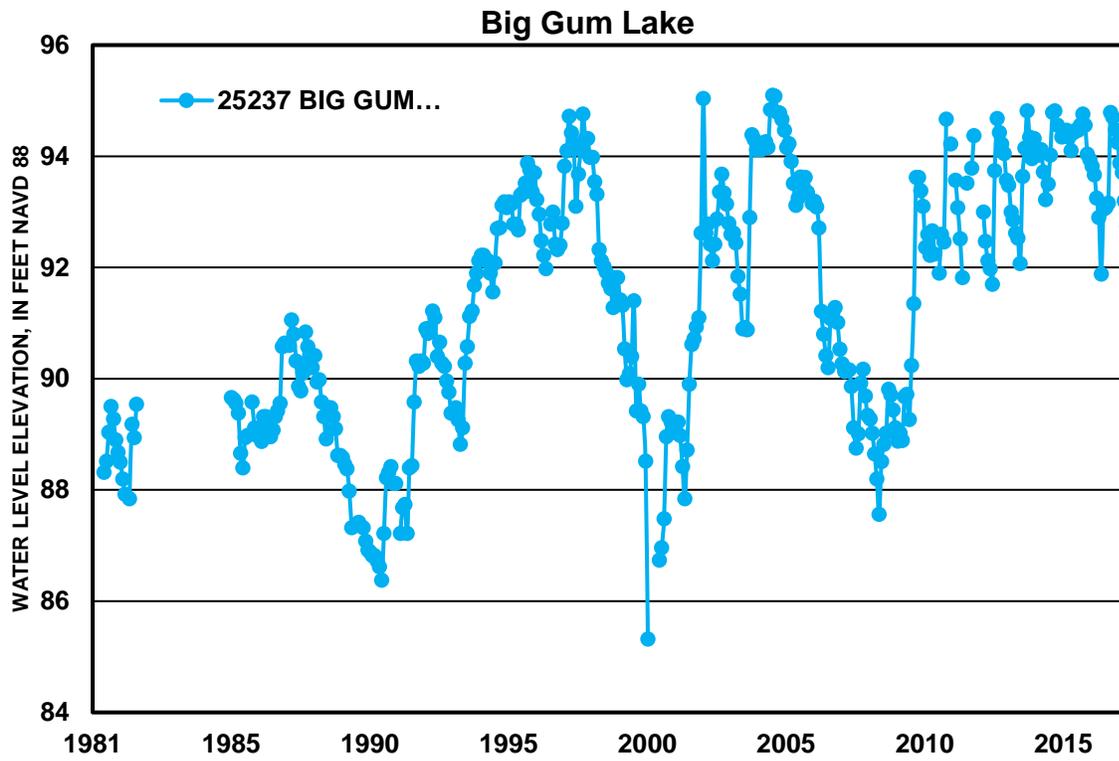
Figure 16. Period-of-record water level data for Big Gum Lake.

Big Gum Lake is a Ridge lake that changed stress status from Stressed to Not Stressed. The staff gage data for this lake indicates stable water levels since about 2010 (Figure 16). As shown on historical aerial photographs, a large ditch was constructed in the northern portion of the lake some time during the 1940s; however, since the 1970s, lake levels have been relatively stable. Combined with the period-of-record water level data and the review of historical aerials, the field inspection indicated that the lake is not hydrologically stressed (Figure 17).

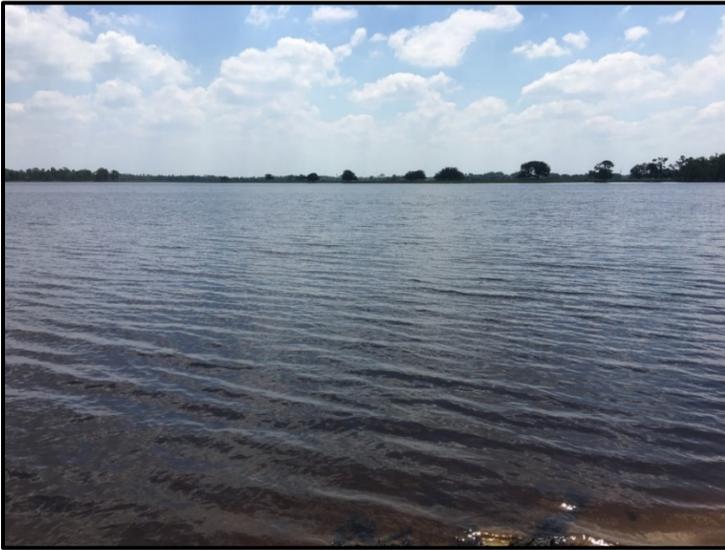
**Figure 18. Gator Lake, April 19, 2018.**

Gator Lake is a Ridge lake that changed stress status from Not Stressed to Stressed. While the review of the historical aerials from the 1940s through the present indicates no change in the lake level, the field visit indicated hydrologic stress in the wetlands along the lake shore on the site where the staff gage is accessed (Figures 18 and 19). A review of the staff gage data from the mid-1990s through the present indicates more fluctuation in lake levels prior to 2010 as compared to after 2010; the lowest lake levels were recorded before 2010, and levels since 2010 have been more stable (Figure 20).

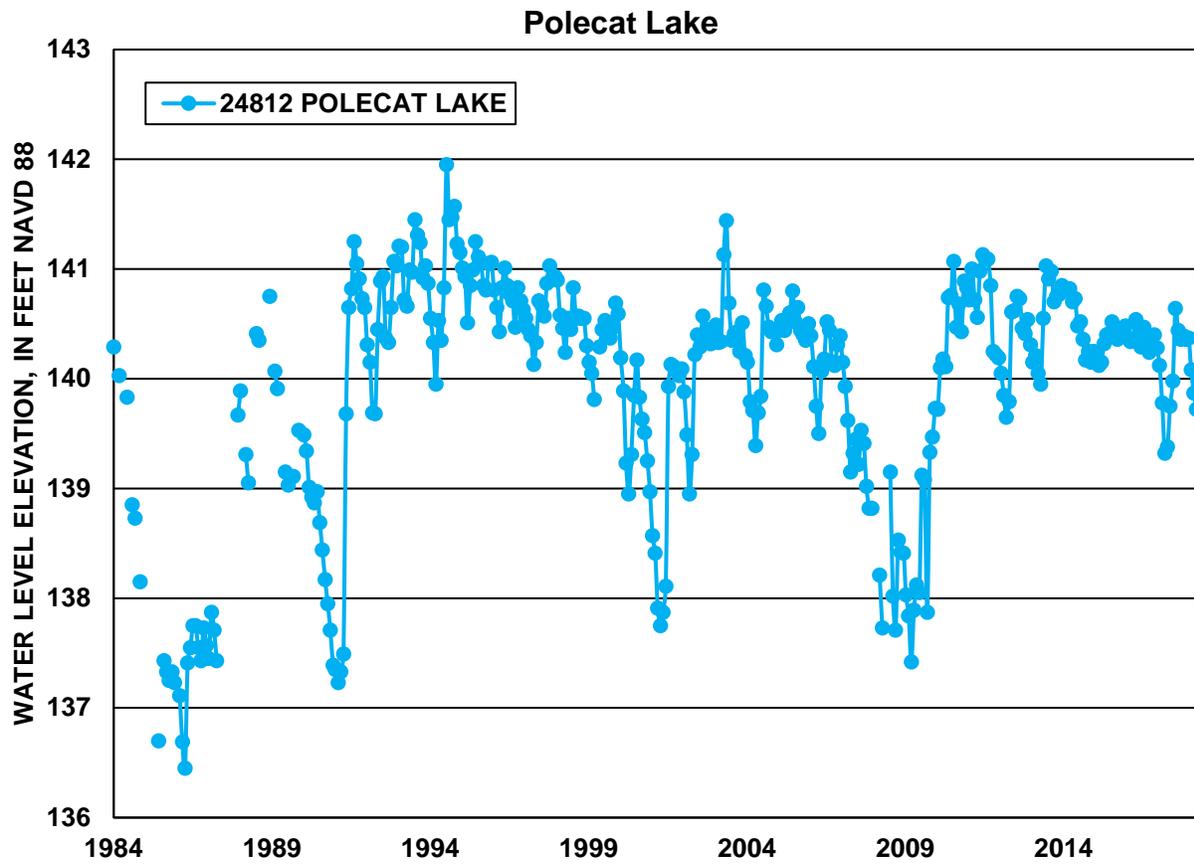
Figure 21. Period-of-record water level data for Polecat Lake.

Polecat Lake is a Ridge lake that changed stress status from Stressed to Not Stressed. The review of the historical aerials indicated stable lake levels. Since about 1991, lake water levels have been stable, with lowest levels recorded during the mid-1980s (Figure 21). The field inspection indicated that the lake was of poor quality because of water quality issues but not hydrologically stressed (Figure 22).

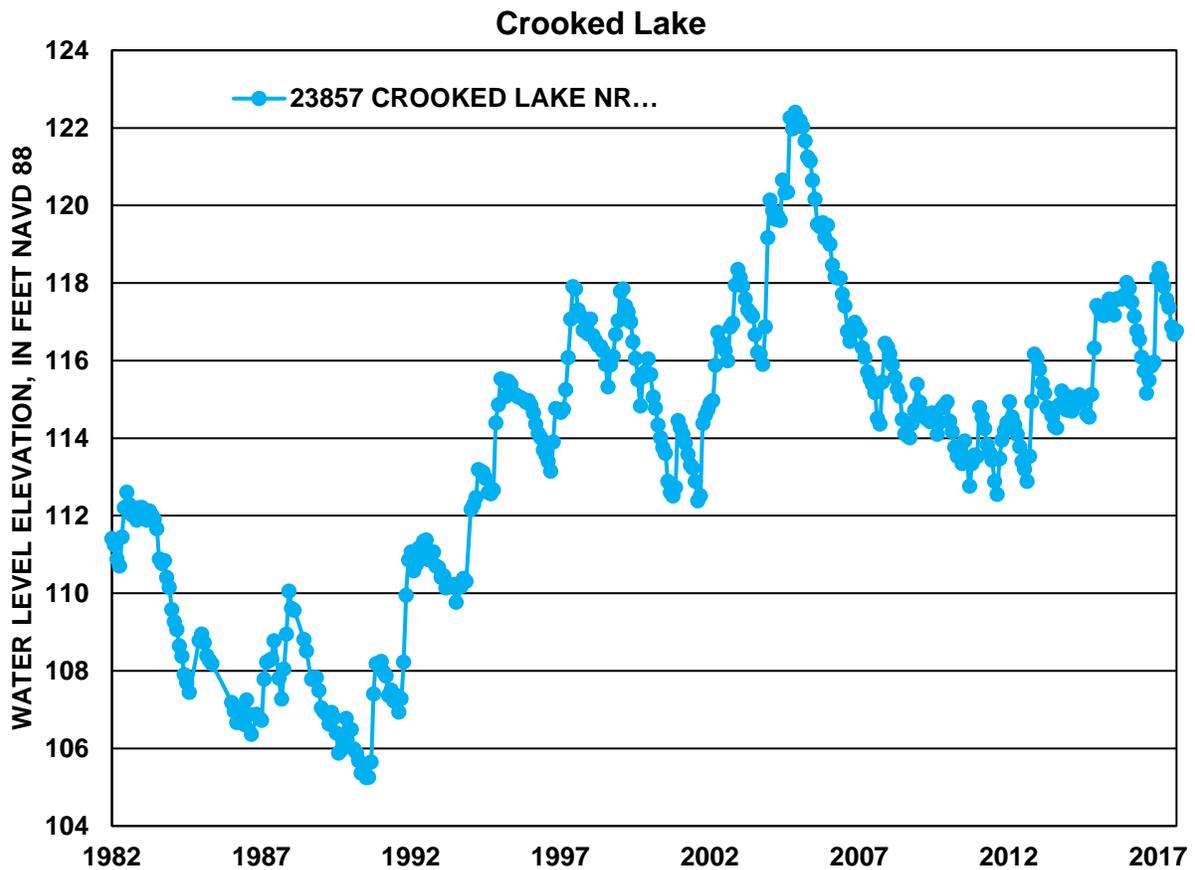
Figure 23. Period-of-record water level data for Crooked Lake.

Crooked Lake is a Ridge lake that changed stress status from Stressed to Not Stressed. The review of the historical aerials indicated a stable lake over time with levels varying from low to high depending on rainfall conditions. The period-of-record staff gage data indicates that lake levels have increased in recent years (Figure 23). There is historical evidence that water was pumped directly from the lake for irrigation; removal of this stressor may have contributed to the recent increased lake levels. The lake was not hydrologically stressed during the field inspection (Figure 24). Crooked Lake is meeting its high minimum level and was 0.1' from meeting its low minimum level in 2016.
