# Single-Family Home Rainwater-Harvesting System Demonstration Project For Stormwater-Runoff Control and Utility-Water Saving

Hammerstrom, J. and T. Younos. 2014. Single-family home rainwater-harvesting system demonstration project for stormwater-runoff control and utility-water saving. The Cabell Brand Center Special Report No. 100-2014, 34 pp.

## **Abstract**

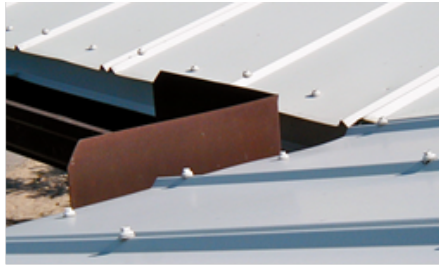
Figure 2

Components of the rainwater capture system include a 1,956 square-foot white metal Galvalume™ roof with 6-inch copper gutters and splash guards (Figure 2); Schedule 40 PVC downspouts and conveyance; a pre-filtration and first-flush system (Figure 3); calming inlets (Figure 4); and a 7,500-usable-gallon, ground-level poured concrete tank which is integrated into the concrete home structure (Figures 5a and 5b). The total volume of the storage tank is 10,000 gallons, with usable volume diminished by unusable water below the foot valves and dead space above the overflow. The tank is separated into two halves by an internal concrete wall with overflow gaps at the top, such that when the first half is full, rain overflows to the second half. When the second half is full, the tank overflows passively to a spreader swale (Figure 6).

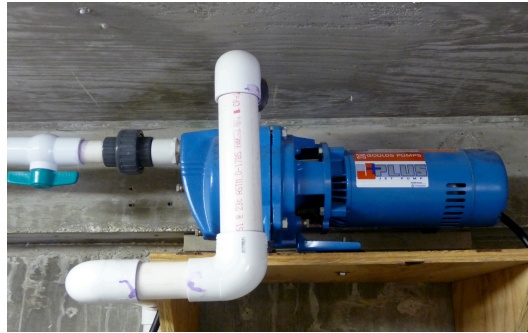
Figure 9

both foot valves by a  $\frac{3}{4}$  hp Jet Pump shown in Figure 9. Water pressure is maintained by an 80-gallon pressure tank (Figure 10). For treatment, rainwater flows from left to right through the three canisters of a Pura Big Boy UVBB3, filtration, and 115-volt ultraviolet system (Figure 11). The first canister houses a dual-density polypropylene sediment filter, (nominal 25-micron pre-filtration and 1-micron post filtration), the second houses a 5-micron nominal carbon block and the final canister is the UV chamber for disinfection (Figure 11). After final treatment, the treated rainwater flows through the selection valves (Fig. 7) to the household fixtures.

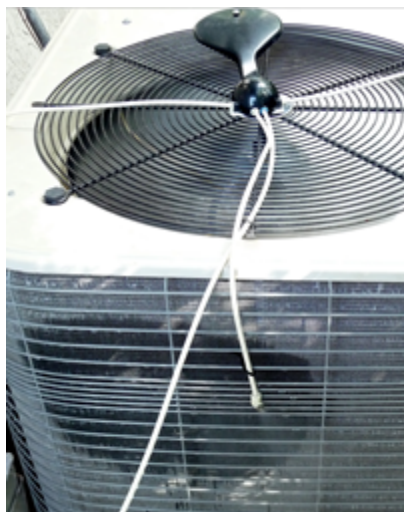
Figure 12

Onsite uses of treated rainwater include uses typical of a residence, from landscape and toilet flushing to ice making. The home is equipped with dual-flush toilets, with the low-flush and high-flush used normally for liquids and solids respectively, but the high flush being used for both purposes during the rainy season to accelerate consumption. In South Florida, the rainy season is also the hot season. Between May or June and November (depending on when the rains begin), rainwater was used as the source for a "Cool-N-Save" air conditioning pre-cooling mist system (Figure 12) to reduce energy consumption and to reduce overflows.
