Dragline Ditch Restoration Sites in Volusia County

The following images and video depict the “before, during and after” for dragline ditch-impacted areas in Mosquito Lagoon and North Peninsula State Park.

Bottle Islands

North Peninsula State Park

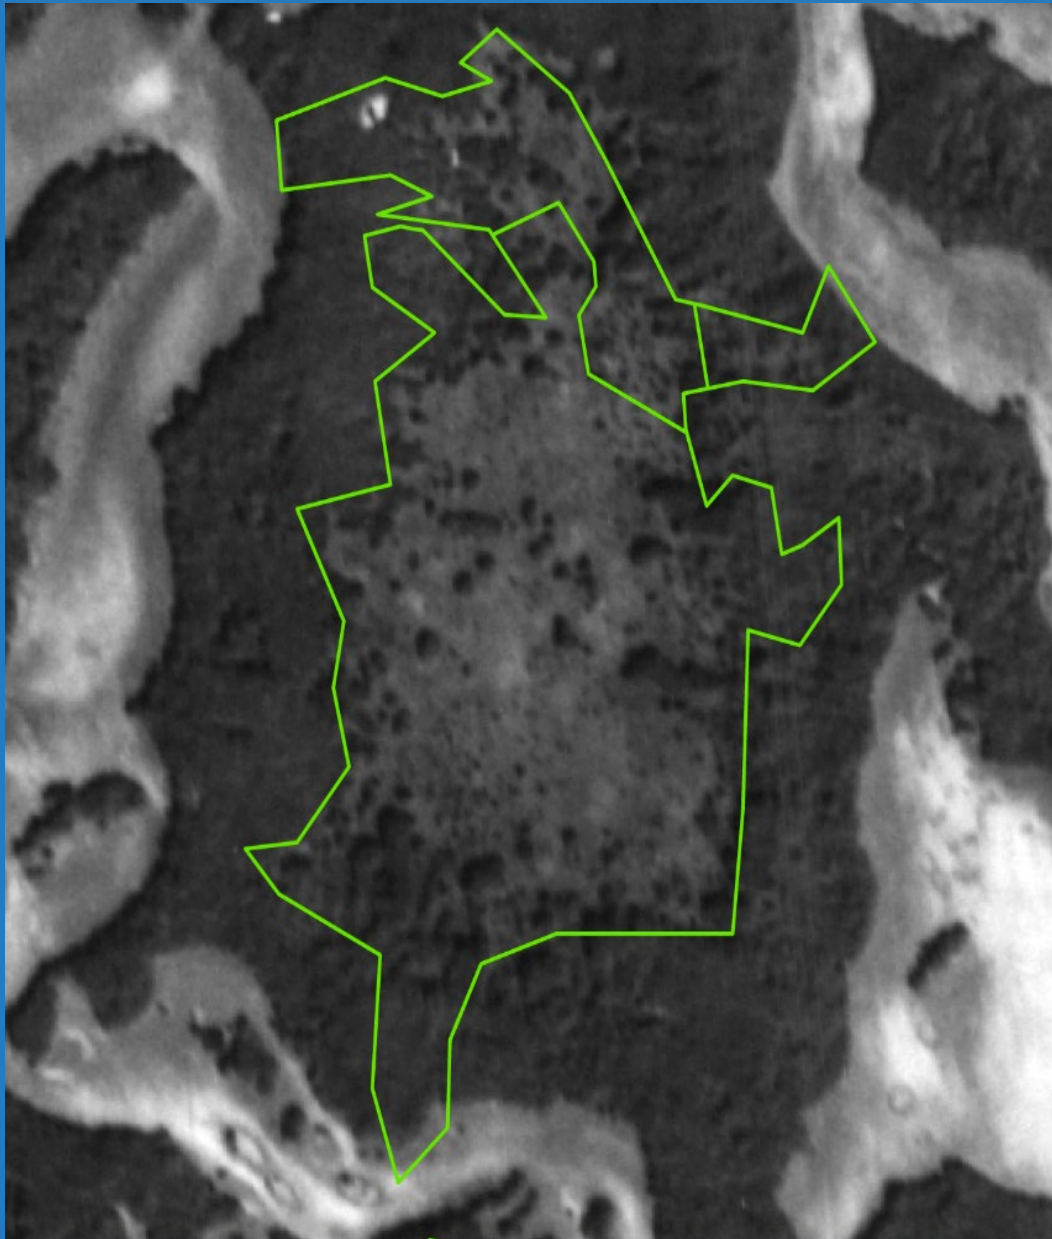
This is a 1943 aerial image of the northernmost member of the Bottle Islands, which are located in the north central portion of Mosquito Lagoon in Volusia County.

North Bottle Island was impacted by 19 acres of dragline ditch (within the green lines), and restoration was completed in 2009.

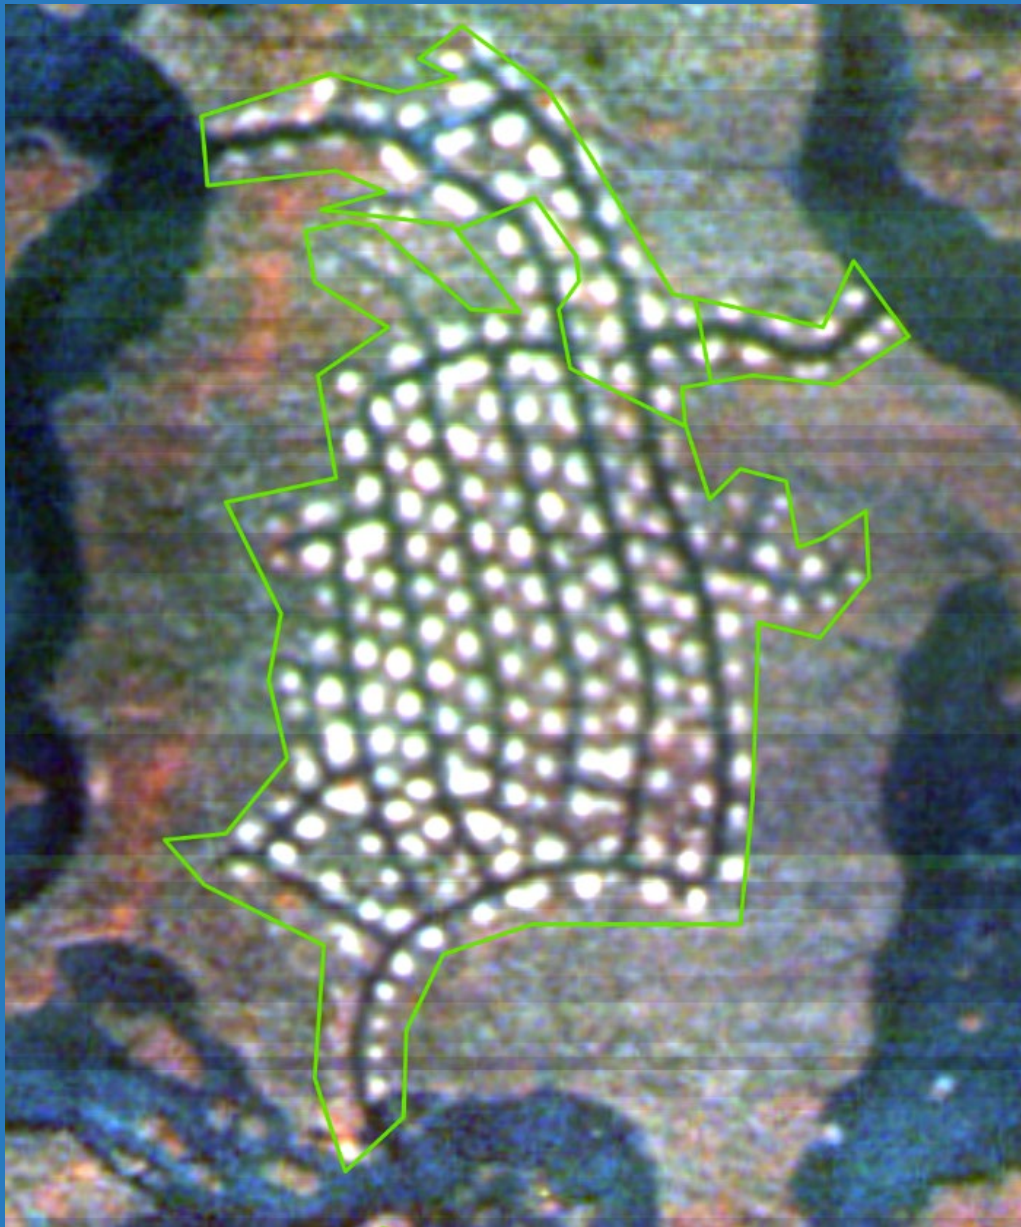
This is a 1984 aerial image of North Bottle Island.

Notice the distinct spoil piles (in white) throughout the island.

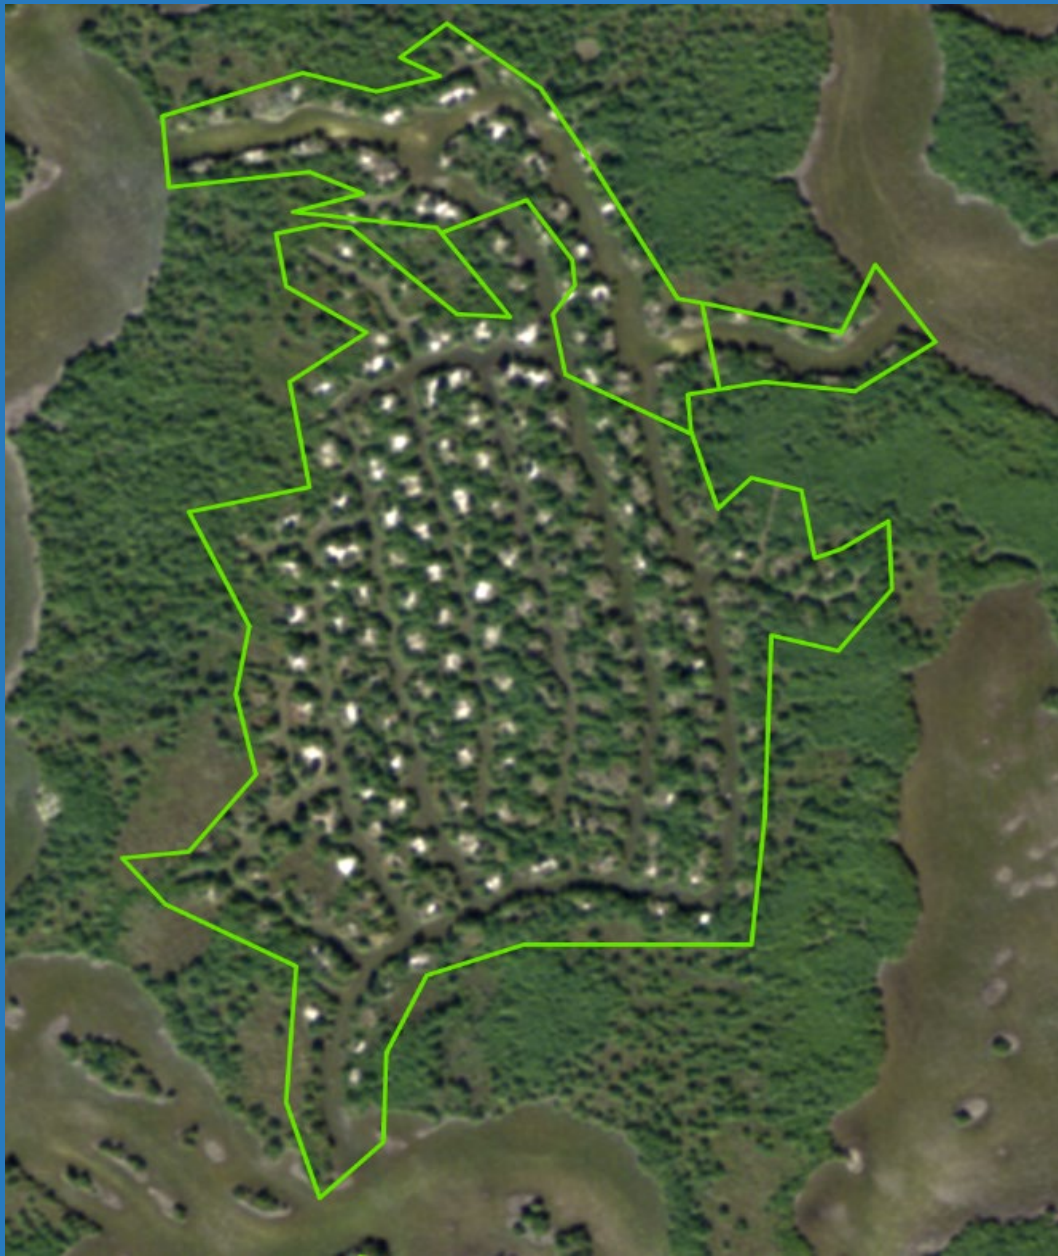
This is a 2004 aerial image of North Bottle Island.

Less of the spoil piles are visible as vegetation expands.

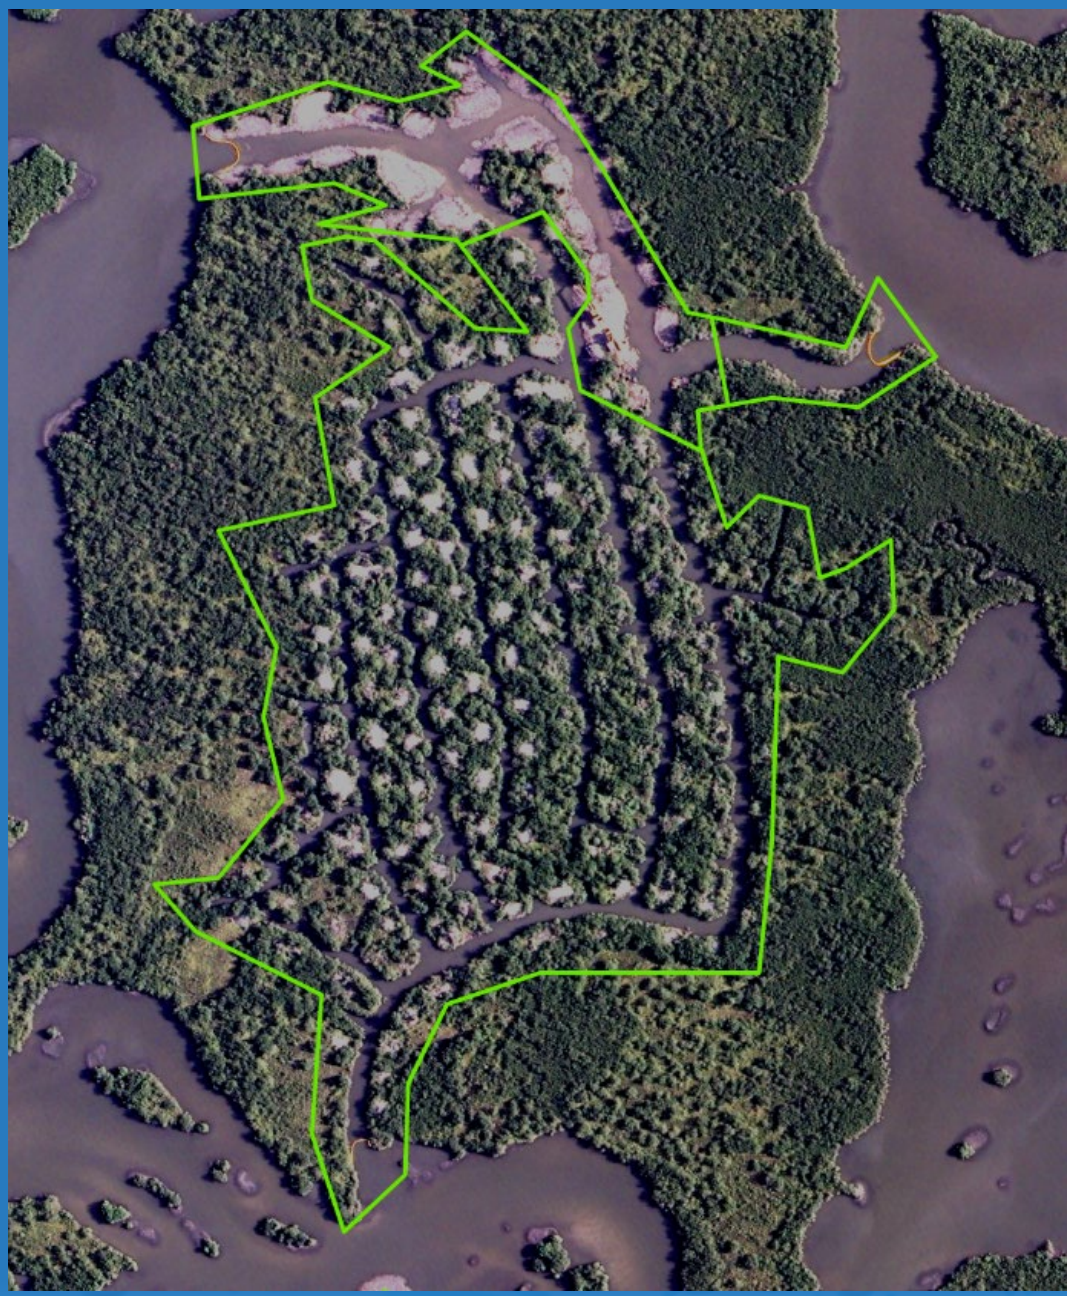
This is a 2008 aerial image of North Bottle Island.

Notice the restoration work in progress in the upper portion of the island.

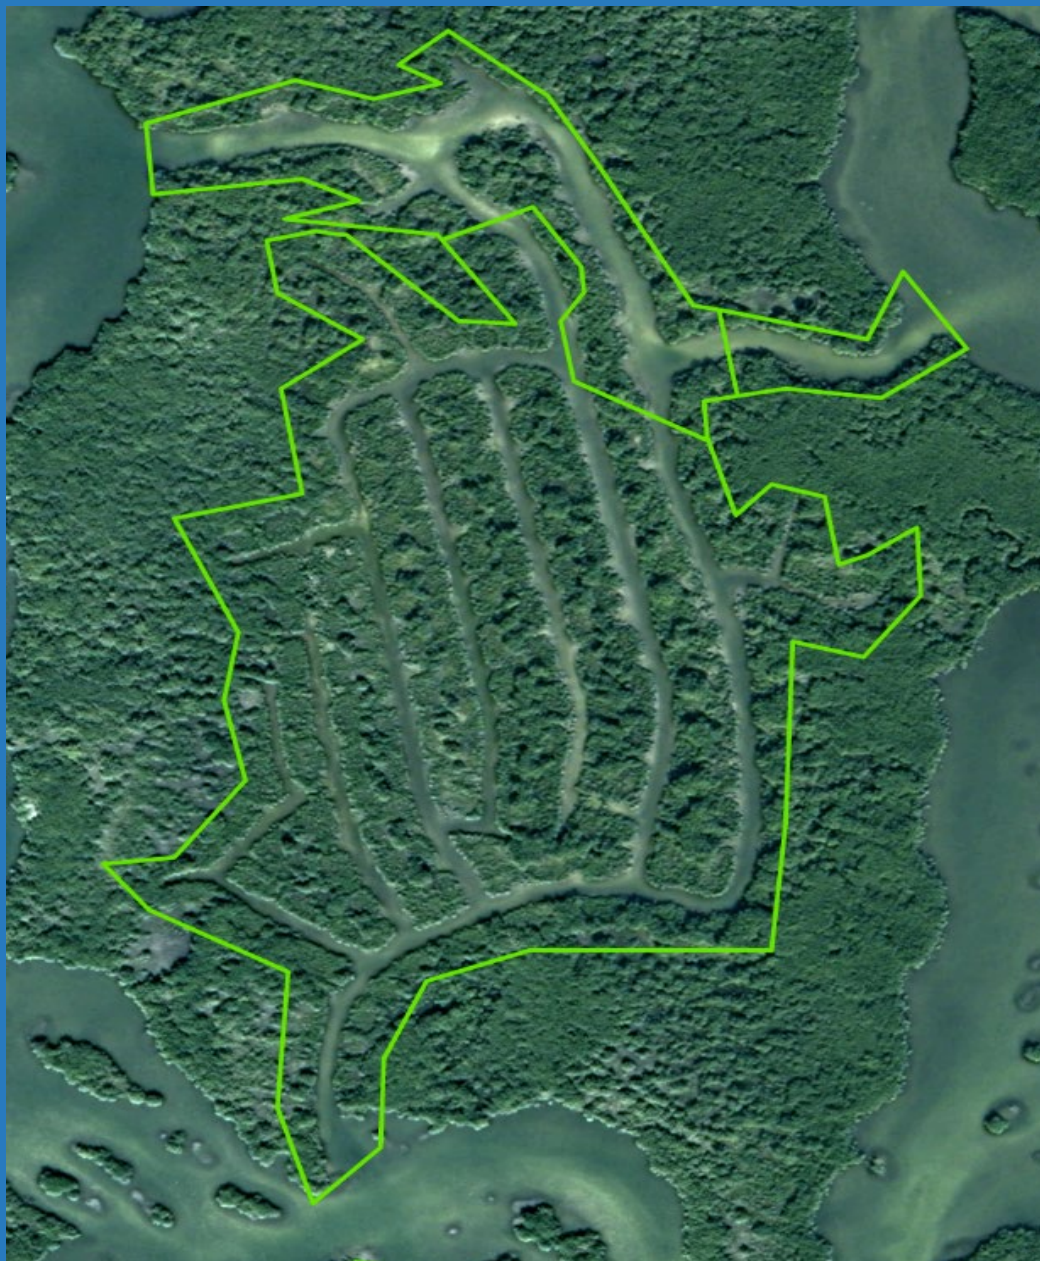
This is a 2014 aerial image of North Bottle Island that depicts approximately five years of recovery.

Notice the dense vegetation, including mangroves, on each of the former spoil piles.

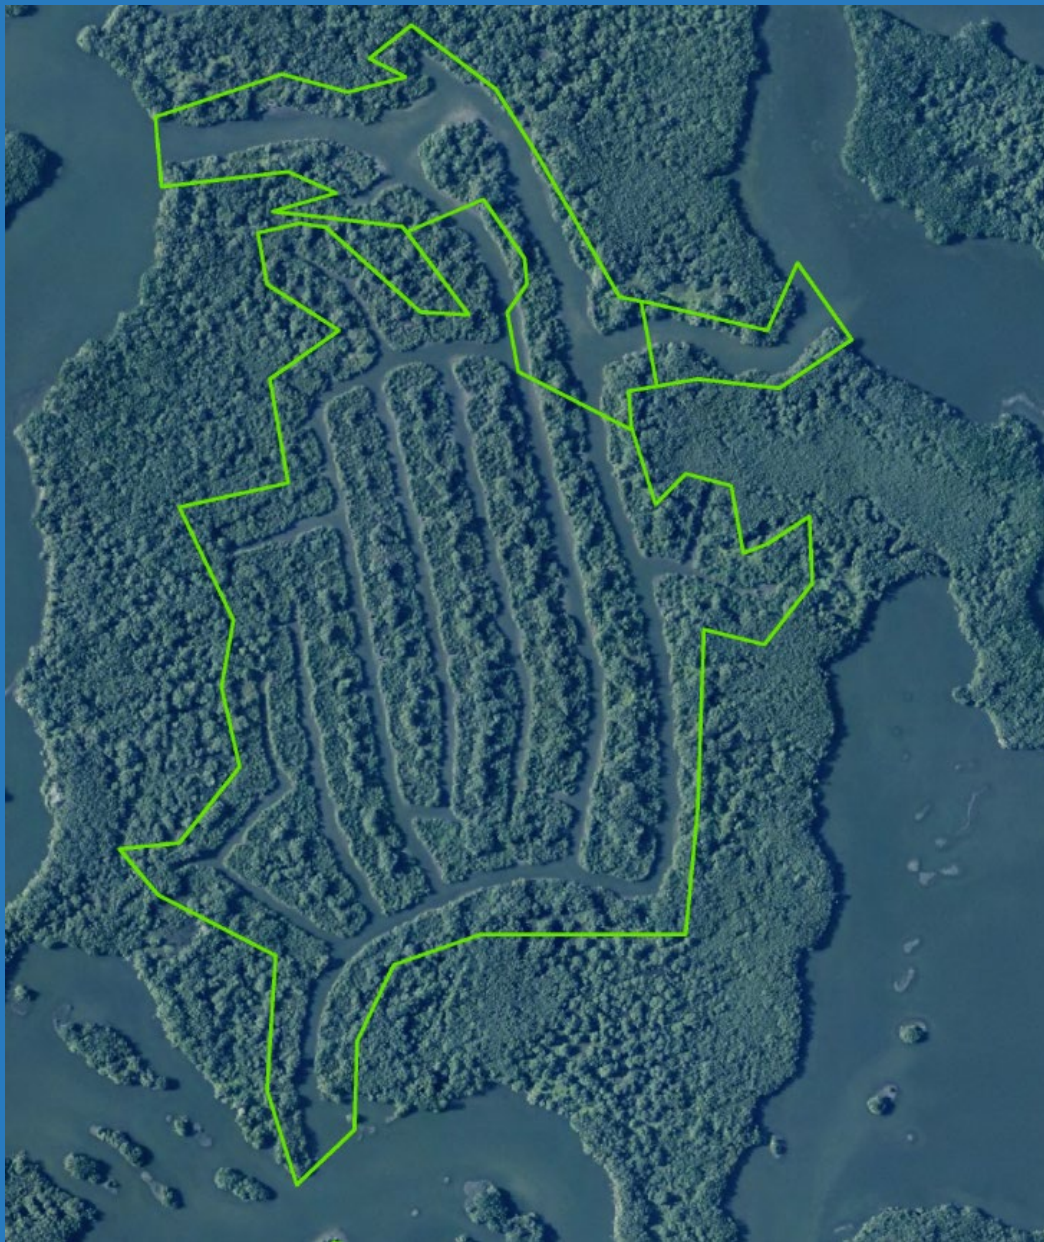
This is an aerial image taken in 2017, approximately eight years after restoration was completed.

Notice the well-defined vegetation of the restored wetlands.

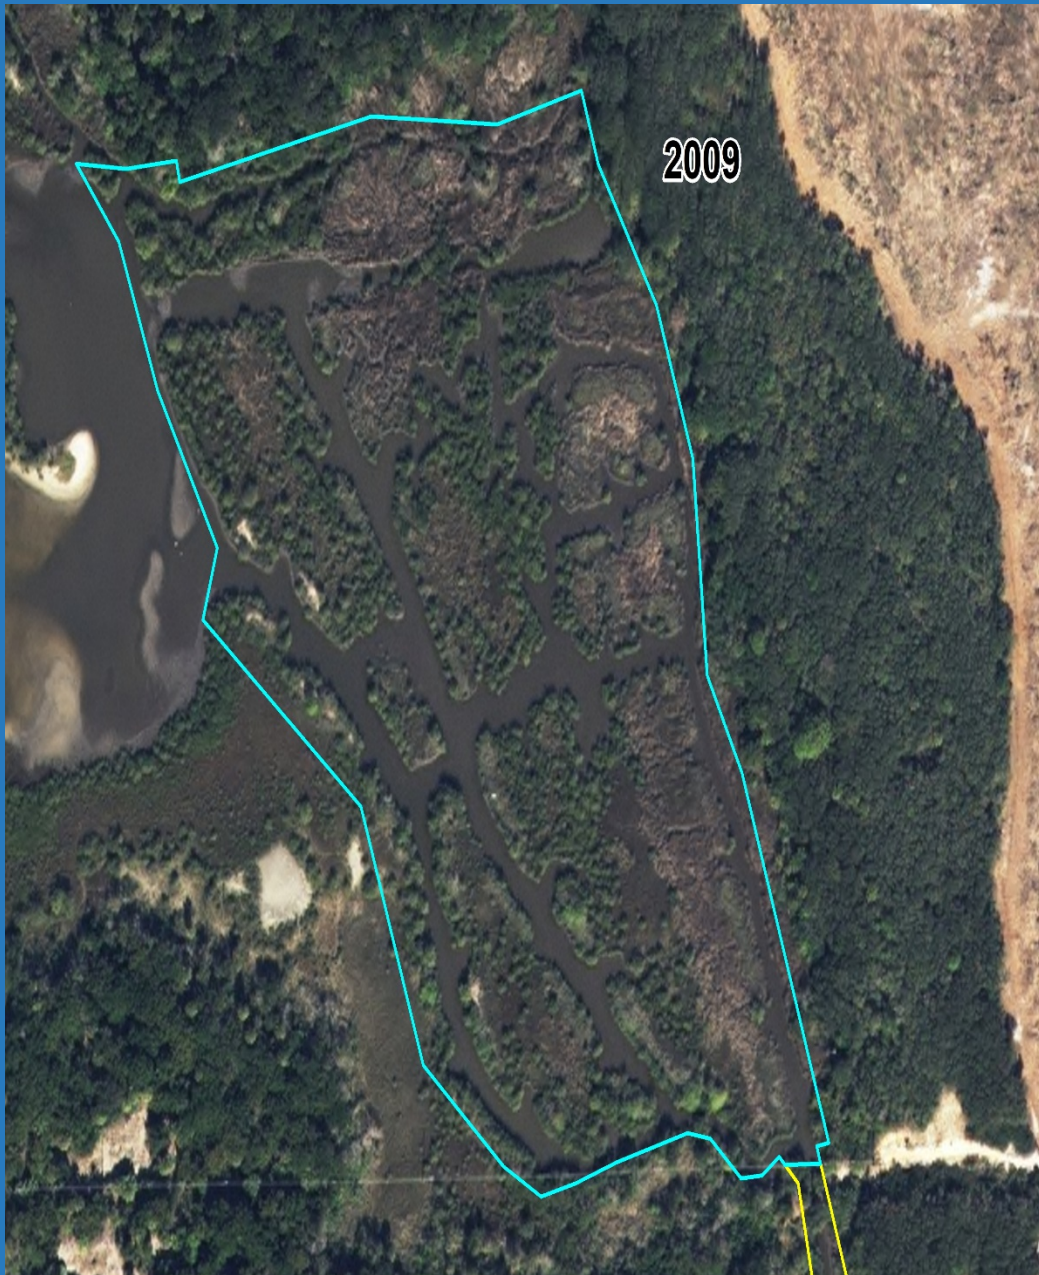
This is an aerial image taken in 2009 of dragline ditch impacts in North Peninsula State Park.

Restoration on these 10 acres began in 2010 (highlighted in blue).

In addition, there were over 90 acres of dredge spoil-impacted wetlands restored in this area. This work required trucking out large quantities of spoil; this process is not part of the proposed work at the Flagler County site.

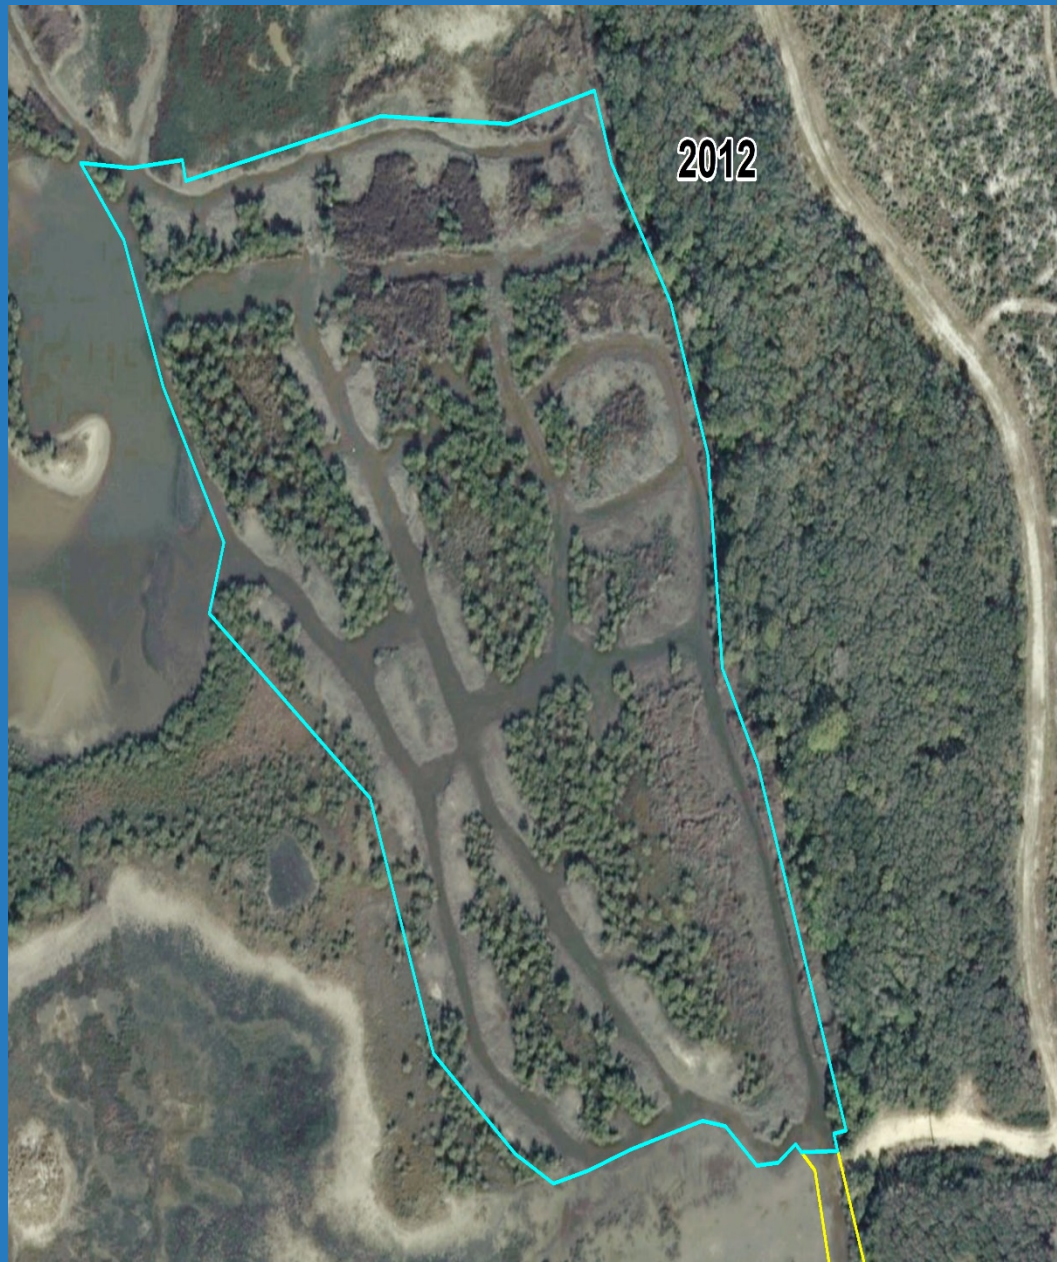
This is a 2012 aerial image of the area, approximately two years after the restoration project was completed.

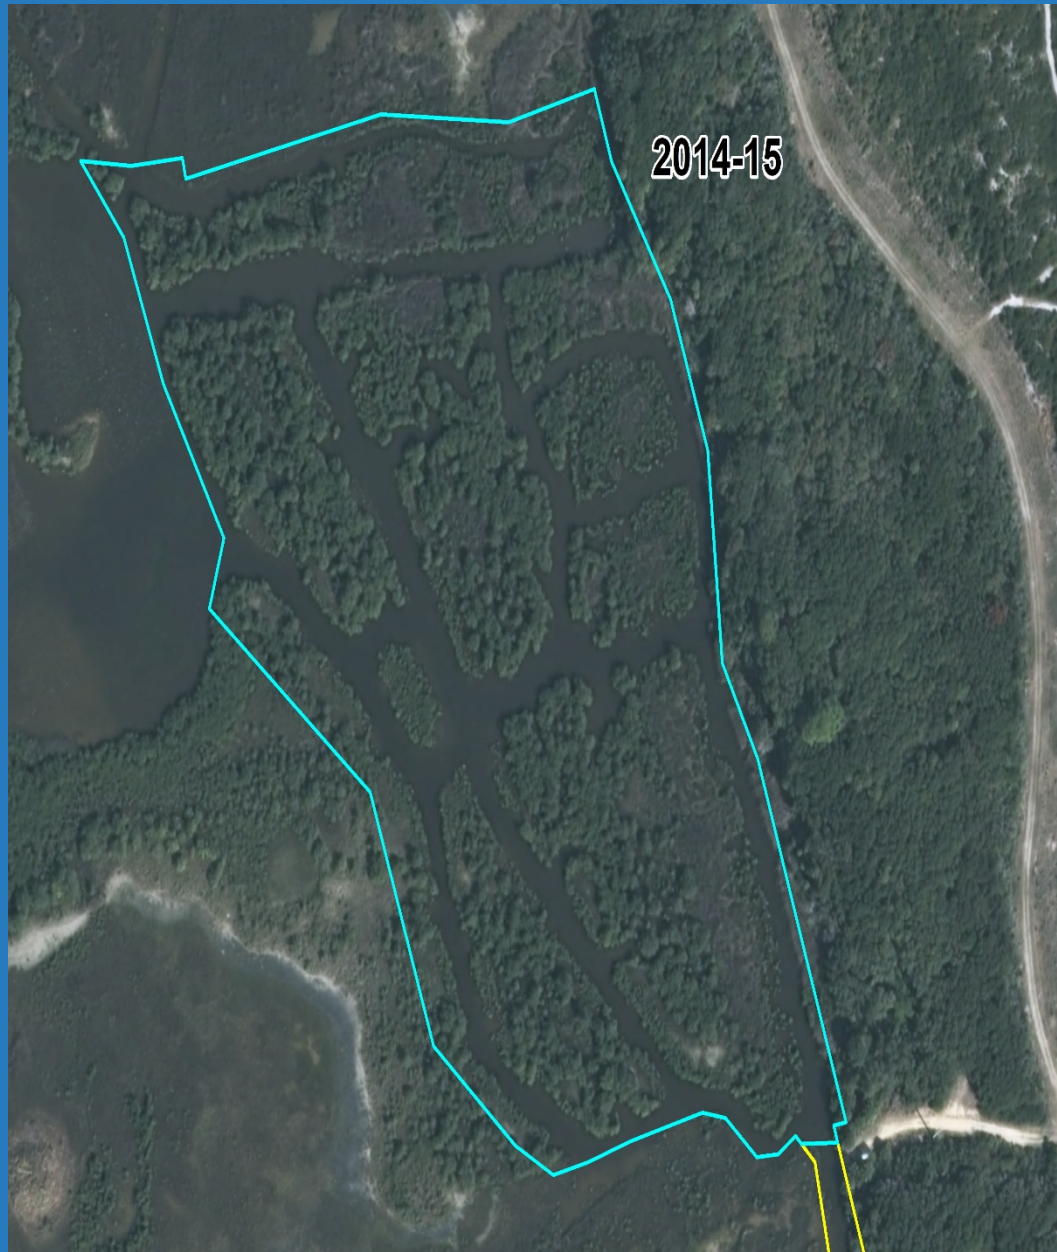
This is a 2014-2015 aerial image showing the well-defined vegetation in the restored area.
