## MEMORANDUM

Subject: Lake Prevatt Minimum Levels Peer Review  
Task A: Kick-Off Meeting and Site-Visit Summary

This memorandum summarizes the December 11, 2023, kick-off meeting and lake and watershed visit for engineering and environmental services contract 39104, work order 1: an independent scientific peer review of St. Johns River Water Management District's (SJRWMD) Hydrologic Simulation Program FORTRAN (HSPF) numerical simulation of water levels in Lake Prevatt, in Orange County, Florida (fig. 1). This meeting was public and part of a Central Florida Water Initiative peer review. The kick-off meeting and site visit are task A of work order 1.

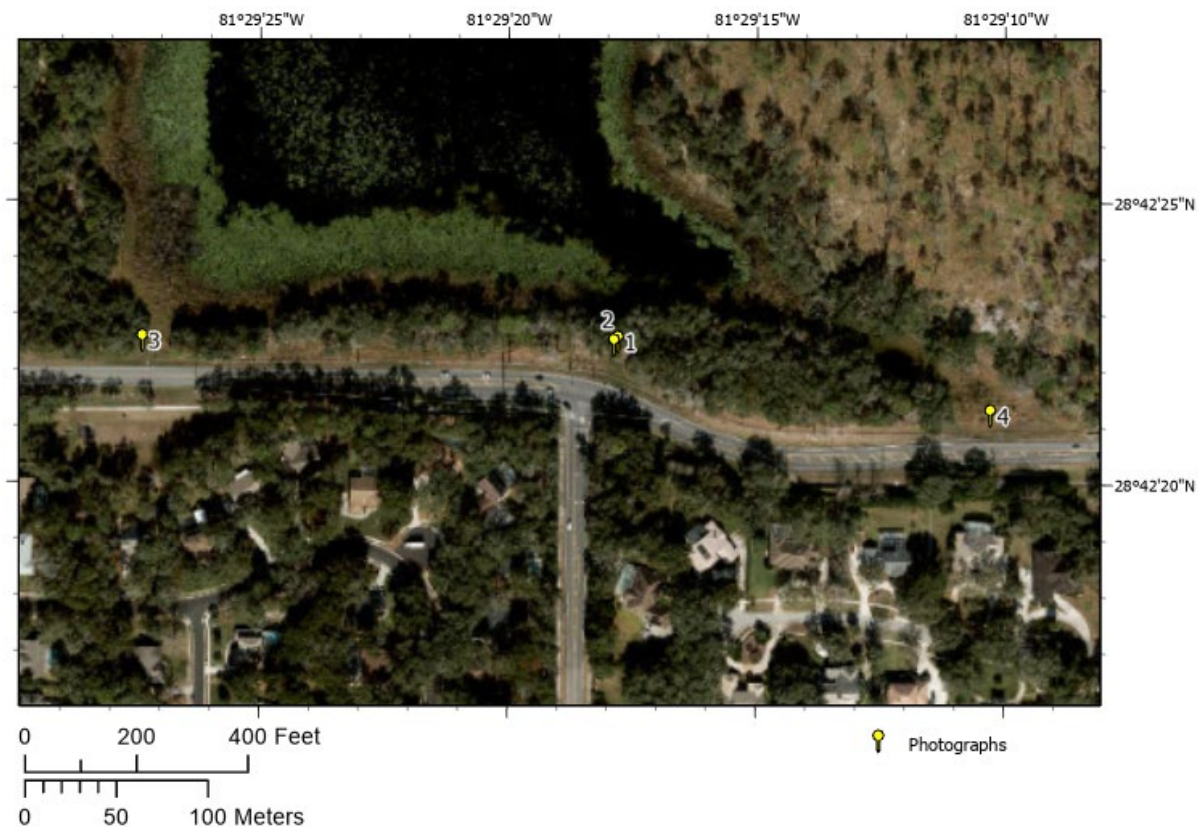
**Figure 3.** Photograph locations (yellow pins) north of Welch Road West, over a January 28, 2021 aerial photograph attributed to Orange County, Florida in the ESRI World Imagery basemap.

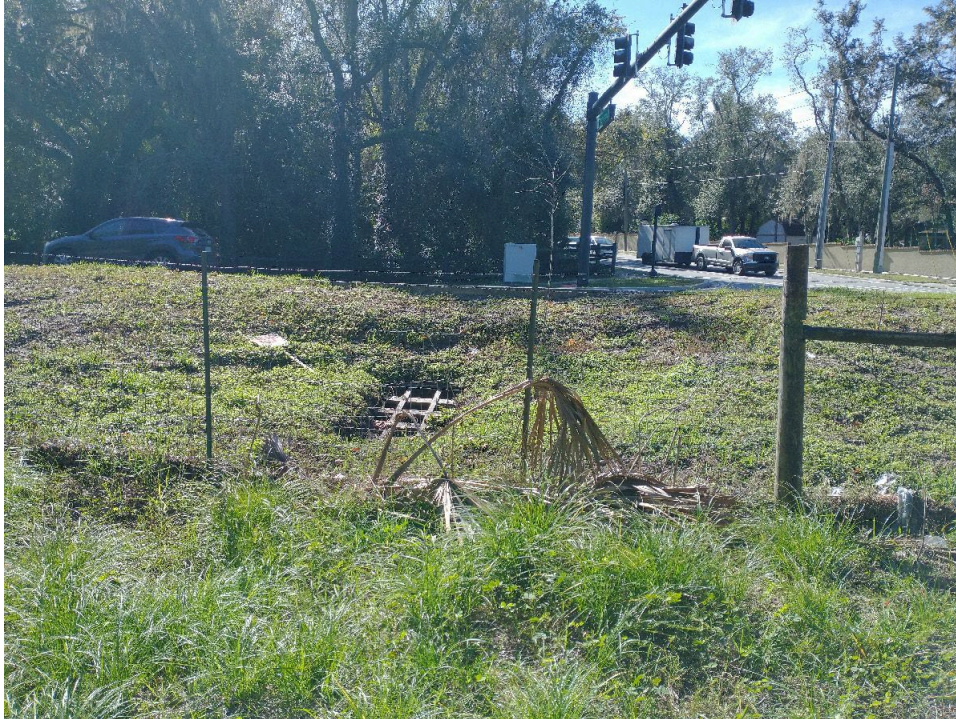
**Photograph 1.** North side of Welch Road West, looking south on December 11, 2023 at 11:42 EST from 28° 42' 22.3 " N 81° 29' 17.8 " W.

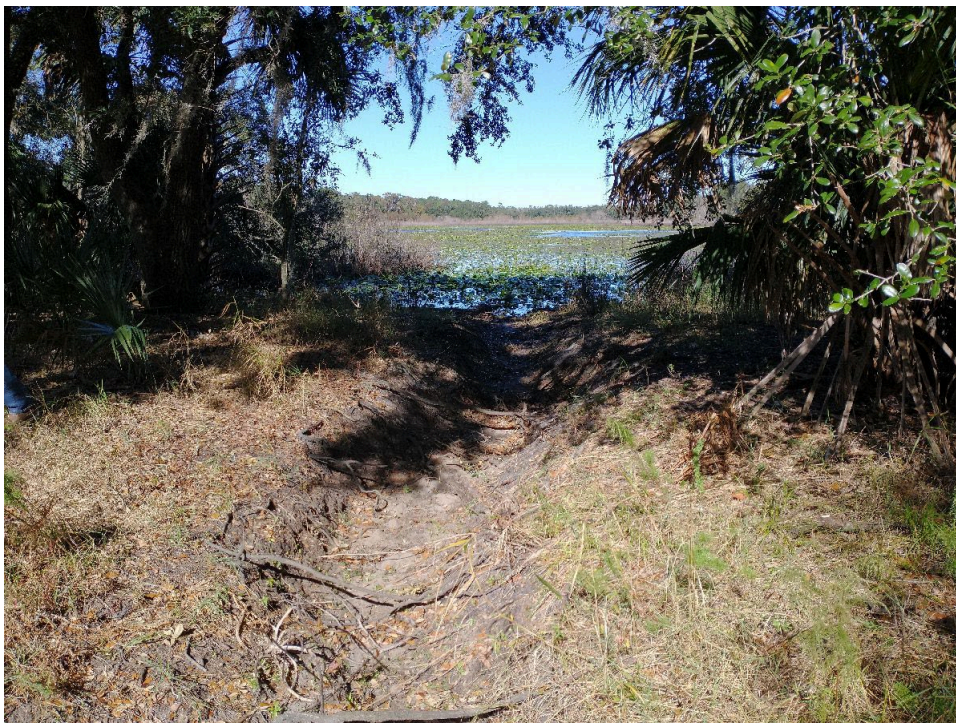
**Photograph 2.** North side of Welch Road West, looking north toward Lake Prevatt on December 11, 2023 at 11:43 EST from 28° 42' 22.3 " N 81° 29' 17.8 " W.

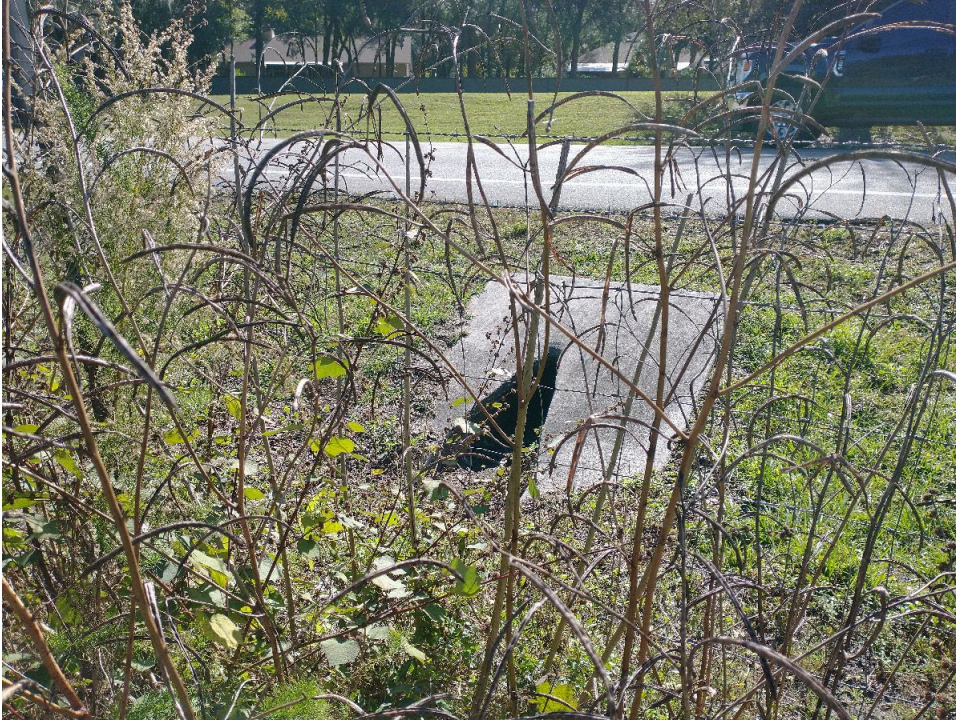
**Photograph 3.** North side of Welch Road West, looking south on December 11, 2023 at 11:47 EST from 28° 42' 22.3 " N 81° 29' 27.3 " W.

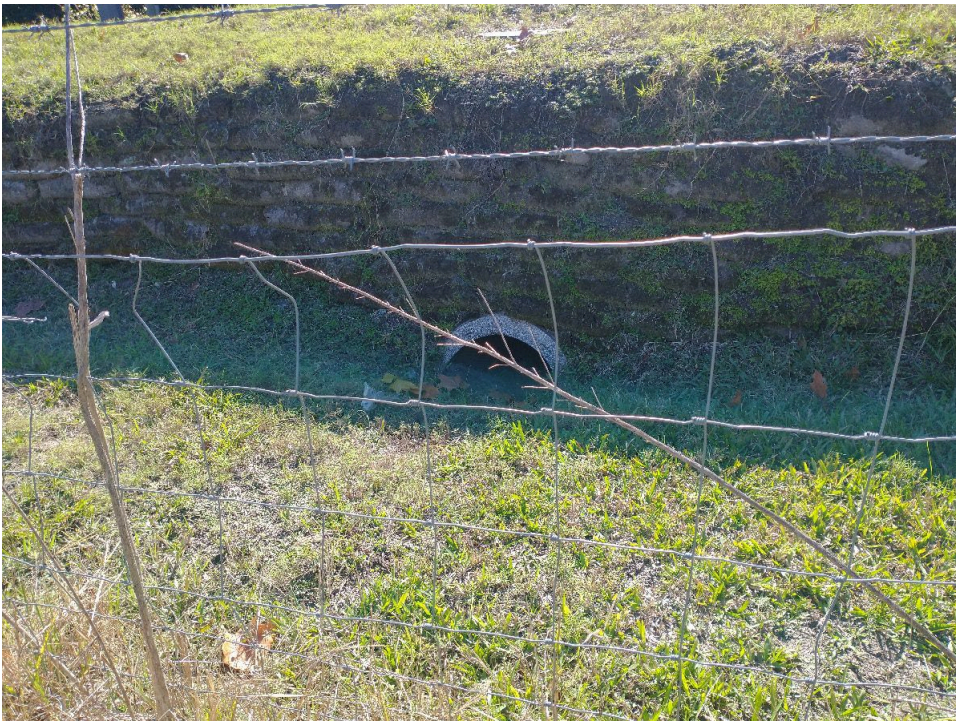
**Photograph 4.** North side of Welch Road West, looking south on December 11, 2023 at 11:54 EST from 28° 42' 21 " N 81° 29' 10.3 " W.

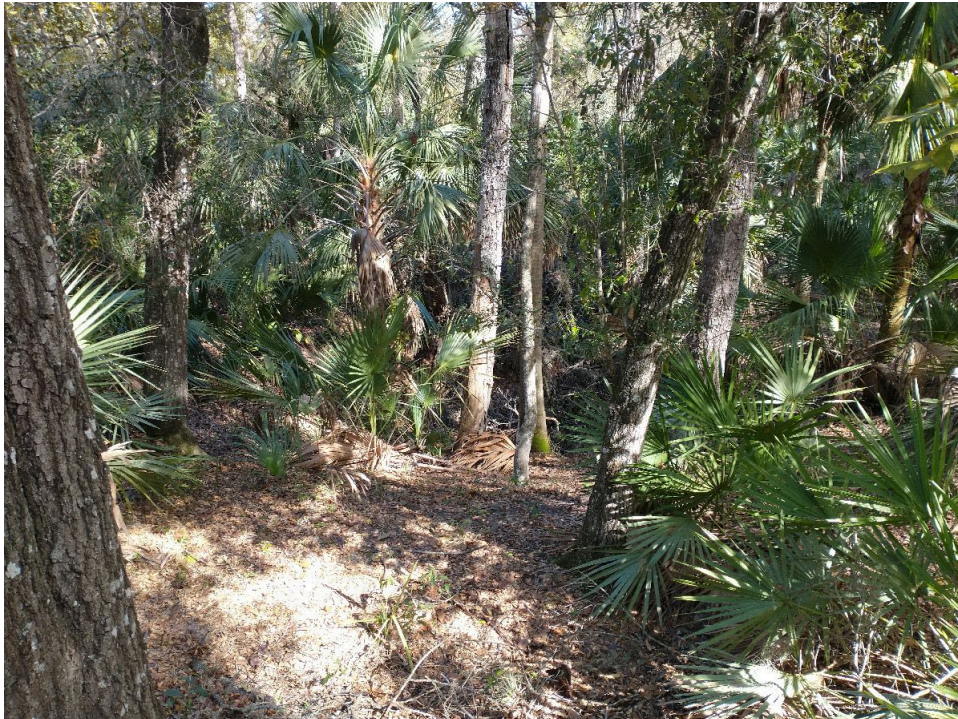
**Photograph 5.** Wekiva Springs State Park looking northeast over the sub-watershed divide, on December 11, 2023 at 12:05 EST from 28° 43' 1.6 " N 81° 29' 8 " W.

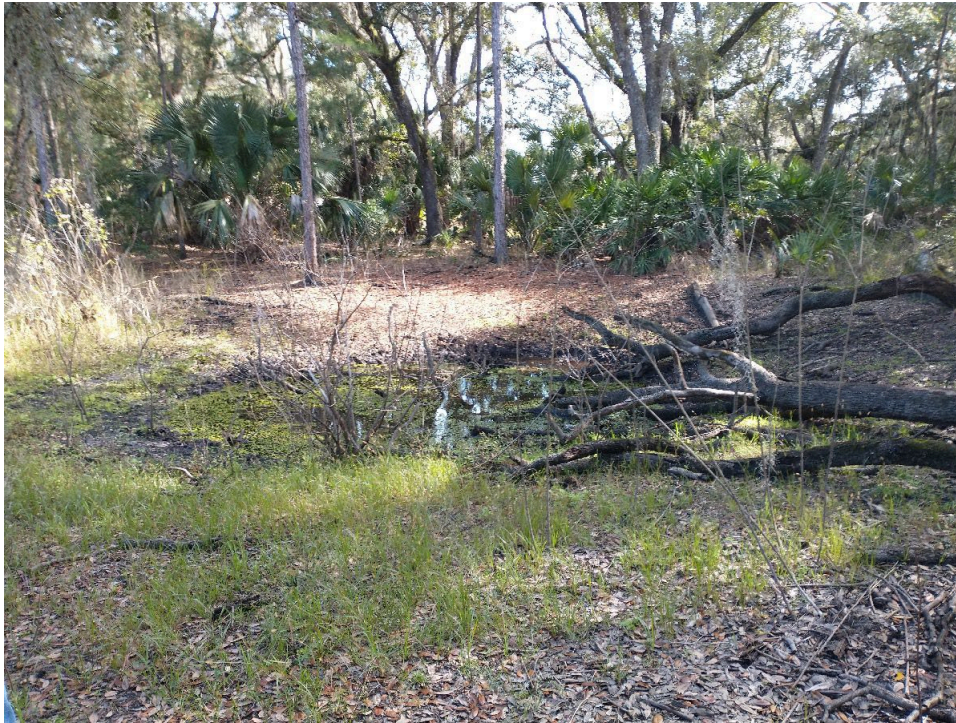
**Photograph 6.** Wekiva Springs State Park near Carpenter Branch, looking south-southeast on December 11, 2023 at 12:14 EST from 28° 43' 2.1 " N 81° 29' 27.3 " W.

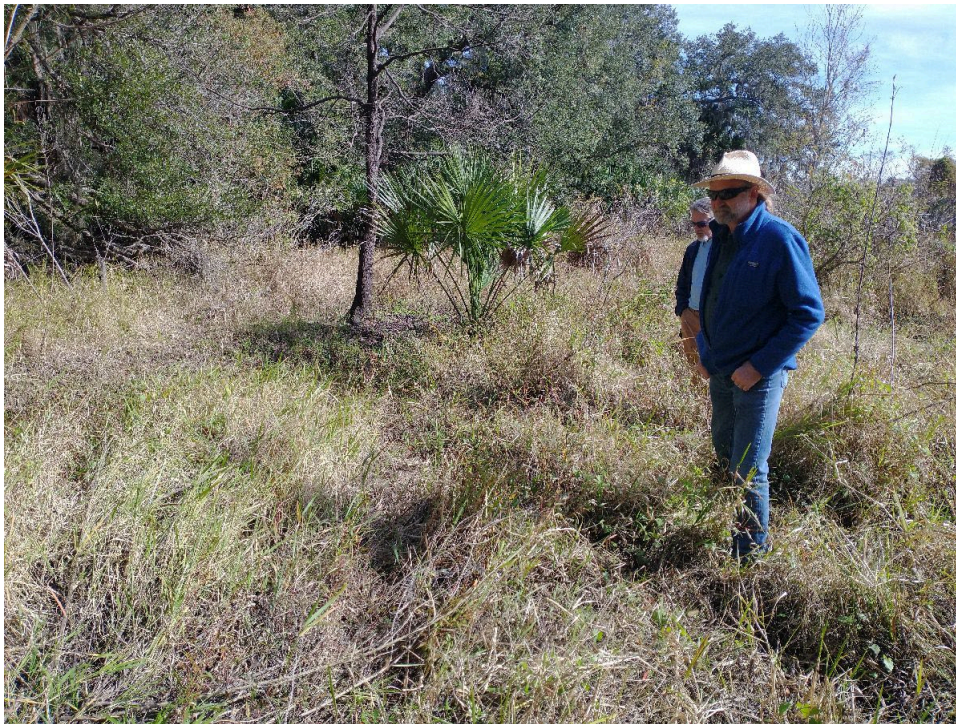
**Photograph 7.** Wekiva Springs State Park near Carpenter Branch, looking south-southeast on December 11, 2023 at 12:18 EST from 28° 43' 1.4 " N 81° 29' 25.7 " W.

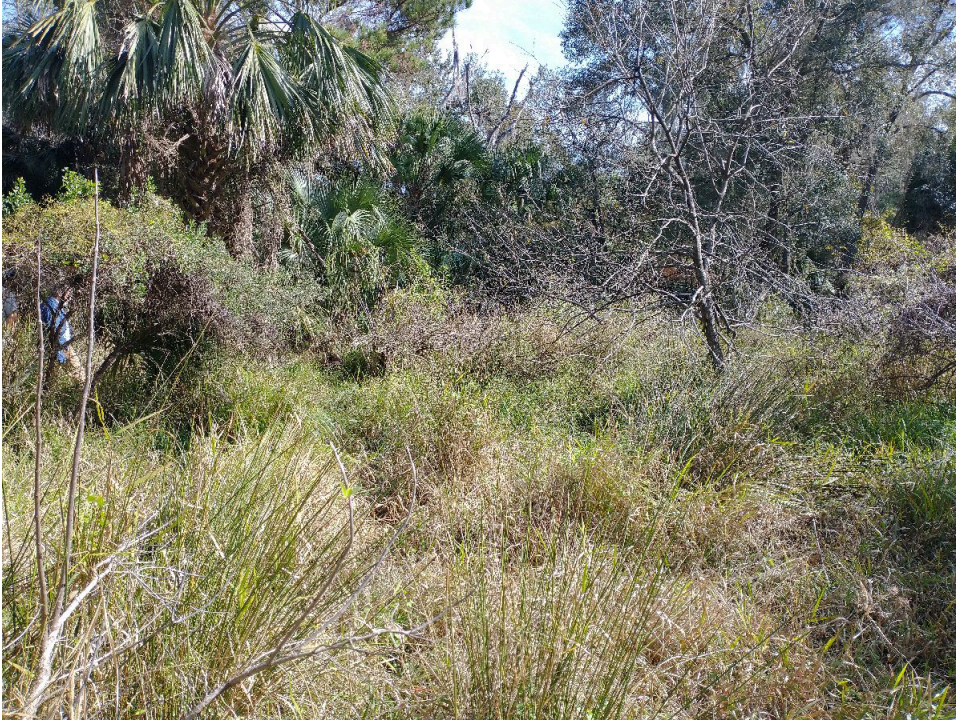
**Photograph 8.** Wekiva Springs State Park near the north lobe of Lake Prevatt, looking southeast on December 11, 2023 at 12:21 EST from 28° 43' 0 " N 81° 29' 26.2 " W.

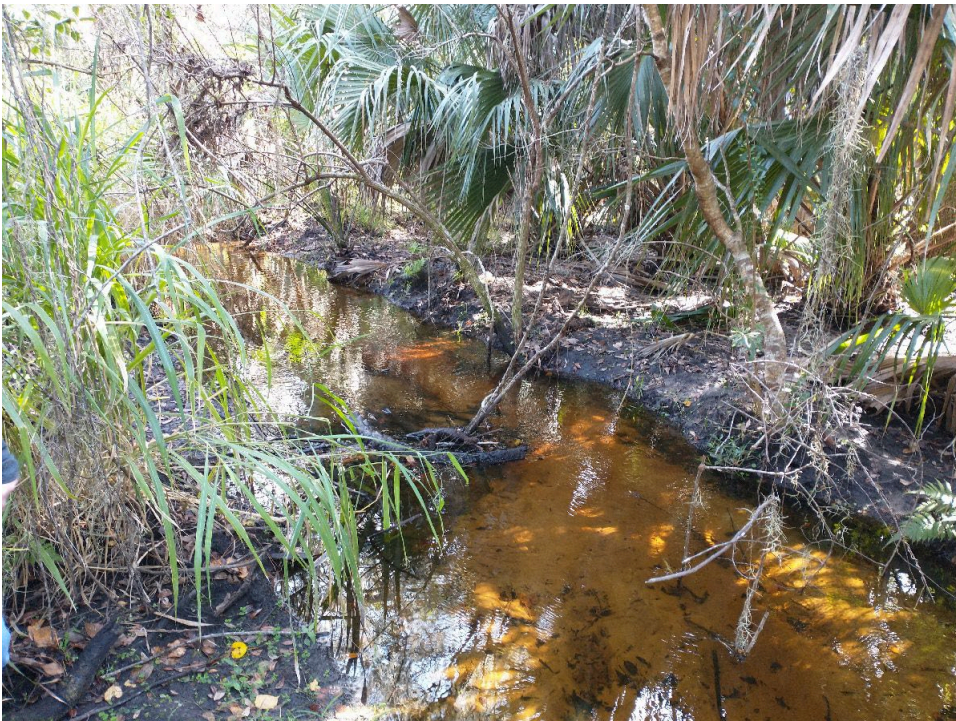
**Photograph 9.** Wekiva Springs State Park near the outfall of an unnamed creek that drains the northern and western sub-watershed into Lake Prevatt, looking southeast on December 11, 2023 at 12:23 EST from 28° 42' 59.4 " N 81° 29' 27 " W. Creek water flowed to the southeast on December 11.

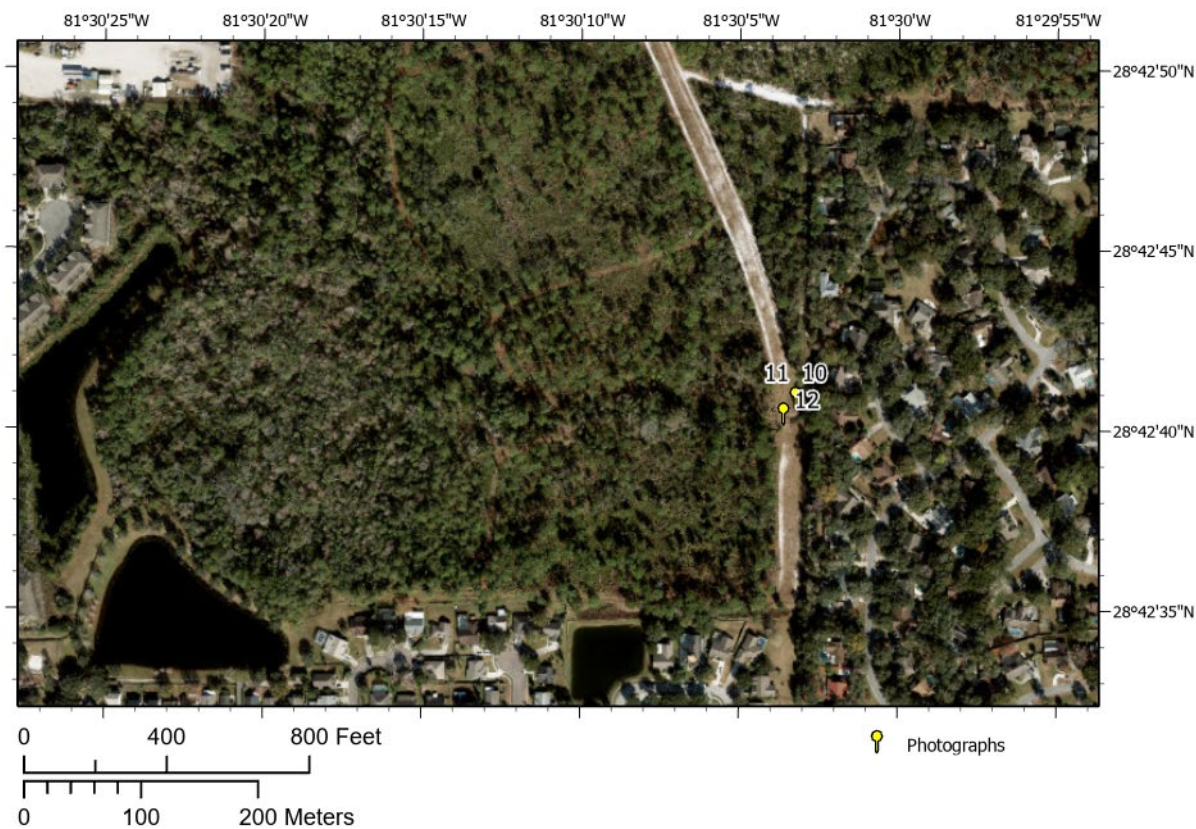
**Figure 5.** Photograph locations (yellow pins) near a Wekiva Springs State Park boundary, west of Oak Leaf Court, over a January 28, 2021 aerial photograph attributed to Orange County, Florida in the ESRI World Imagery basemap.

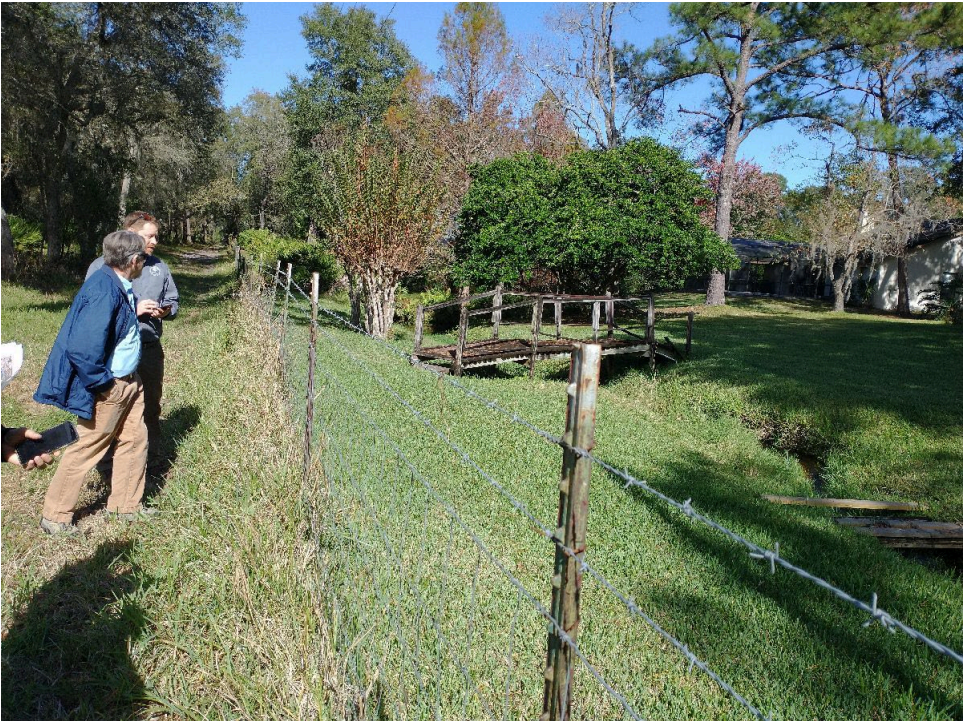
**Photograph 10.** Western side of the unnamed creek in photograph 8, looking northeast on December 11, 2023 at 12:39 EST from 28° 42' 40.6 " N 81° 30' 3.2 " W.

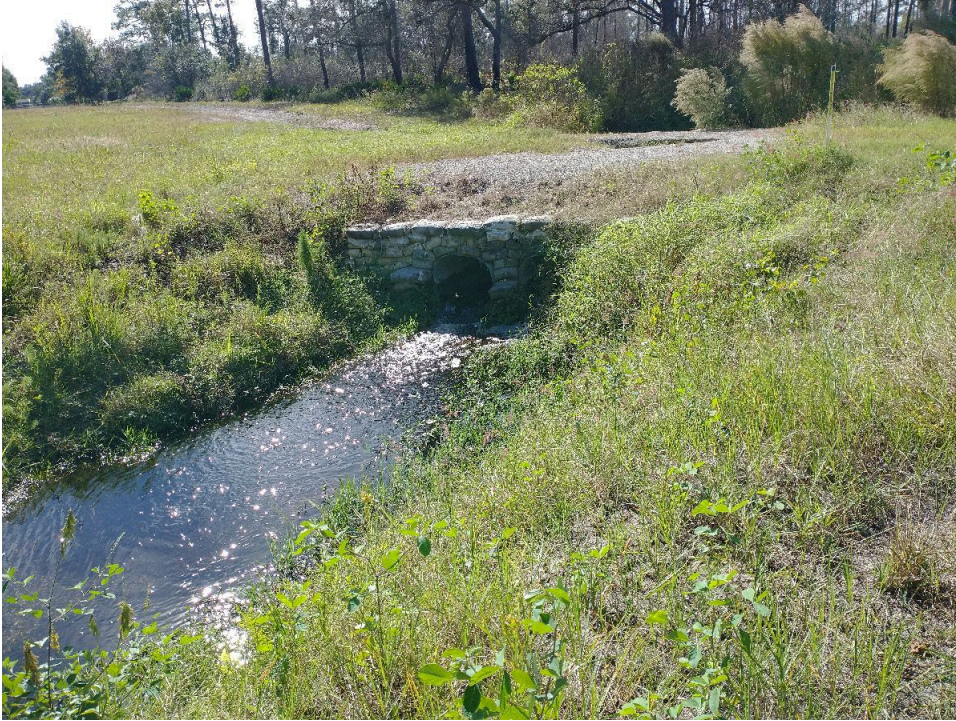
**Photograph 11.** Northern side of unnamed creek in photographs 8 and 10, looking southwest on December 11, 2023 at 12:40 EST from 28° 42' 40.6 " N 81° 30' 3.3 " W.

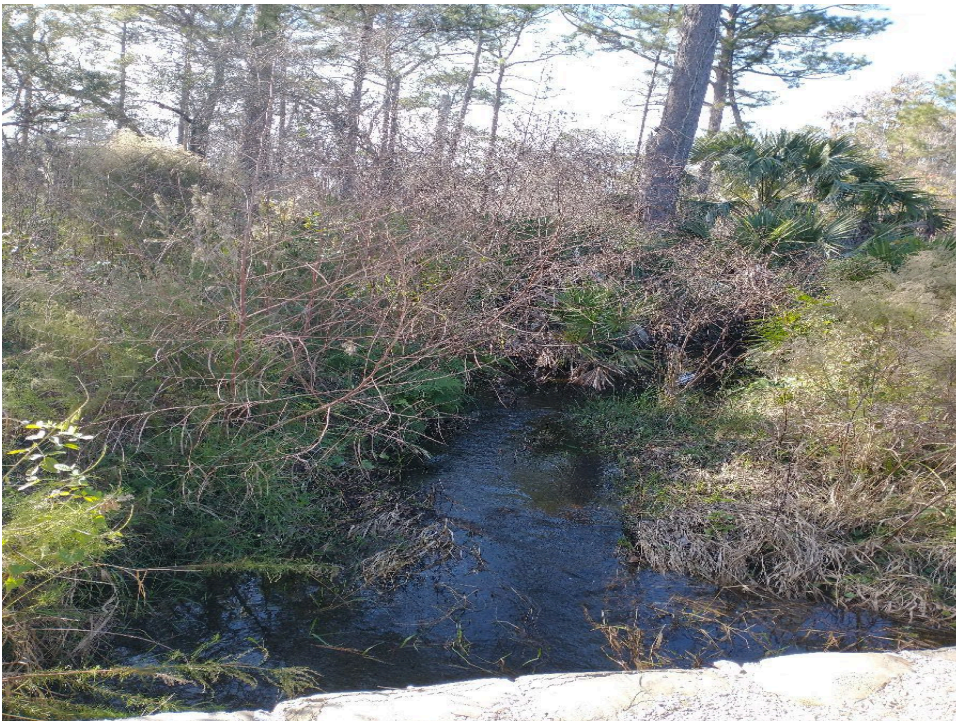
**Photograph 12.** Bridge over unnamed creek in photographs 8, 10, and 11, looking southwest on December 11, 2023 at 12:41 EST from 28° 42' 40.2 " N 81° 30' 3.6 " W.

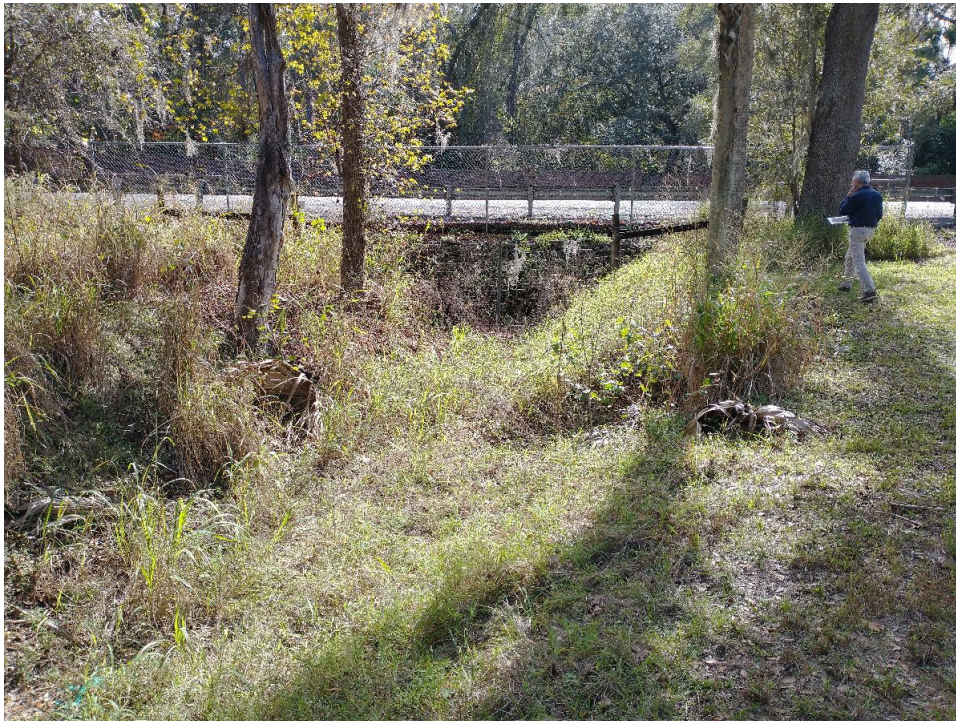
**Photograph 13.** Wekiva Springs State Park ranger's residence, looking south on December 11, 2023 at 13:18 EST from 28° 42' 22.7 " N 81° 29' 41.4 " W.

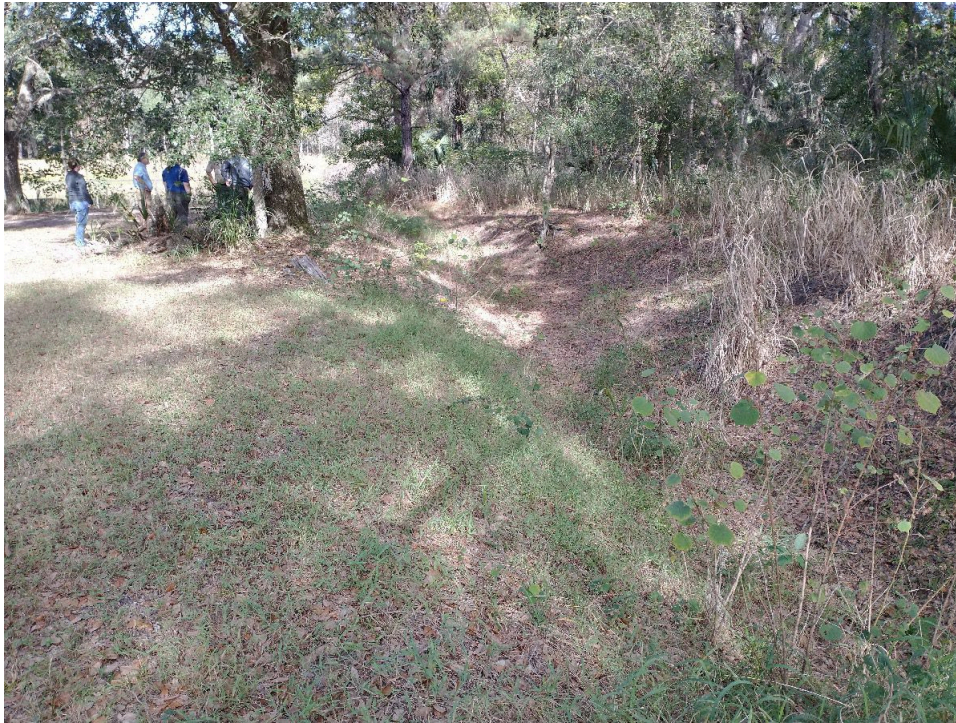
**Photograph 14.** Wekiva Springs State Park ranger's residence, looking north on December 11, 2023 at 13:19 EST from 28° 42' 22.9 " N 81° 29' 41.4 " W.

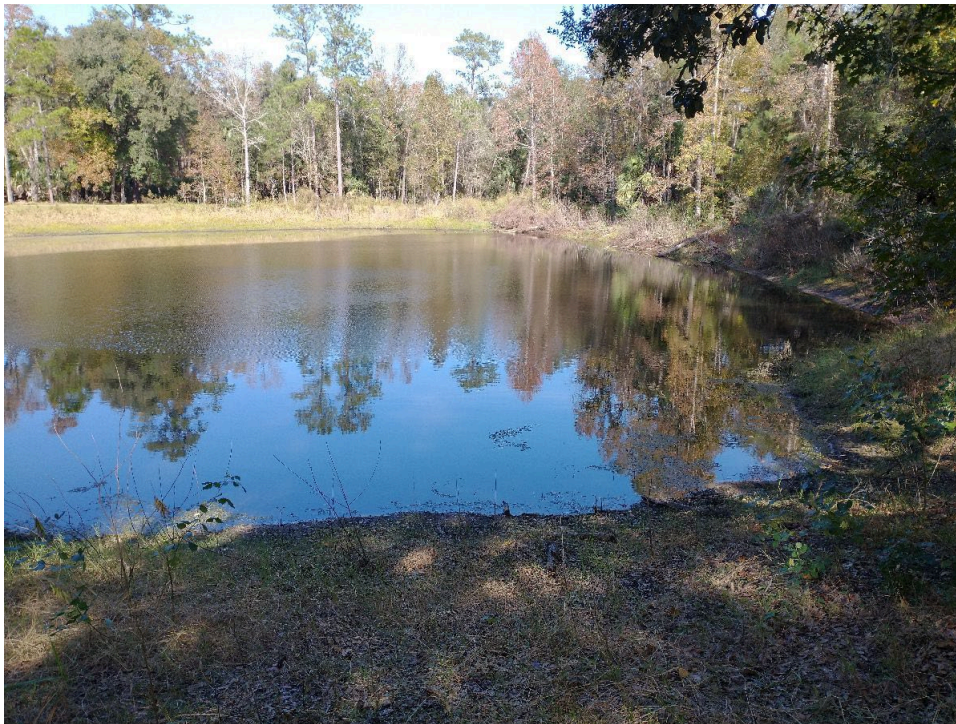
- Wekiva Springs State Park Manager Robert Brooks asserted discharge from Lake Coroni inundates from the south, the pond near the park manager's residence (fig. 6, photo. 15), one-to-three days after relatively large episodic rainfall events, such as rainfall events associated with 2010s and 2020s era hurricanes and tropical depressions. Manager Brooks stated that the maximum pond stage in response to this episodic discharge inundates the pond adjacent to the park manager's residence (photo. 15) to a point that is equidistant between the normal pond shoreline and the park manager's residence. Manager Brooks asserted that a governmental entity controlled and managed this discharge, with water management actions such as the opening of a water control gate.

**Photograph 15.** Southern side of pond east of Wekiva Springs State Park ranger's residence, looking northeast on December 11, 2023 at 13:29 EST from 28° 42' 23.8 " N 81° 29' 41.7 " W.

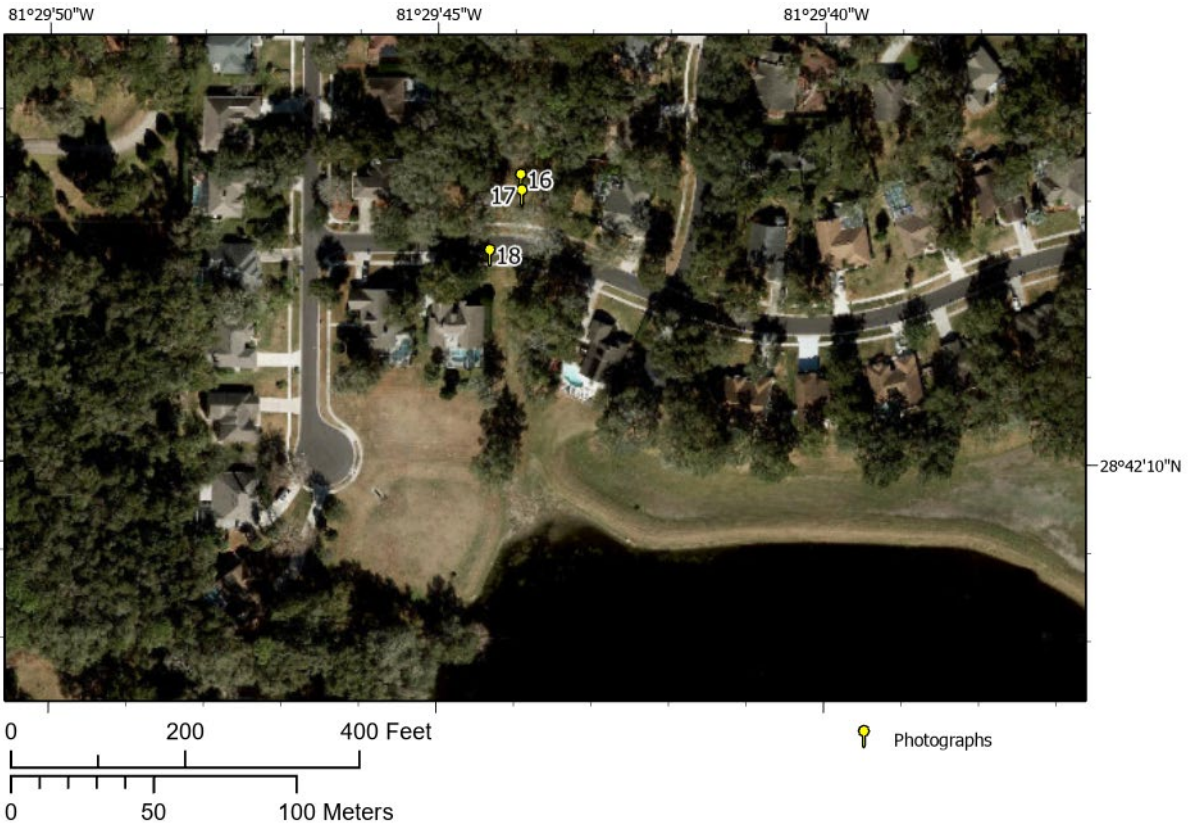
- SJRWMD staff and I inspected two locations south of the ranger's residence (figs. 7 and 8) and found that Lake Coroni was dry on December 11. The group agreed that this volume is likely sufficient to contain relatively lesser events, and that this volume is likely sufficient to significantly lag a storm of relatively larger magnitude. We inspected and photographed a 60-inch diameter round concrete pipe that controls flows to the south, toward the ranger's residence. If Lake Coroni is dry during an episodic event, lake water may eventually pop off during the

**Figure 7.** Photograph locations (yellow pins), north and south of Paradise Isle Drive, over a January 28, 2021 aerial photograph attributed to Orange County, Florida in the ESRI World Imagery basemap. Lake Coroni is south of Paradise Isle Drive.

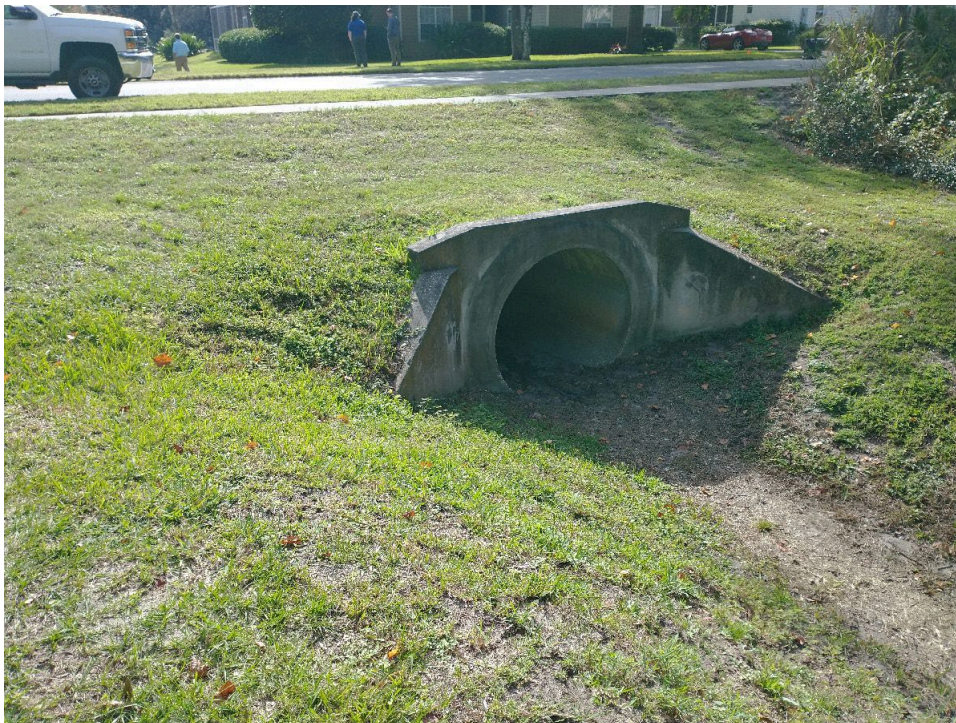
episodic event, through the culvert (photo. 16). We made a similar conclusion relative to a rectangular weir (photo. 19) that controls outflow from Lake McCoy.

**Photograph 16.** North of Paradise Isle Drive looking southwest on December 11, 2023 at 13:38 EST from 28° 42' 13.1 " N 81° 29' 43.9 " W. The diameter of this round concrete pipe culvert is about 60 inches.

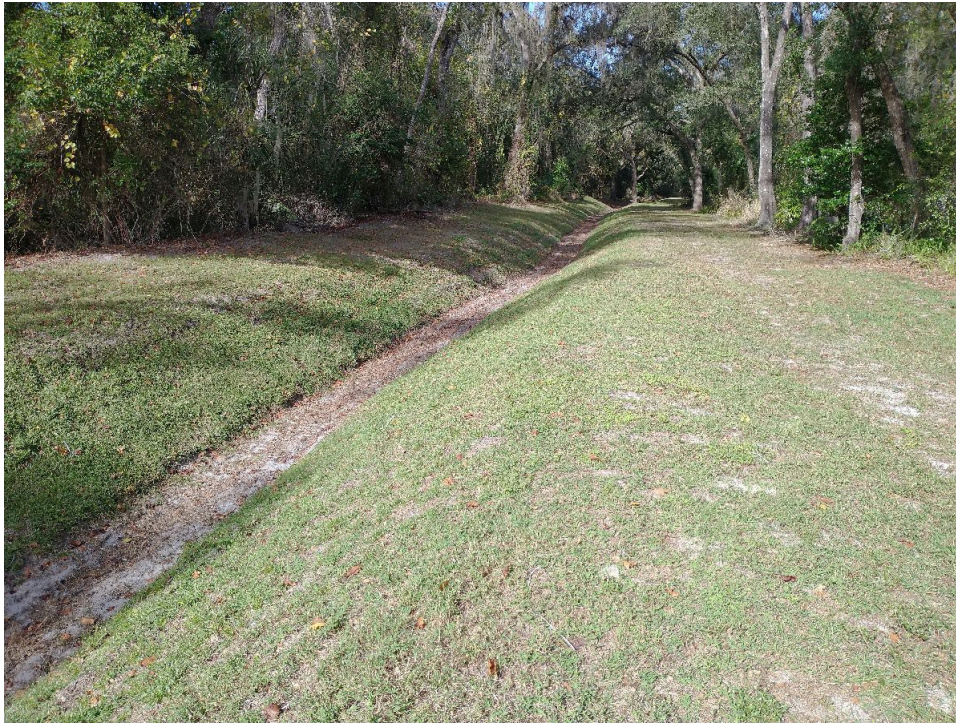
**Photograph 17.** North of Paradise Isle Drive looking north on December 11, 2023 at 13:38 EST from 28° 42' 12.9 " N 81° 29' 43.9 " W.

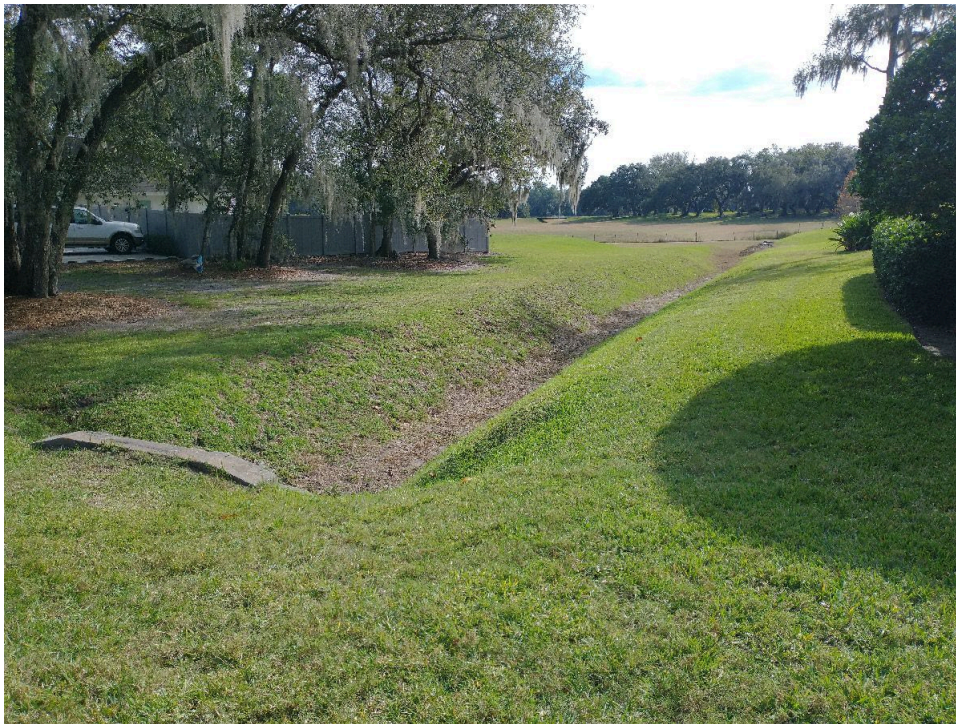
**Photograph 18.** South of Paradise Isle Drive looking south toward Lake Coroni on December 11, 2023 at 13:39 EST from 28° 42' 12.2 " N 81° 29' 44.3 " W. Lake Coroni was dry on December 11, with no apparent standing water in the bottom of the lake, visible from Paradise Isle Drive.

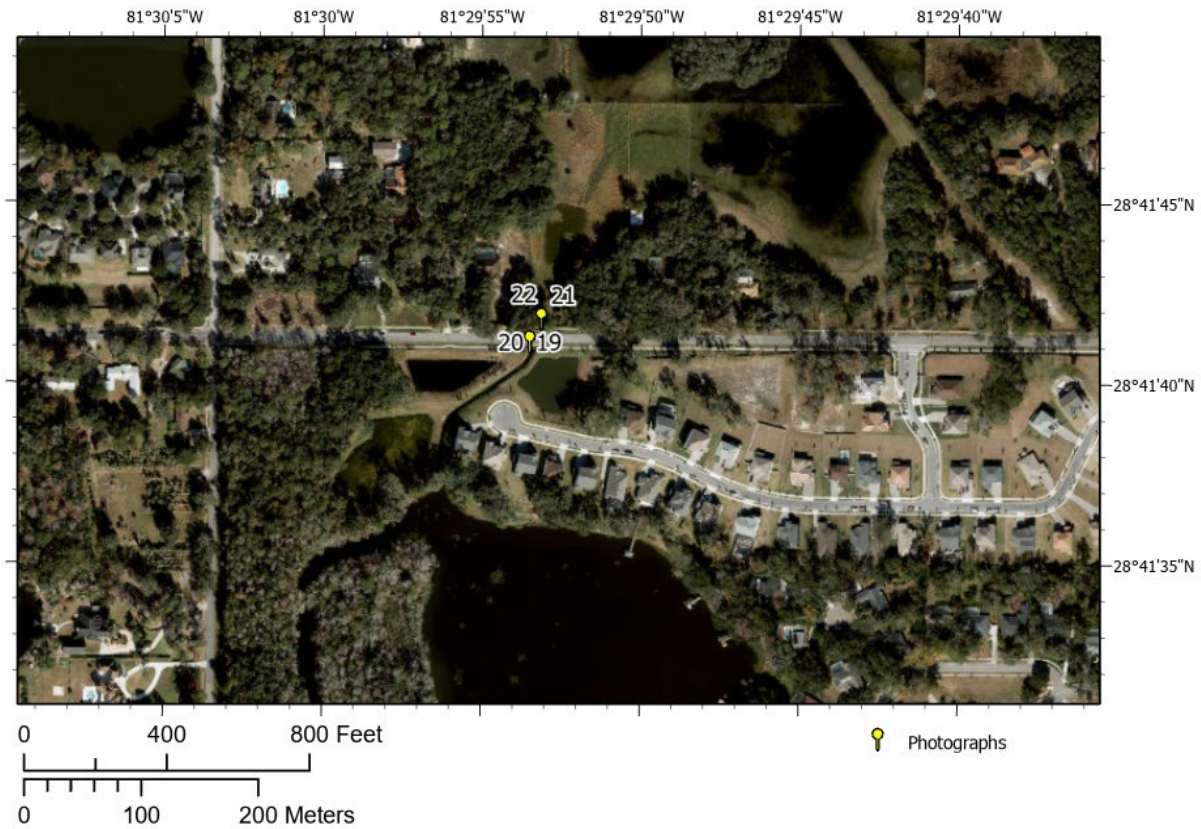
**Figure 8.** Photograph locations (yellow pins) north and south of East Sandpiper Street, over a January 28, 2021 aerial photograph attributed to Orange County, Florida in the ESRI World Imagery basemap. Lake Coroni is north of East Sandpiper Street; Lake McCoy is south of East Sandpiper Street.

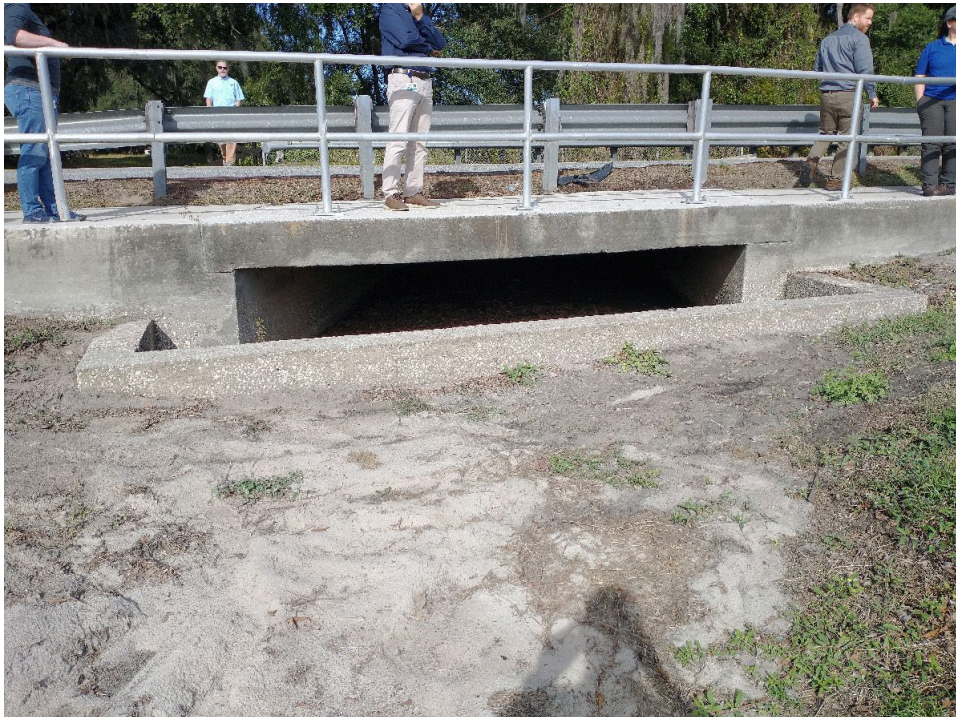
**Photograph 19.** South of East Sandpiper Street looking north on December 11, 2023 at 13:53 EST from 28° 41' 40.8 " N 81° 29' 53.5 " W.

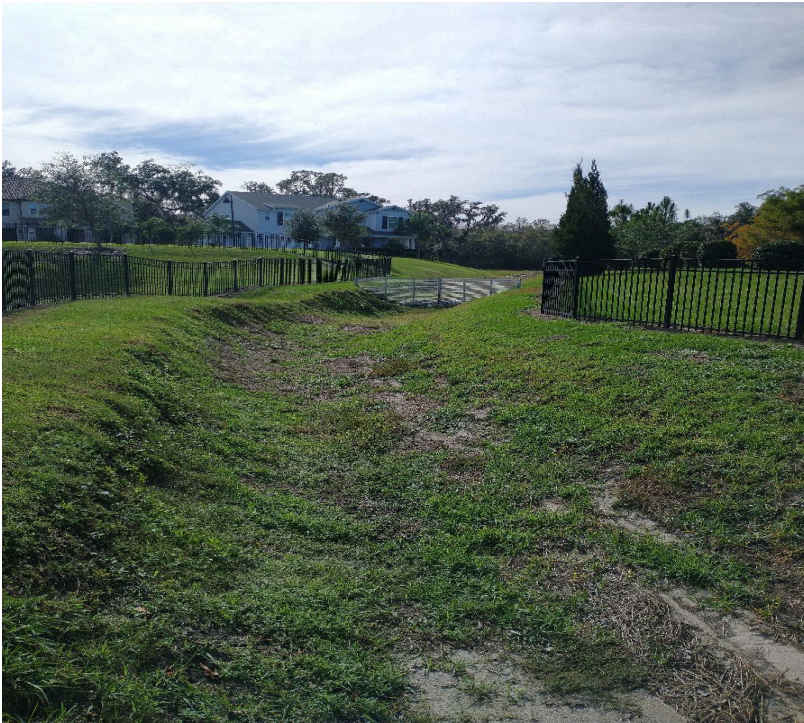
**Photograph 20.** South of East Sandpiper Street looking south on December 11, 2023 at 13:53 EST from 28° 41' 40.8 " N 81° 29' 53.5 " W.

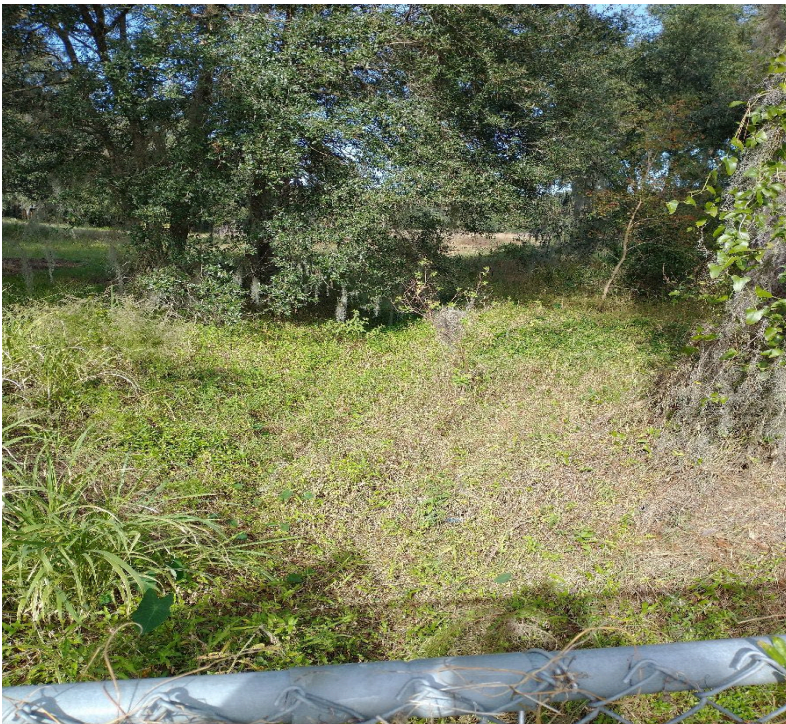
**Photograph 21.** North of East Sandpiper Street looking north on December 11, 2023 at 13:54 EST from 28° 41' 41.5 " N 81° 29' 53.1 " W.

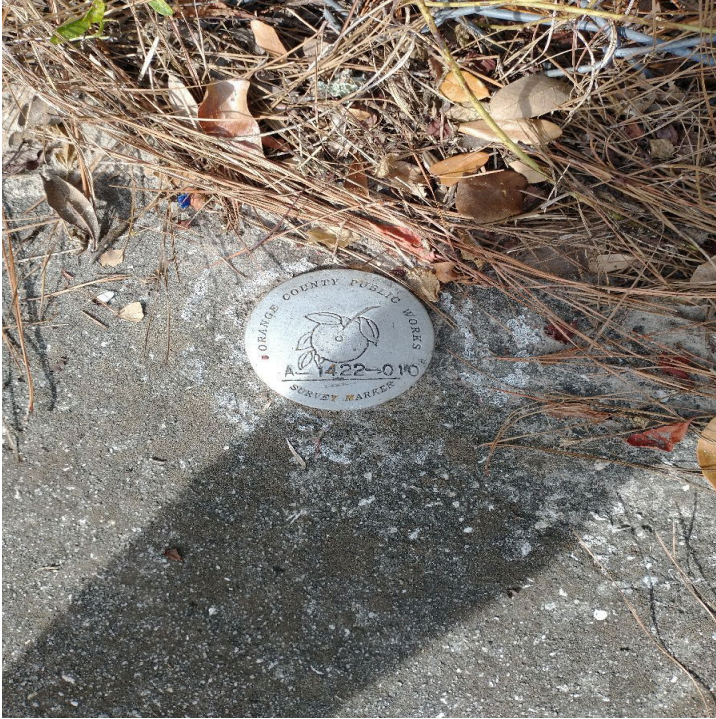
**Photograph 22.** North of East Sandpiper Street looking down on December 11, 2023 at 13:55 EST from 28° 41' 41.5 " N 81° 29' 53.1 " W.
