**A SUMMARY OF SUBMERGED AQUATIC
VEGETATION (SAV) STATUS
WITHIN THE LOWER ST. JOHNS RIVER:
1996 – 2007**

Final Report: September 30, 2007
Contract Period: March 30, 2006 through September 30, 2007
Contract Number: SJ45514

Prepared for:
St. Johns River Water Management District
Division of Environmental Sciences
P.O. Box 1429
Highway 100 West
Palatka, Florida 32178-1429
Project Manager:
Dean Dobberfuhl, Ph.D., Environmental Scientist V
(386) 329-4392

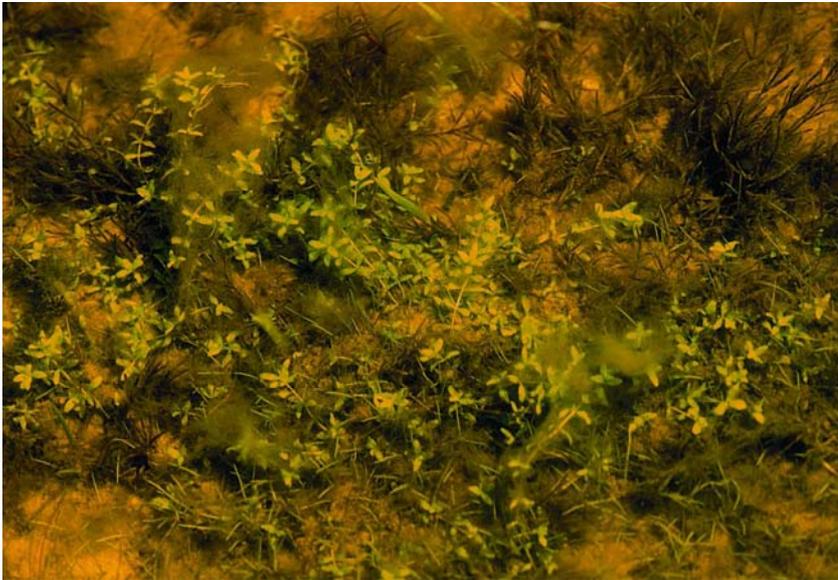
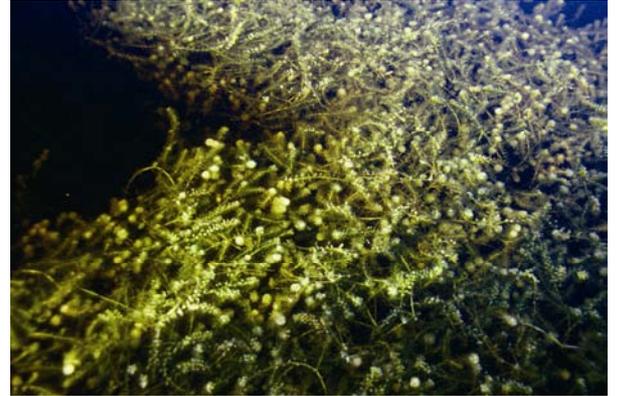
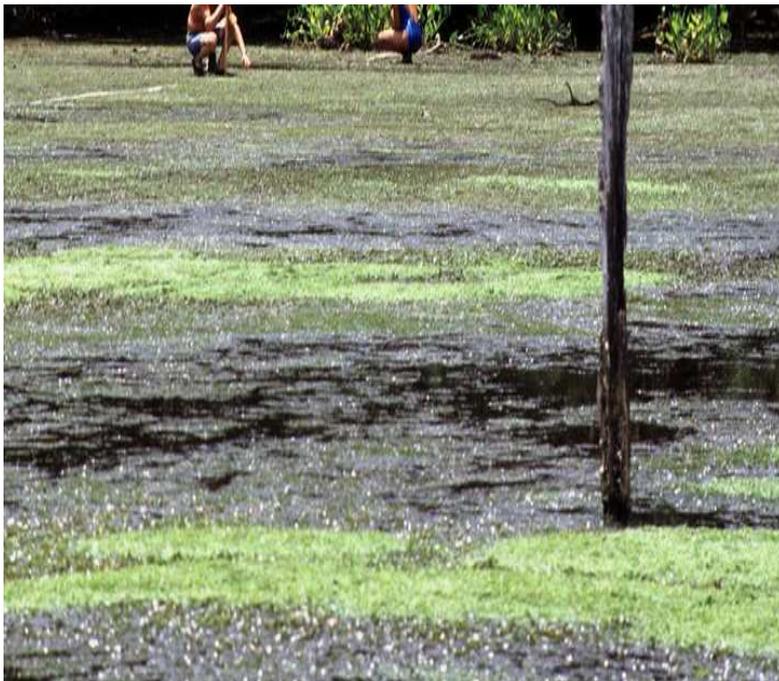
Figure 4a: Examples of SAV Morphology and Density as Seen in the LSJRB

Clockwise from top-left: 1) Approx. 30 cm x 30 cm view of *Eleocharis* sp., charophytes, *Micranthemum* sp., *N. guadalupensis*, *S. subulata*, & *Z. palustris*; 2) *H. verticillata*; 3) 25 cm x 25 cm view of *Z. palustris* with inset of typical plant size; 4) At Scratch Ankle, light green *Micranthemum* sp. mats overlying and around beds of charophytes, *Eleocharis* sp., *N. guadalupensis*, *P. pusillus*, *S. subulata*, *V. americana*, *Z. palustris*. Note that water clarity in many of these photos is atypical; they were taken during the height of the drought in 2001

Even if visibility constraints were not an issue (ex. during low, low tides during winter months), LSJR SAV density and plant morphology (Figures 4a and 4b) was such that in-site determinations of 1) individual plant cover (per m^2) or 2) shoot counts could not be conducted. For instance, many nearshore plants, including the second-most dominant species, *Najas guadalupensis*, produce clonal shoots immediately adjacent to the parent plant through dozens of adventitious roots. Thus, conducting shoot counts would be widely subjective. In addition, many plants (*C. demersum*, *H. verticillata*, *N. guadalupensis*, *Micranthemum* sp.) concentrate foliage at the surface of the water. Even *Vallisneria* takes on a canopy-type architecture during low tides when up to one third of the plant leaves may be layed over onto the surface of the water. Thus, designating a cover category per species according to the Blaun-Blanquet method was not possible, nor was attempting to count shoots within a gridded quadrat to achieve density values.

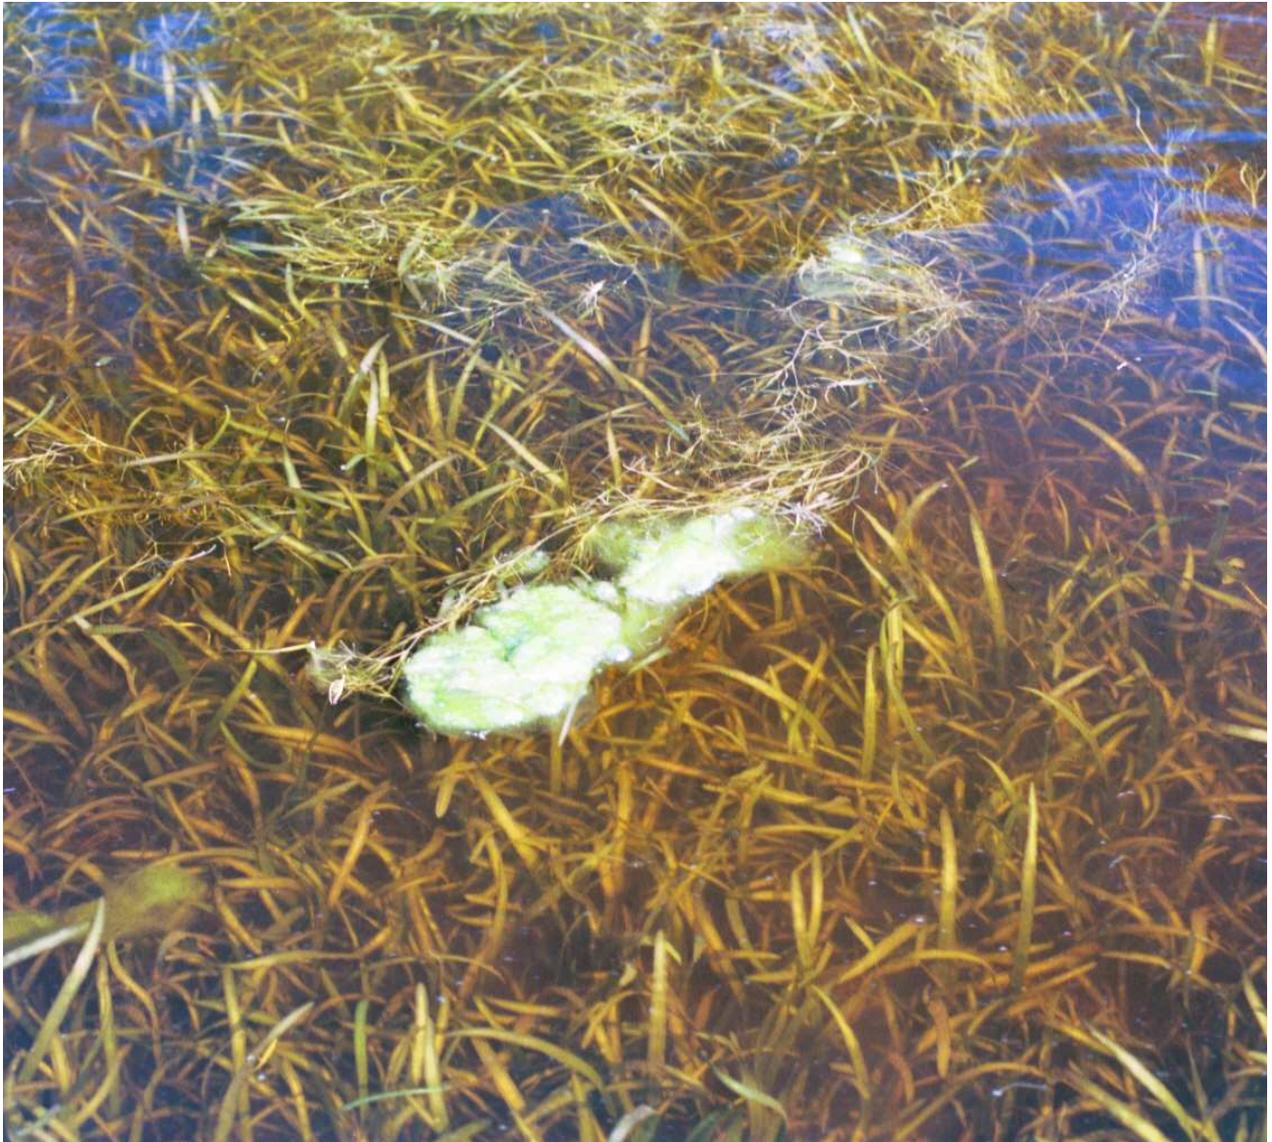
**Figure 4b: Examples of SAV Morphology and Density as Seen in the LSJRB
continued**

Approx. 1.0 m x 1.5 m view of predominantly *V. americana* with *R. maritima* interspersed. Note *Rhizoclonium* sp. entangled around *R. maritima* (Buckman, June 2003).

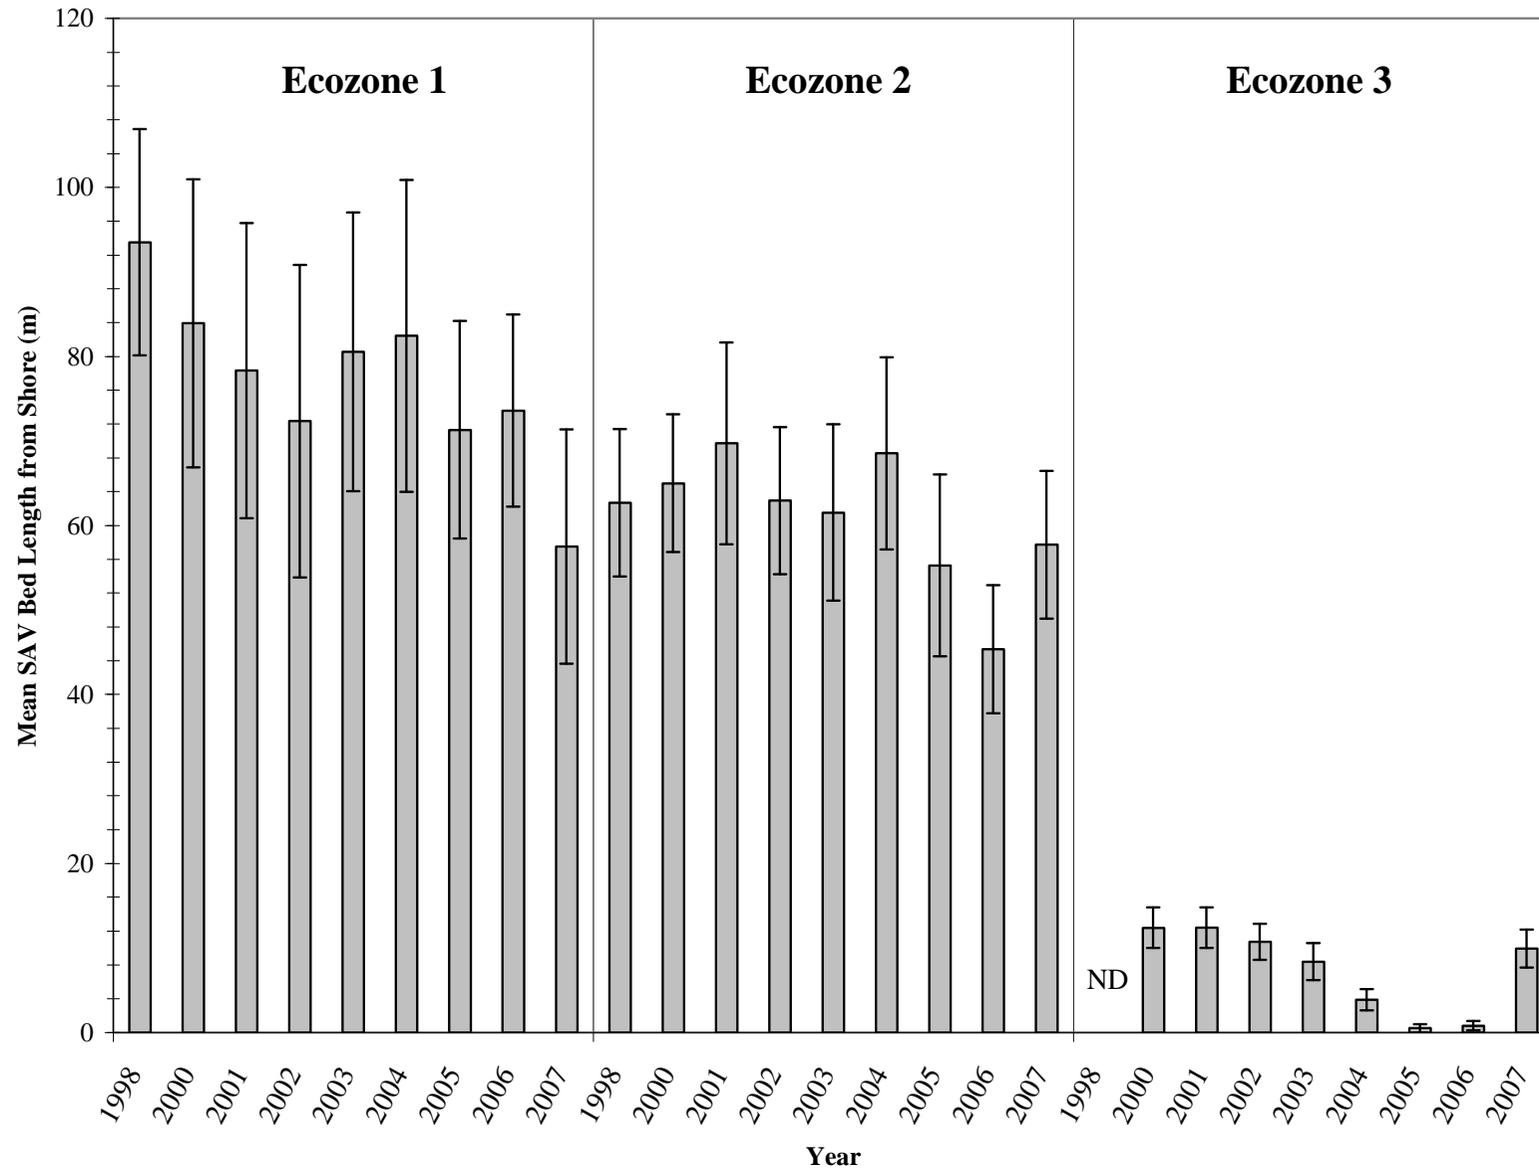
**Figure 7:
SAV Bed Length from Shore
Ecozones 1 - 3**

ND = No data . Adapted from Sagan 2007b.

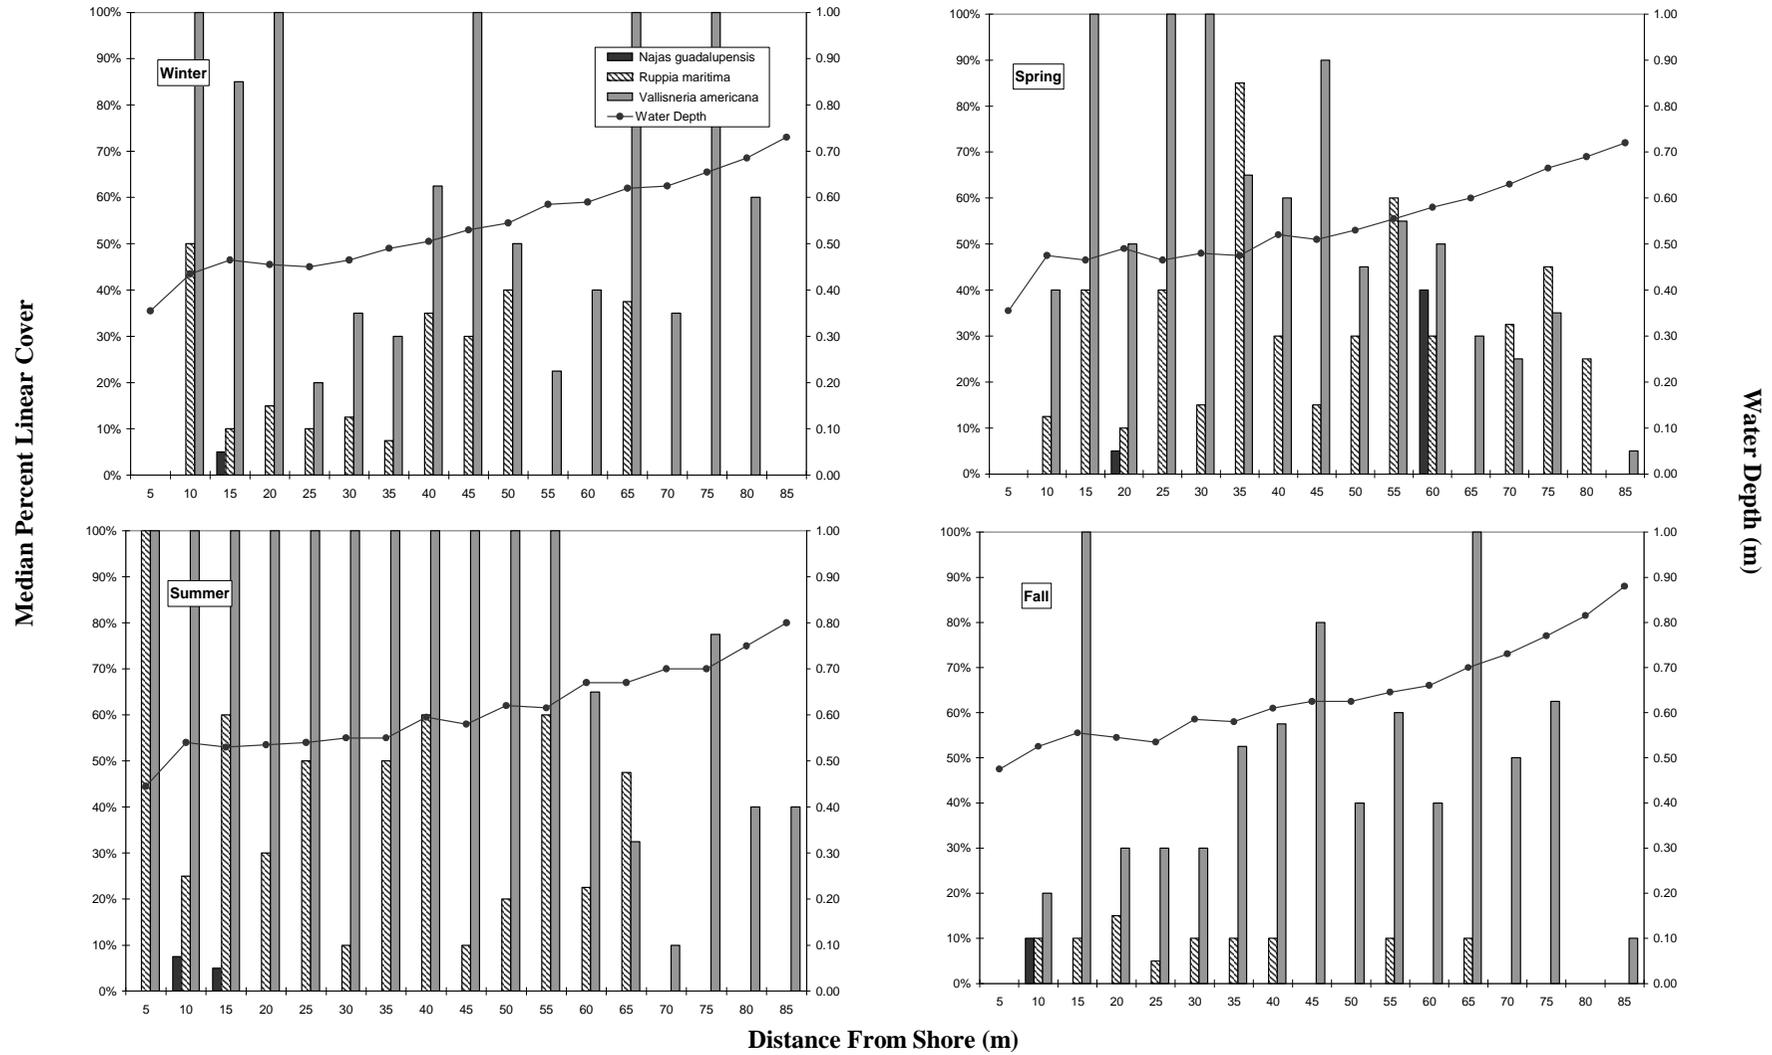
Figure 16: Water Depth Distribution of *Najas guadalupensis*, *Ruppia maritima*, and *Vallisneria americana*: Bolles School (taken from Sagan 2004a)

both drought and normal precipitation (2000 – 2004) conditions, a comparison between *Najas*, *Ruppia*, and *Vallisneria*, showed that *Vallisneria* occurred at significantly deeper water depths (year-round maximum water depth = 0.77 m ± 0.20; mean ± STD) (Sagan 2004a). Recent estimates within the freshwater section of LSJR and Crescent Lake show that *Vallisneria* was found where light within the water column was only 9% of ambient light (Dobberfuhl 2007). It was often found in monospecific meadows presumably under light conditions that did not support the growth of other species. In contrast to many studies (Barko et al. 1991) that suggest *Hydrilla* can out compete *Vallisneria* in low light conditions, we have observed at those locations where *Hydrilla* and *Vallisneria* co-occur, *Vallisneria* dominates, to the exclusion of *Hydrilla*, the deep-water section of the bed (Sagan 2005). This may be related to the quality of water column light (orange to red wavelengths, 600 – 700 nm) characteristic of highly colored and turbid systems like the LSJR (Kirk 1994).

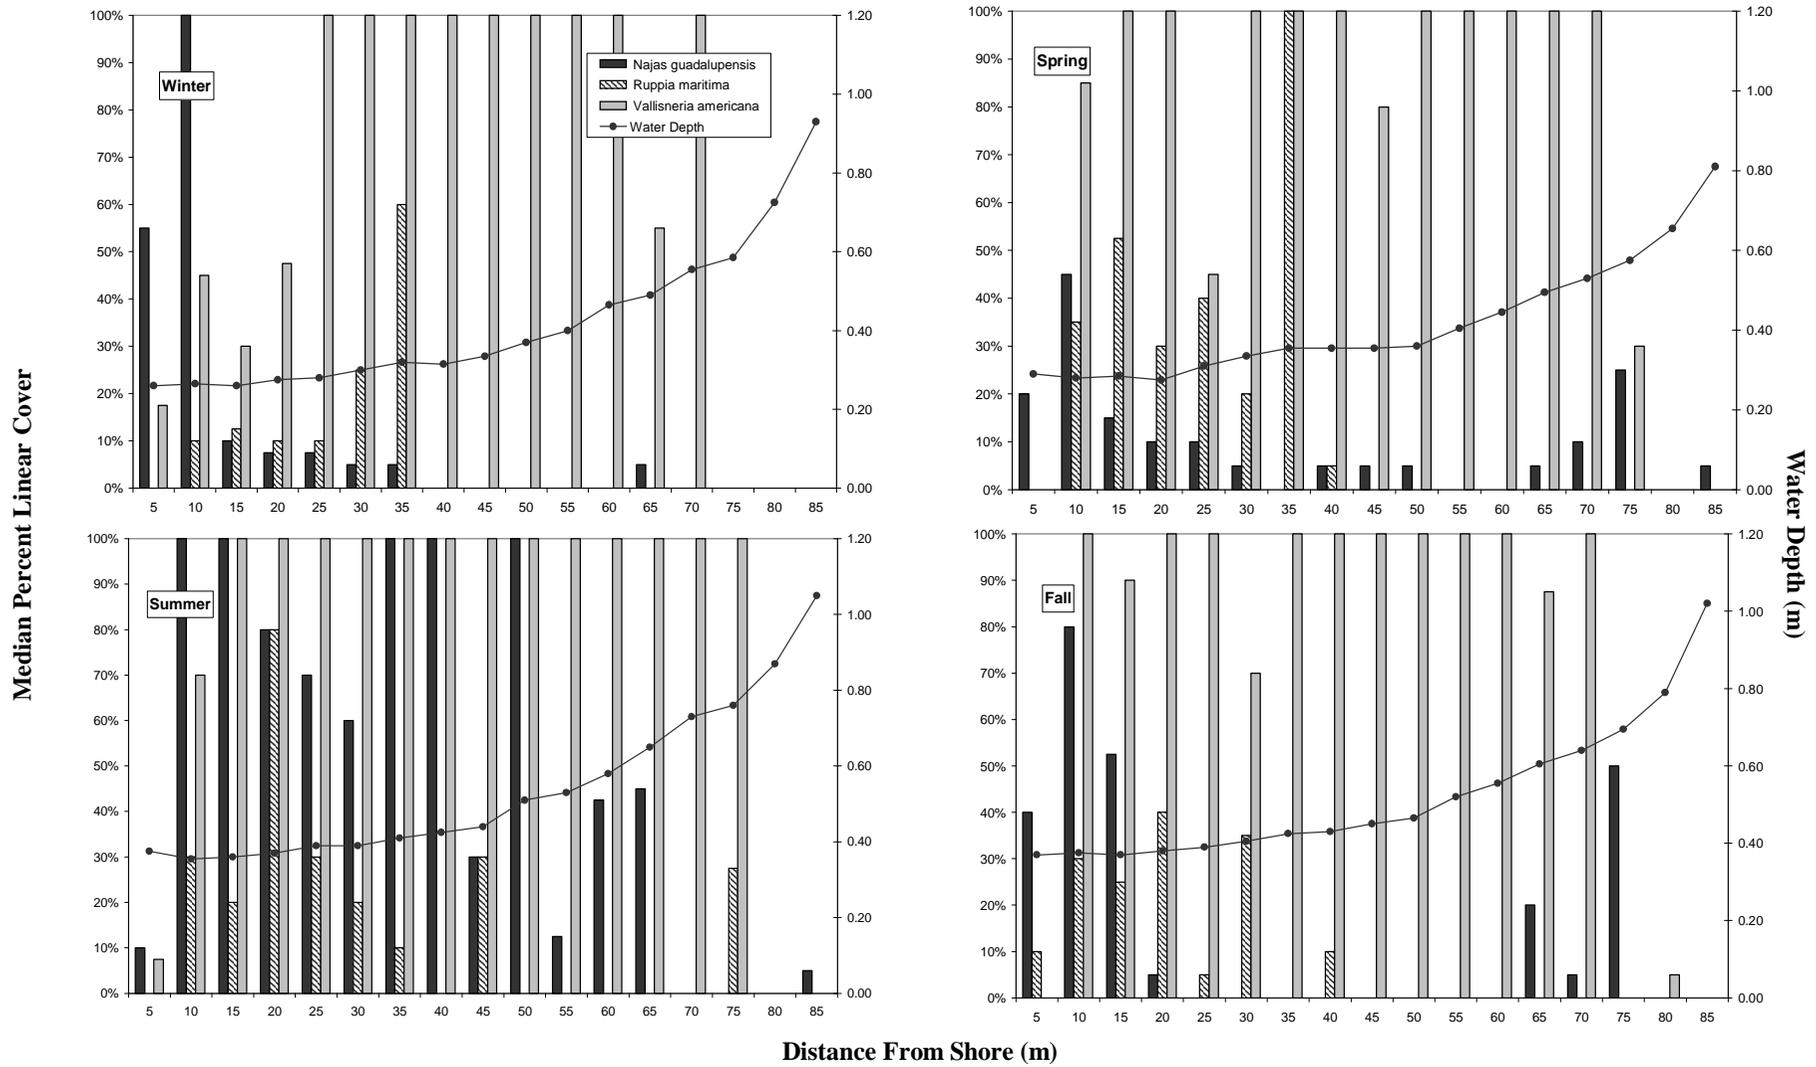
Figure 17: Water Depth Distribution of *Najas guadalupensis*, *Ruppia maritima*, and *Vallisneria americana*: Buckman (taken from Sagan 2004a)

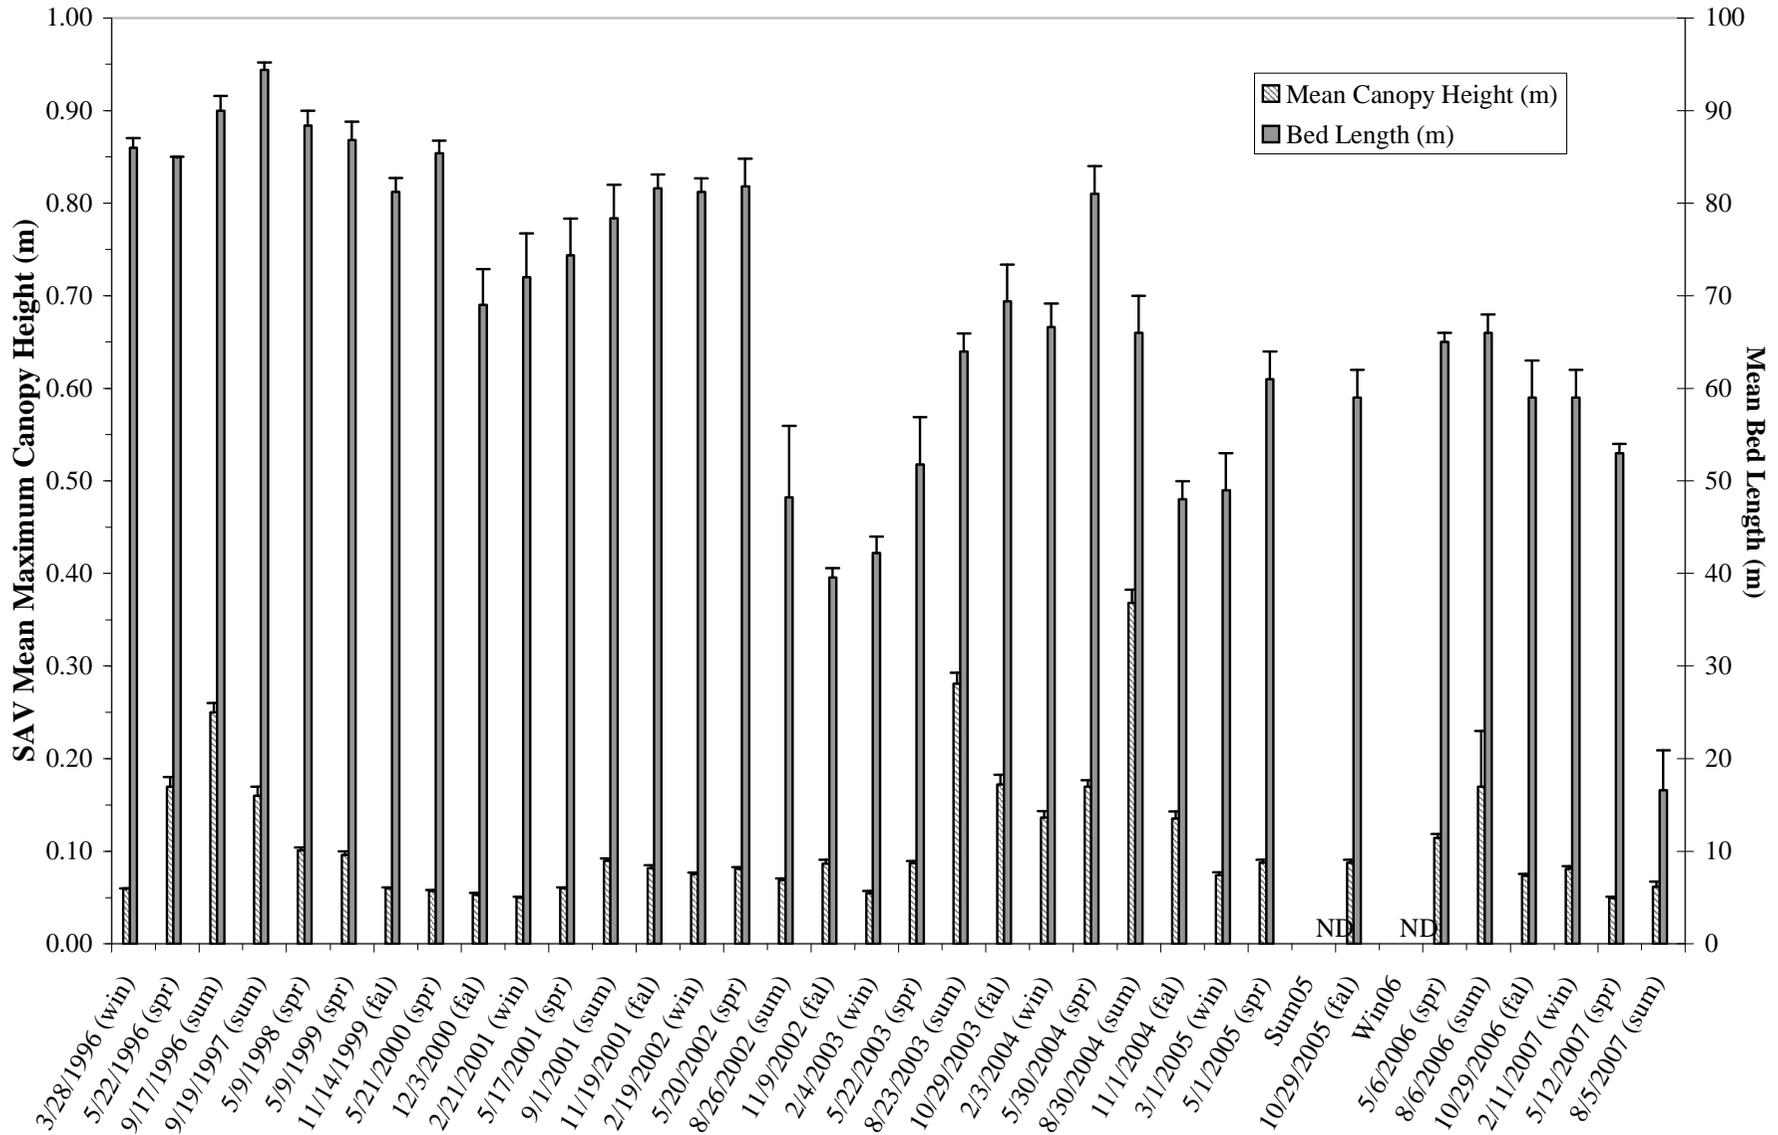
**Figure 23: SAV Mean Maximum Canopy Height & Bed Length
Bolles School 1996 - 2007**

Error bars indicate SE

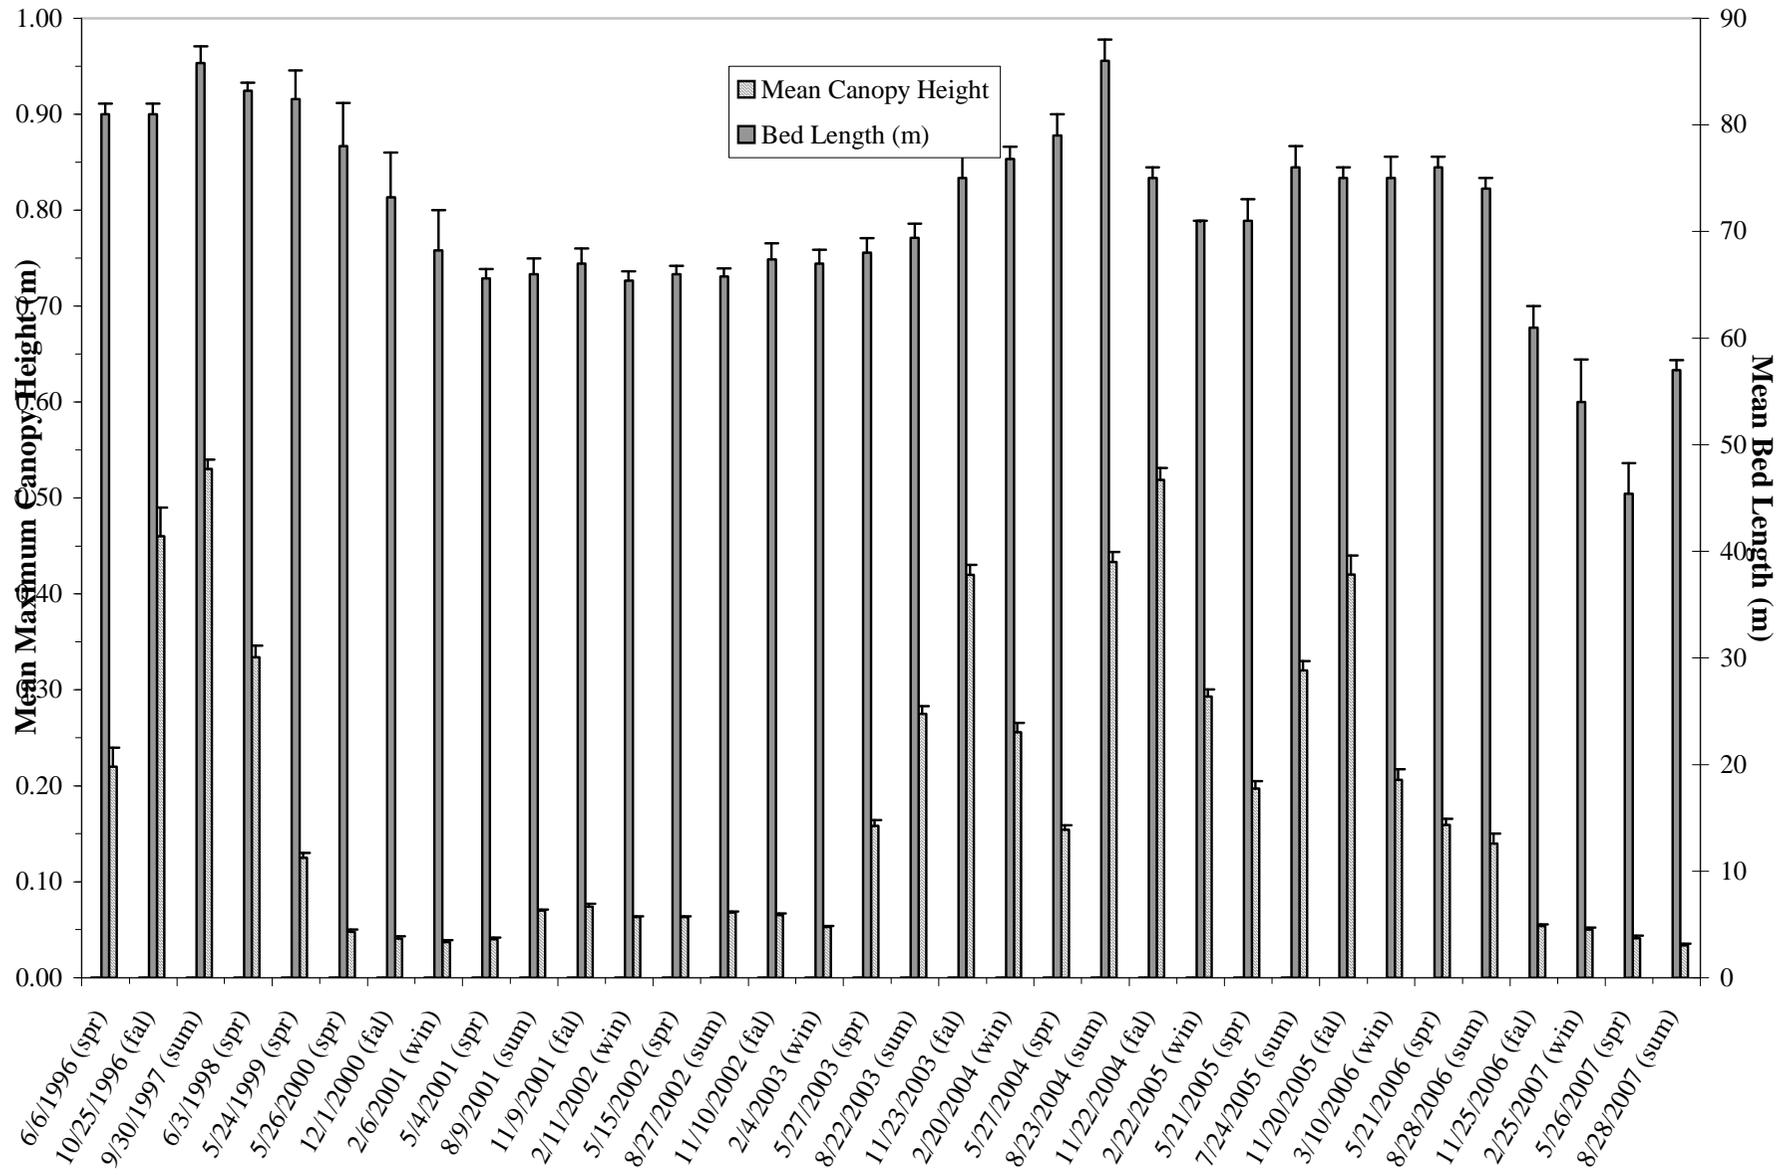
**Figure 24: SAV Mean Maximum Canopy Height & Bed Length
Buckman 1996 - 2007**

Error bars indicate SE

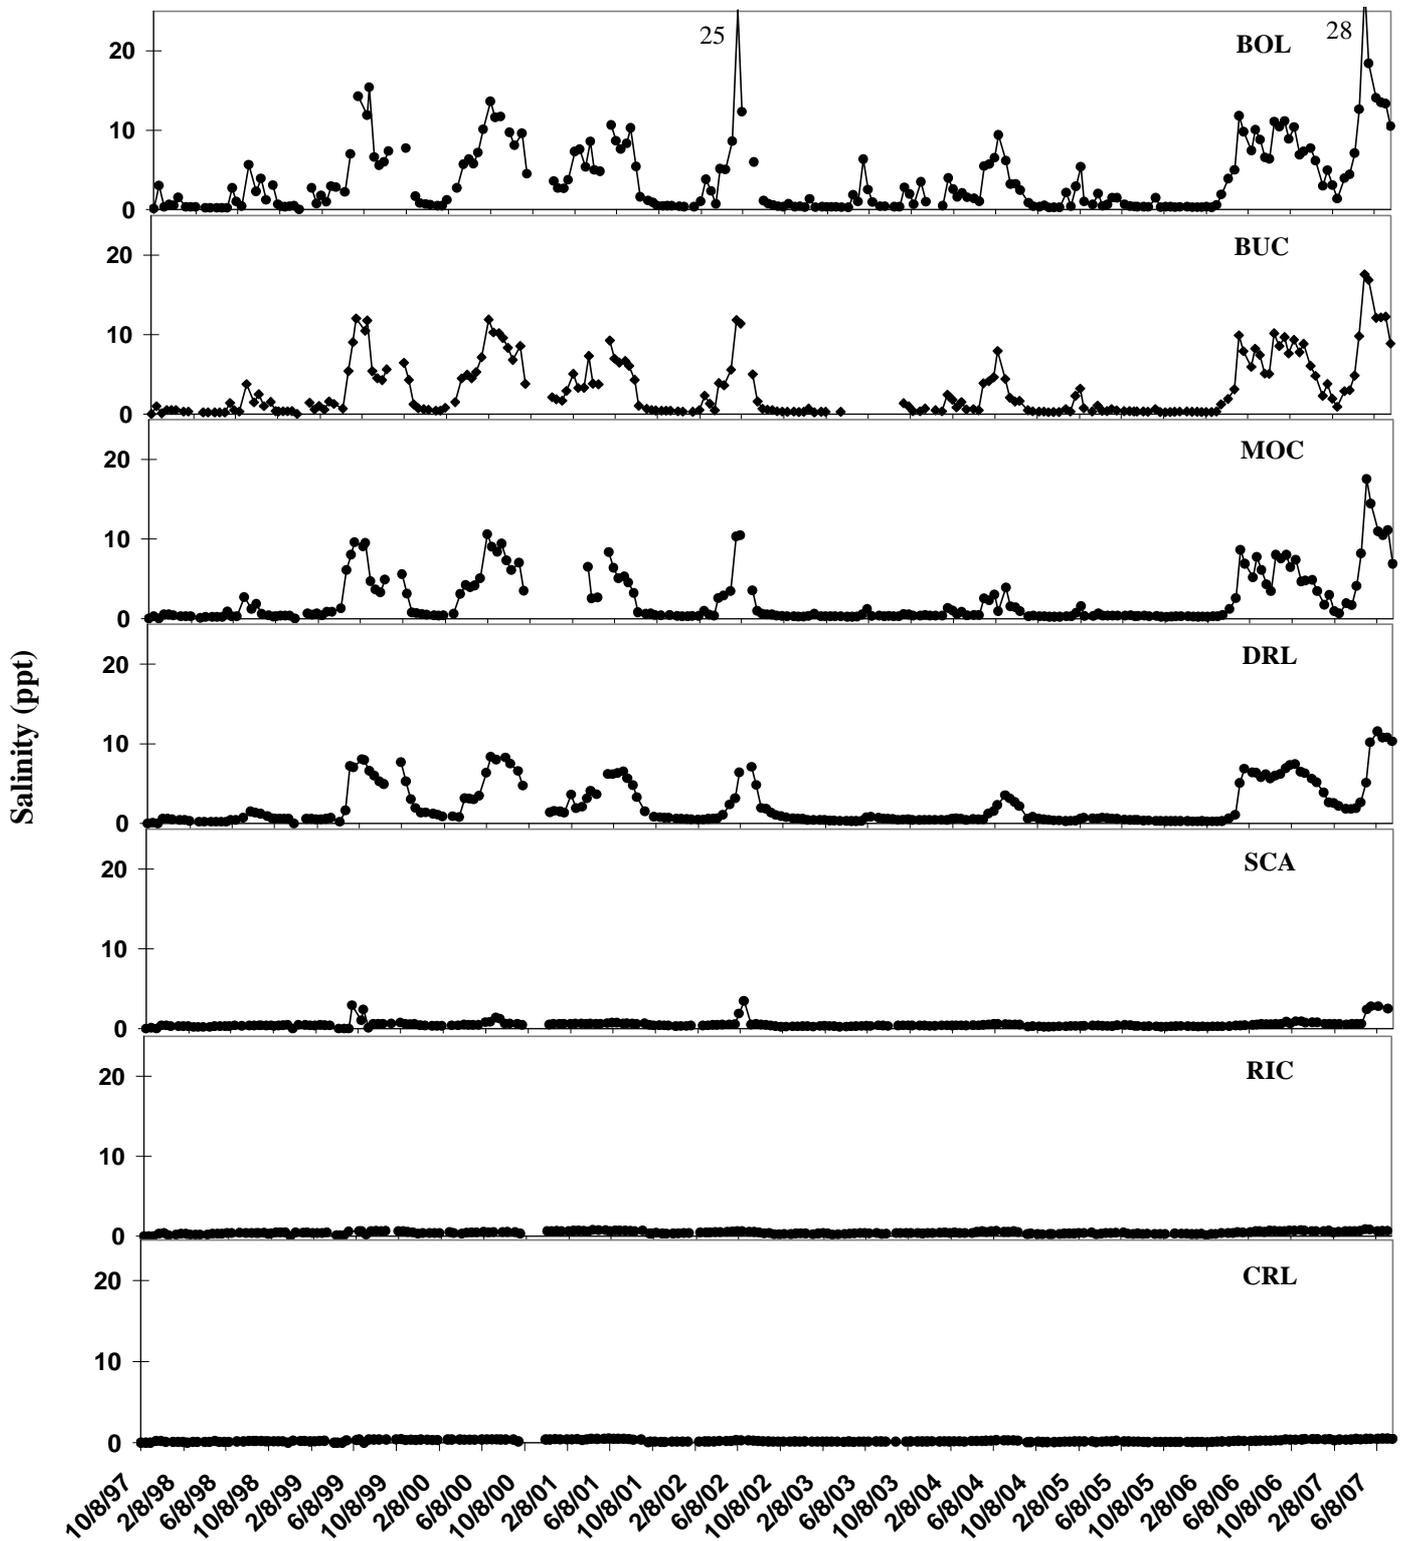
Figure 33: Bi-monthly salinity values, between October 1997 – July 2007, for BOL, BUC, MOC, DRL, SCA, RIC, and CRL

Some water quality parameters decline or increase along the latitudinal gradient of the river. Specifically, color and salinity show incremental changes from upstream to downstream. As would be expected in a tidal system, salinity values increased from RIC downstream to BOL. CRL, RIC, and SCA were freshwater (0 – 0.5 ppt) with SCA rarely oligohaline; DRL oscillated primarily between freshwater and oligohaline (0.5 – 5 ppt) but salinities increased in the mesohaline range (5 - 18 ppt) during drought conditions (Figure 33). Similarly, MOC, BUC, and BOL oscillated between freshwater and mesohaline (5 – 18 ppt) with increasing incidence of salinities in the polyhaline range (18 – 30 ppt) closer to BOL. Declines in salinity follow a seasonal pattern: low salinity during high precipitation months in the late summer and fall. Salinities were highest during drought events.

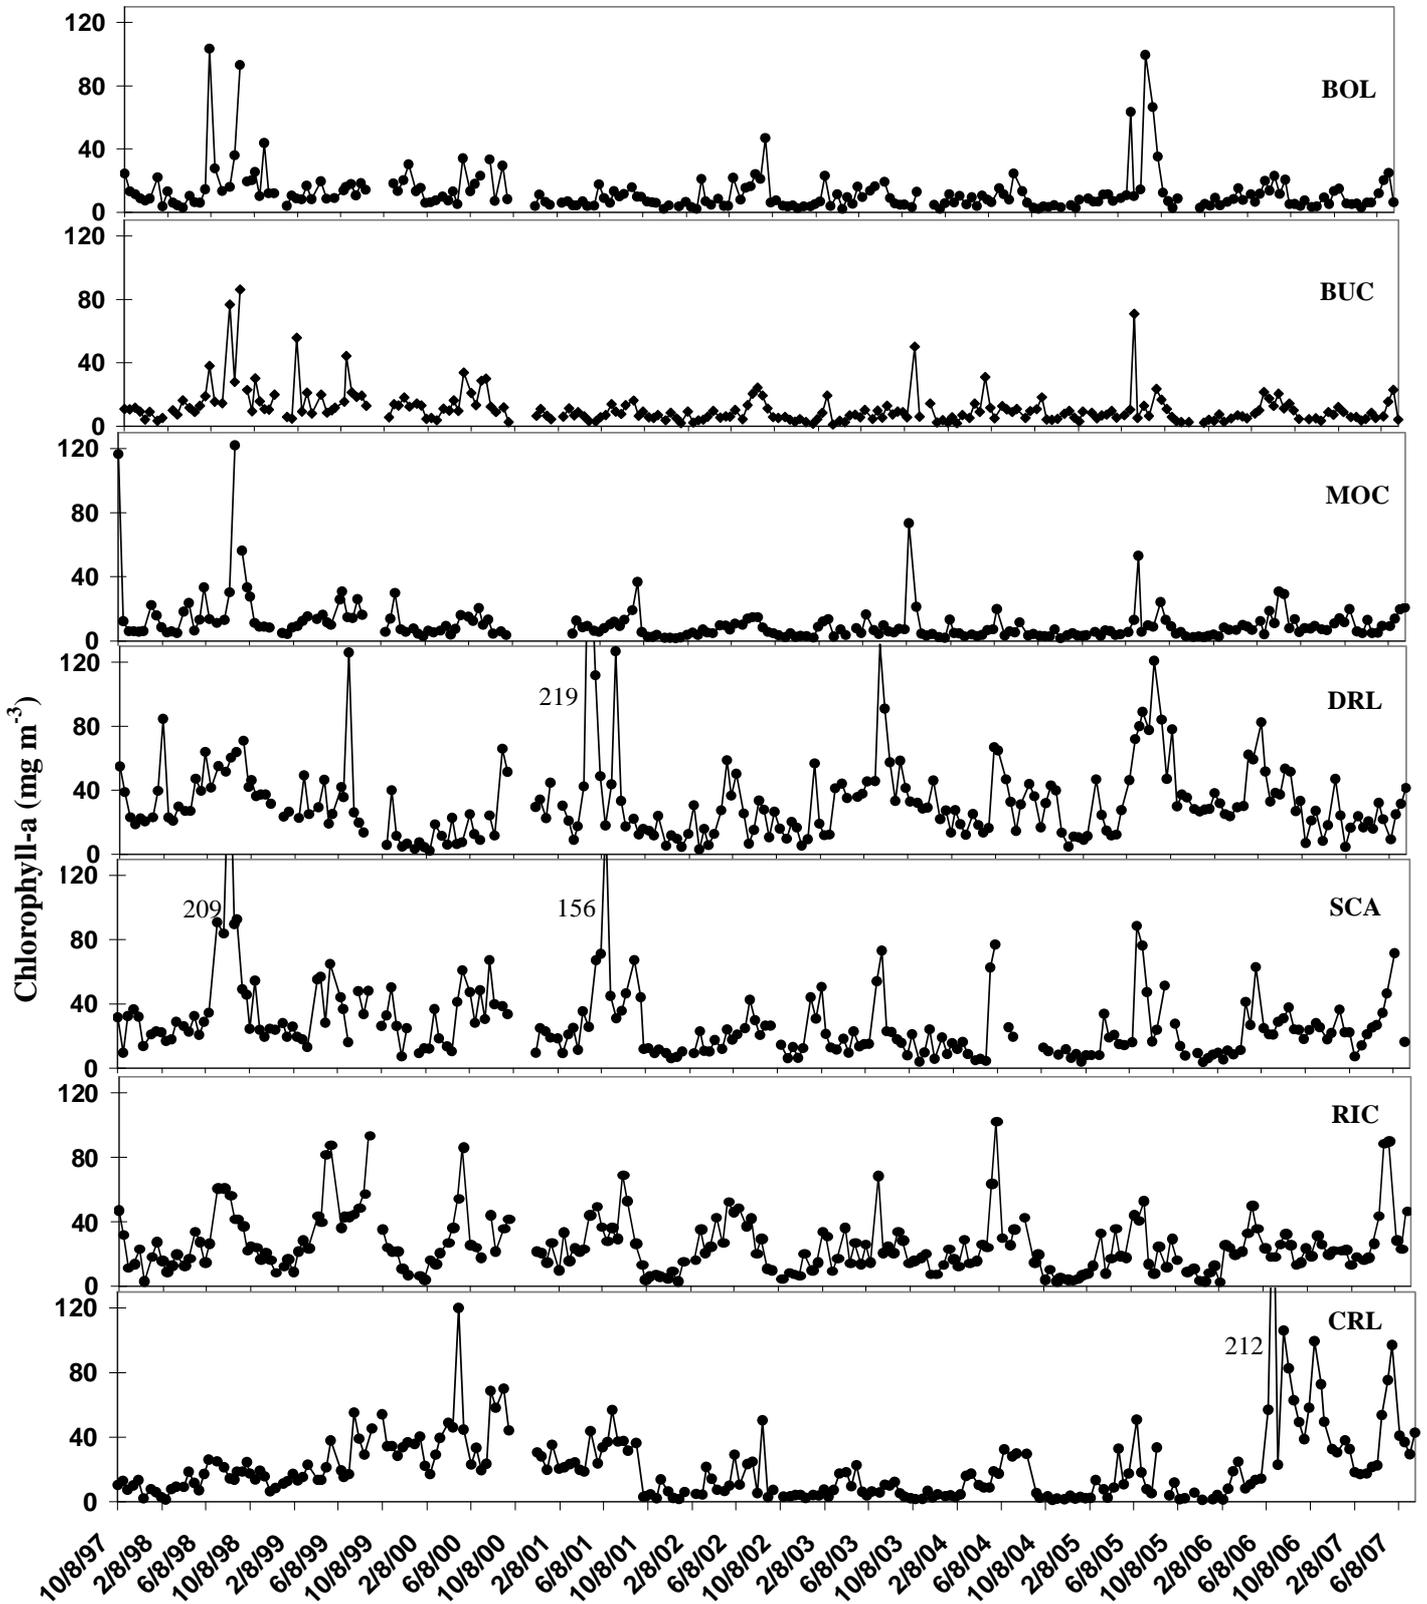
Figure 34: Bi-monthly chlorophyll-a values, between October 1997 – July 2007, for BOL, BUC, MOC, DRL, SCA, RIC, and CRL

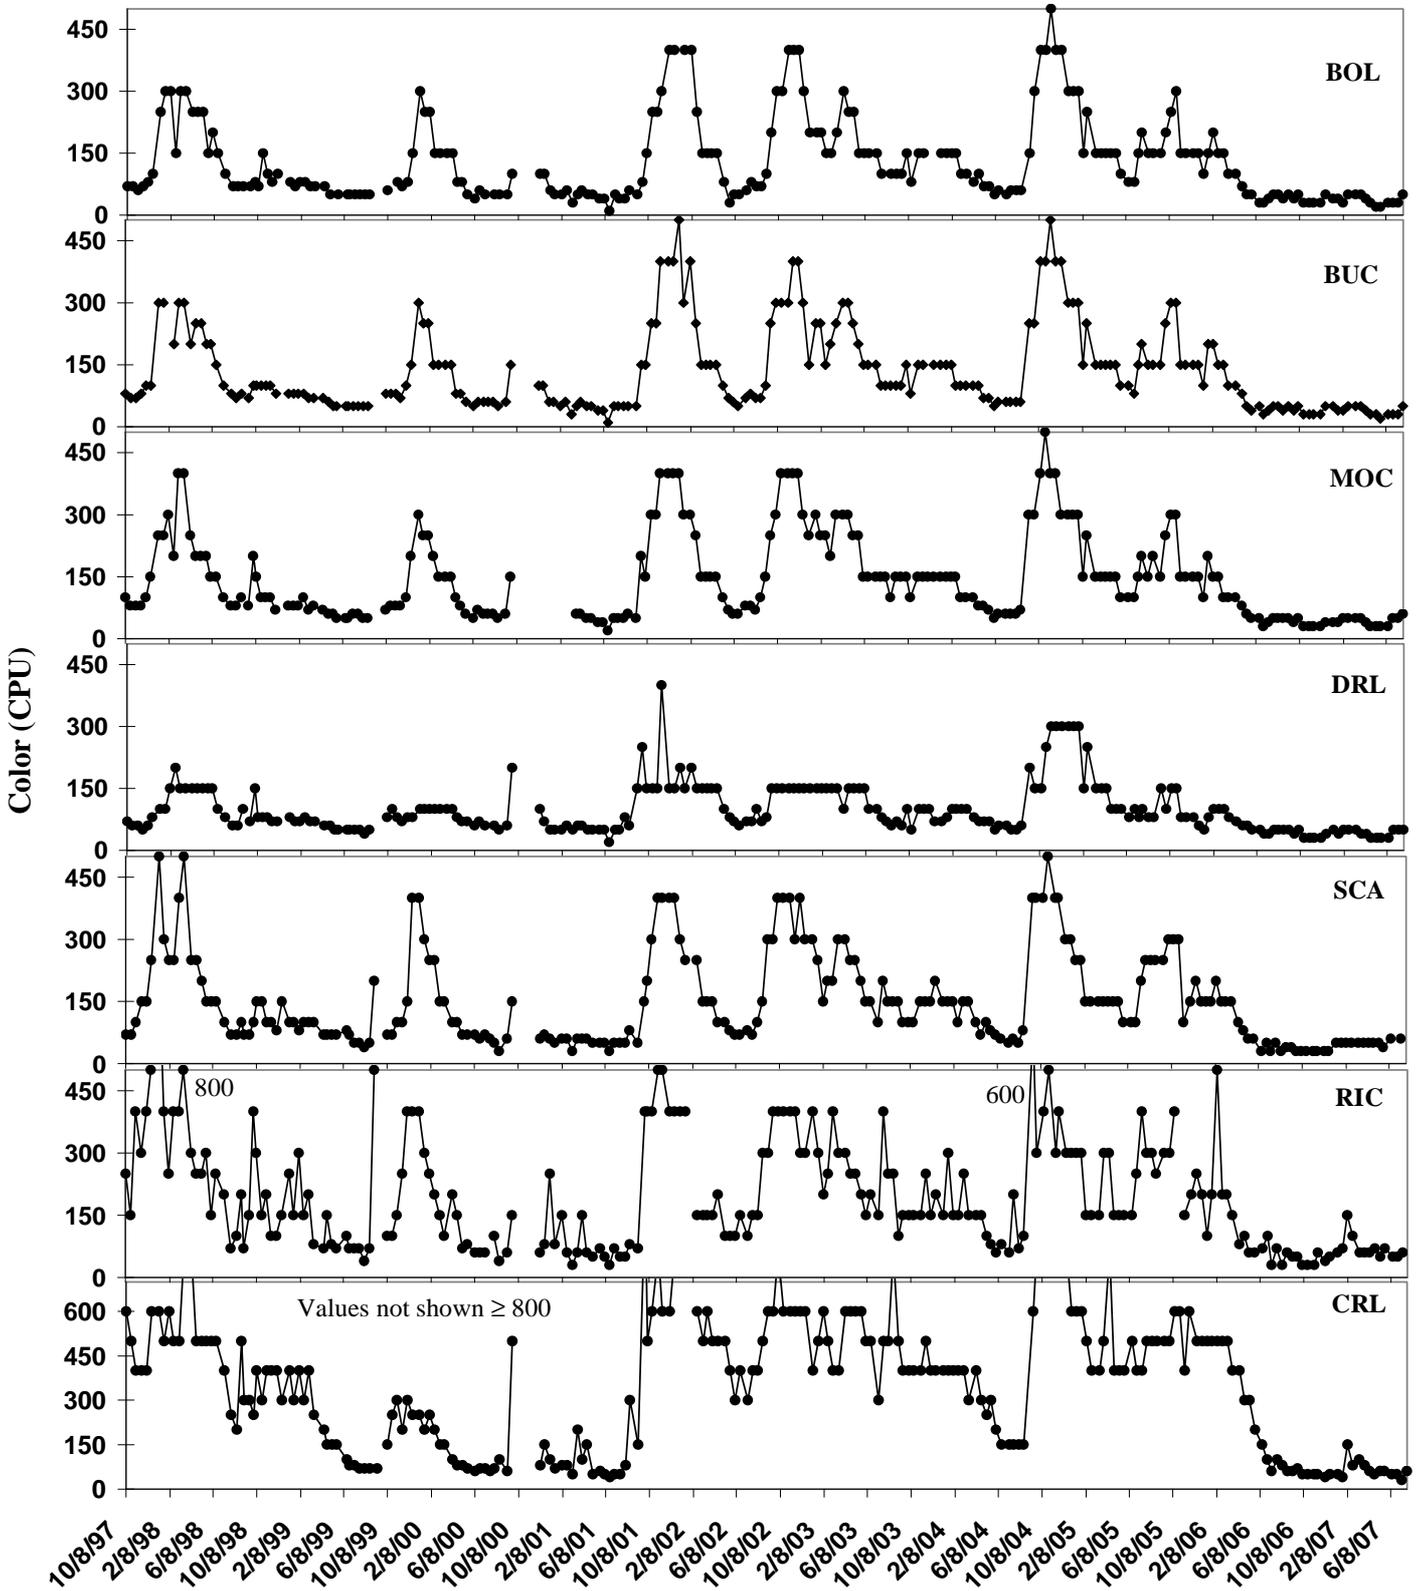
Figure 35: Bi-monthly color values, between October 1997 – July 2007, for BOL, BUC, MOC, DRL, SCA, RIC, and CRL (note scale change for CRL; see text for maximum values)

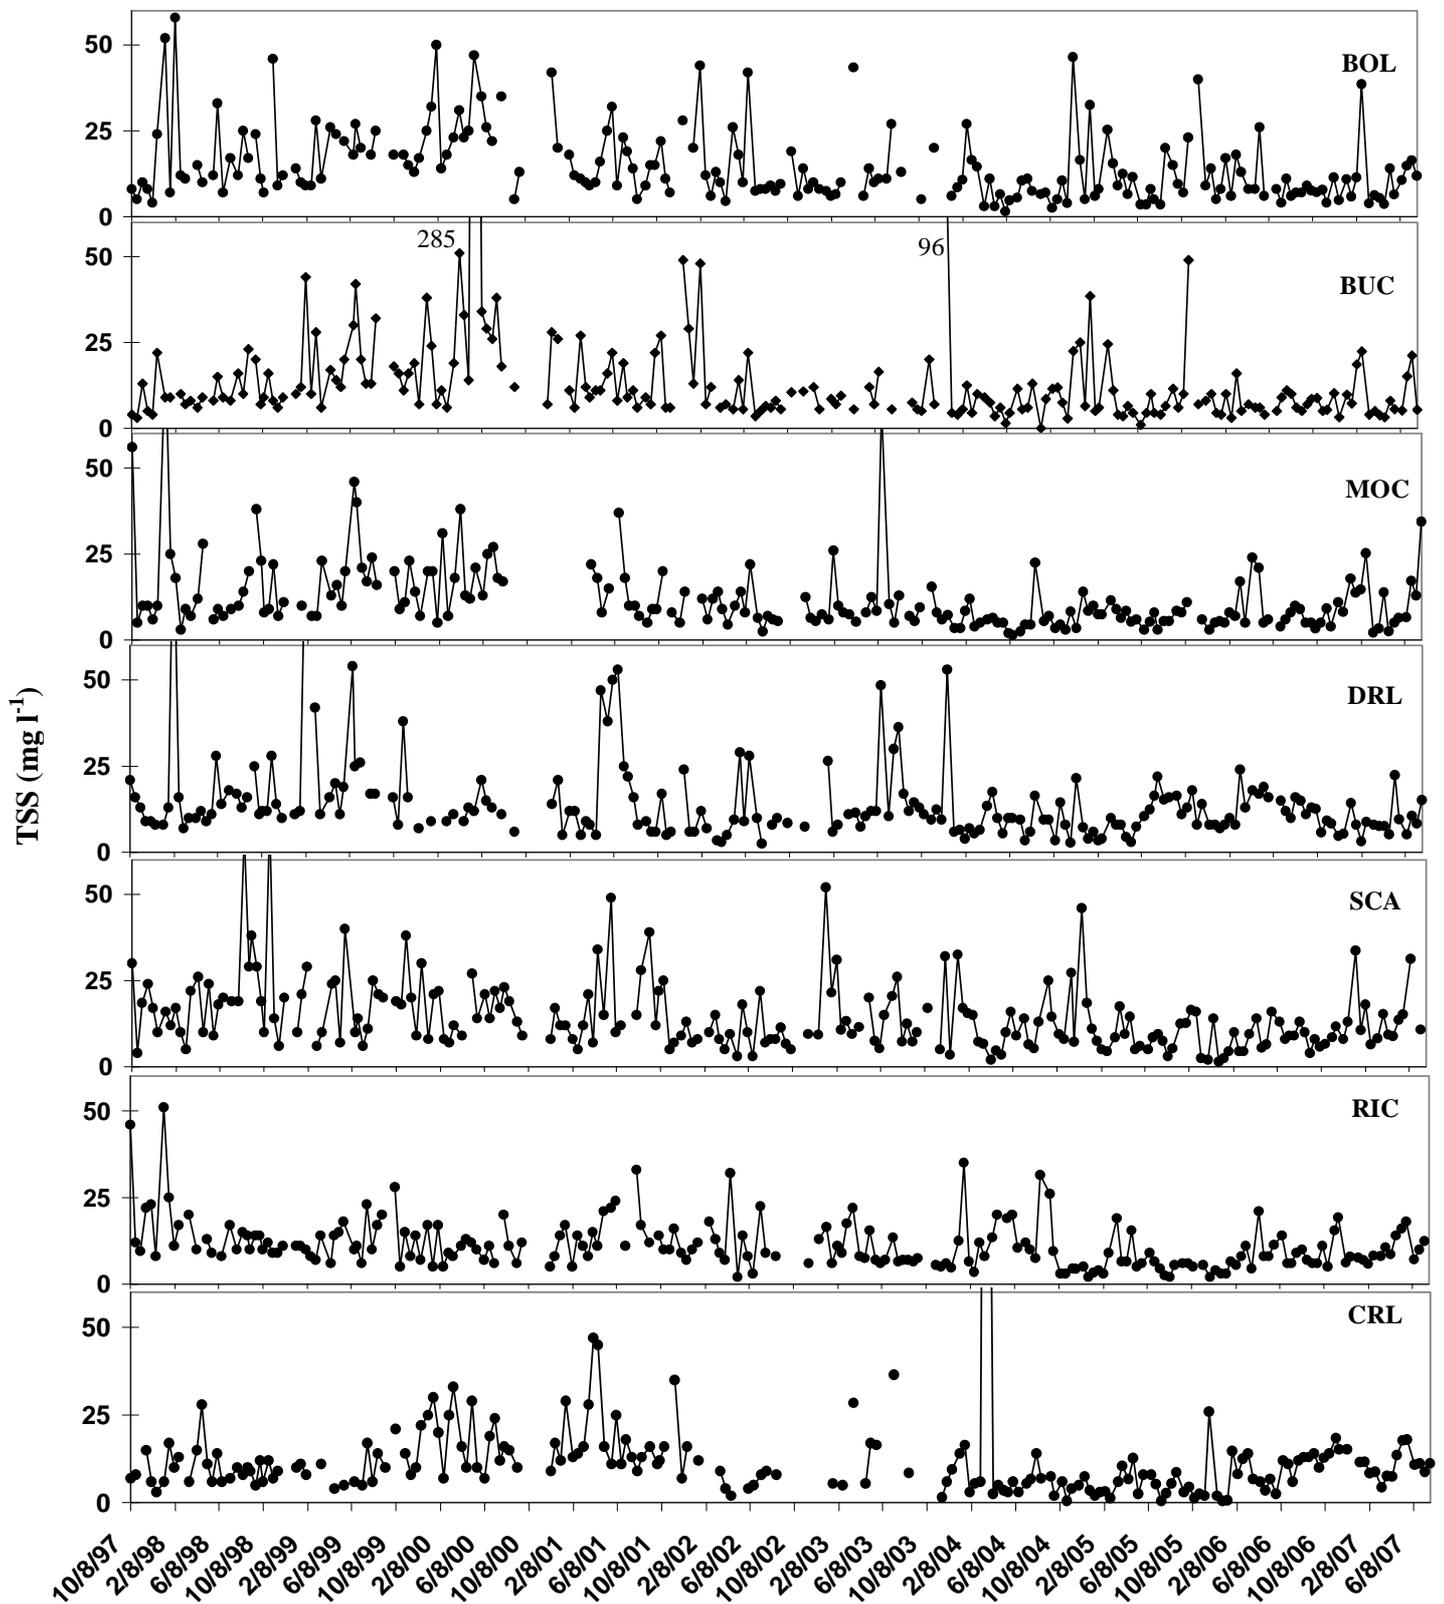
Figure 36: Bi-monthly TSS values, between October 1997 – July 2007, for BOL, BUC, MOC, DRL, SCA, RIC, and CRL
