**A SUMMARY OF SUBMERGED AQUATIC
VEGETATION (SAV) STATUS
WITHIN THE LOWER ST. JOHNS RIVER:
1996 – 2007**

Final Report: September 30, 2007
Contract Period: March 30, 2006 through September 30, 2007
Contract Number: SJ45514

Prepared for:
St. Johns River Water Management District
Division of Environmental Sciences
P.O. Box 1429
Highway 100 West
Palatka, Florida 32178-1429
Project Manager:
Dean Dobberfuhl, Ph.D., Environmental Scientist V
(386) 329-4392

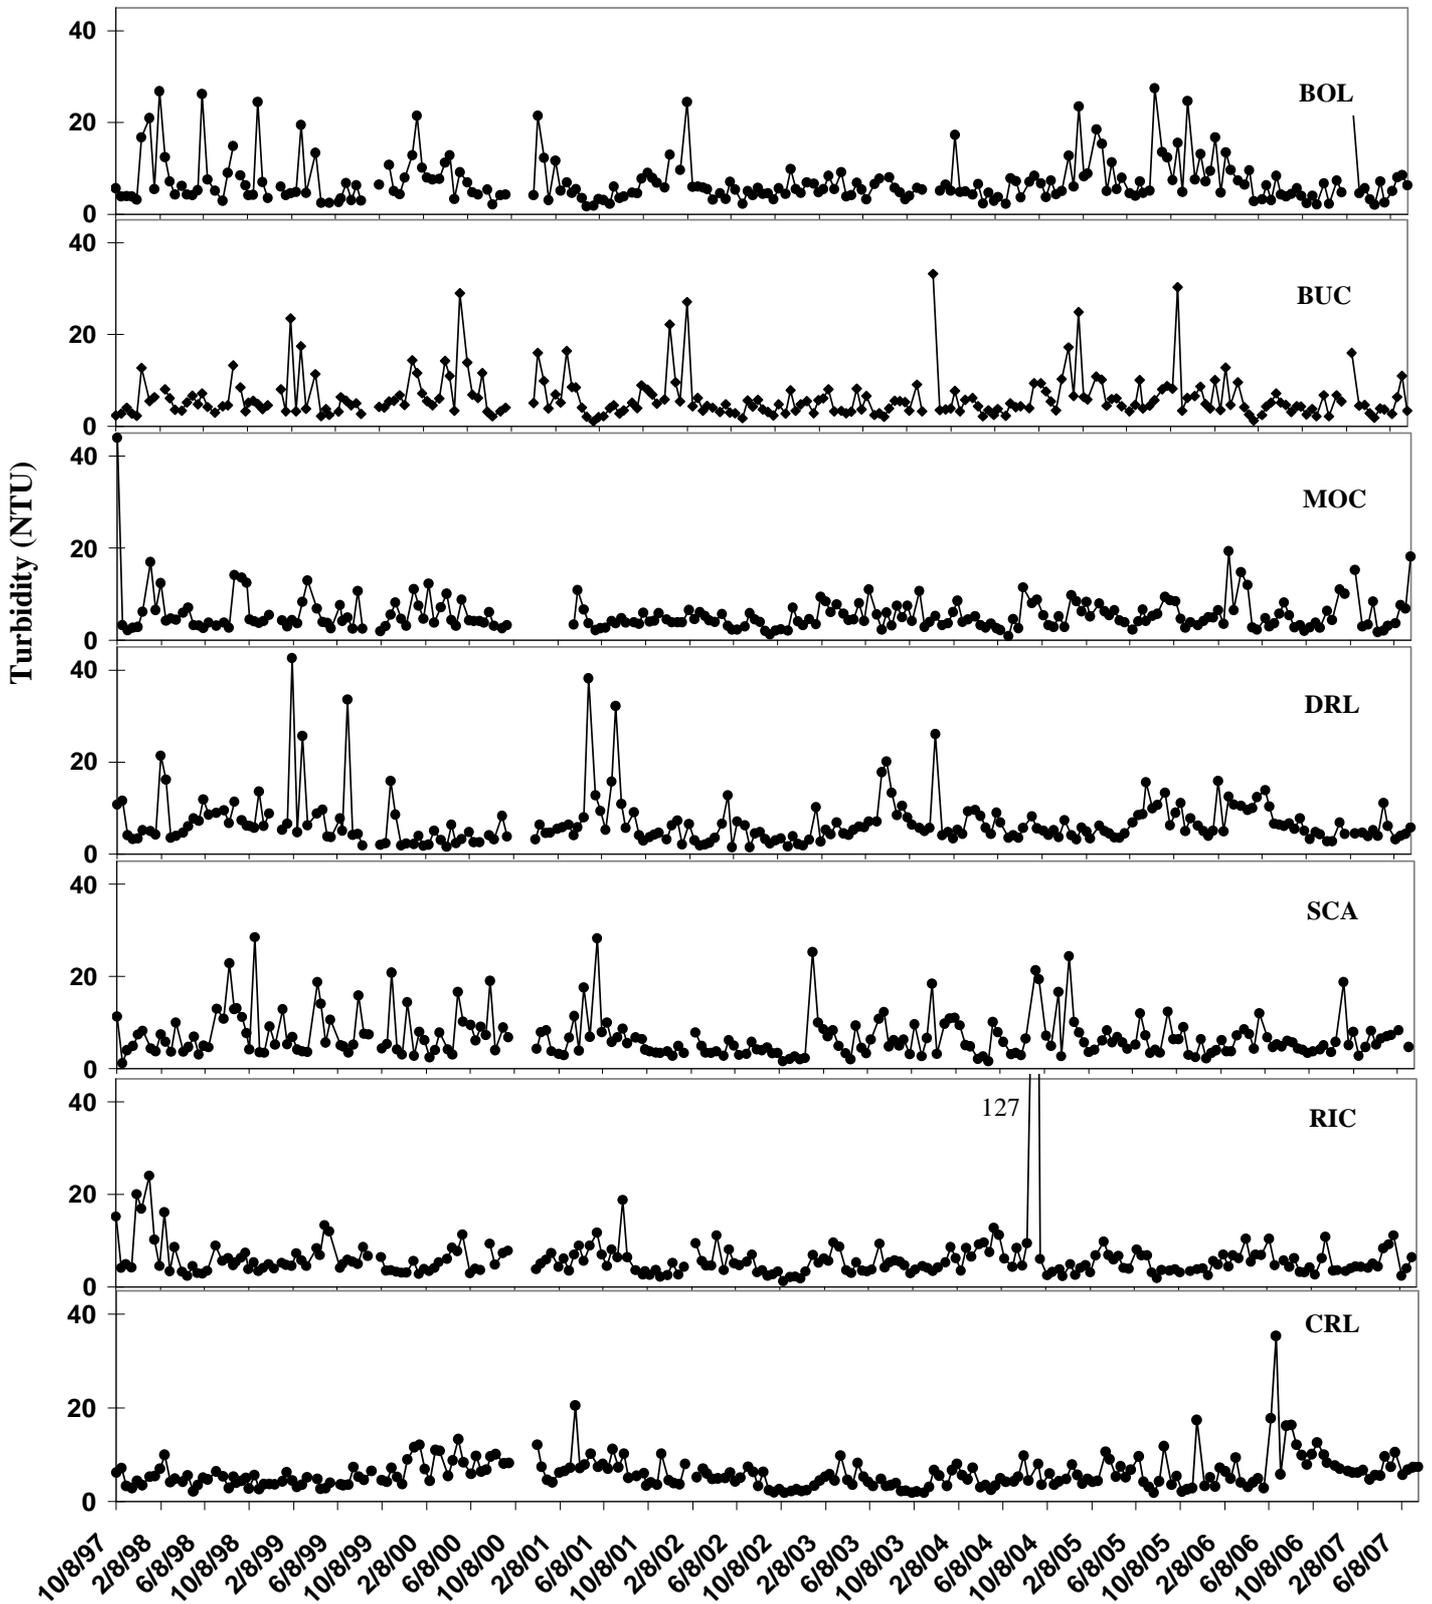
Figure 37: Bi-monthly turbidity values, between October 1997 – July 2007, for BOL, BUC, MOC, DRL, SCA, RIC, and CRL

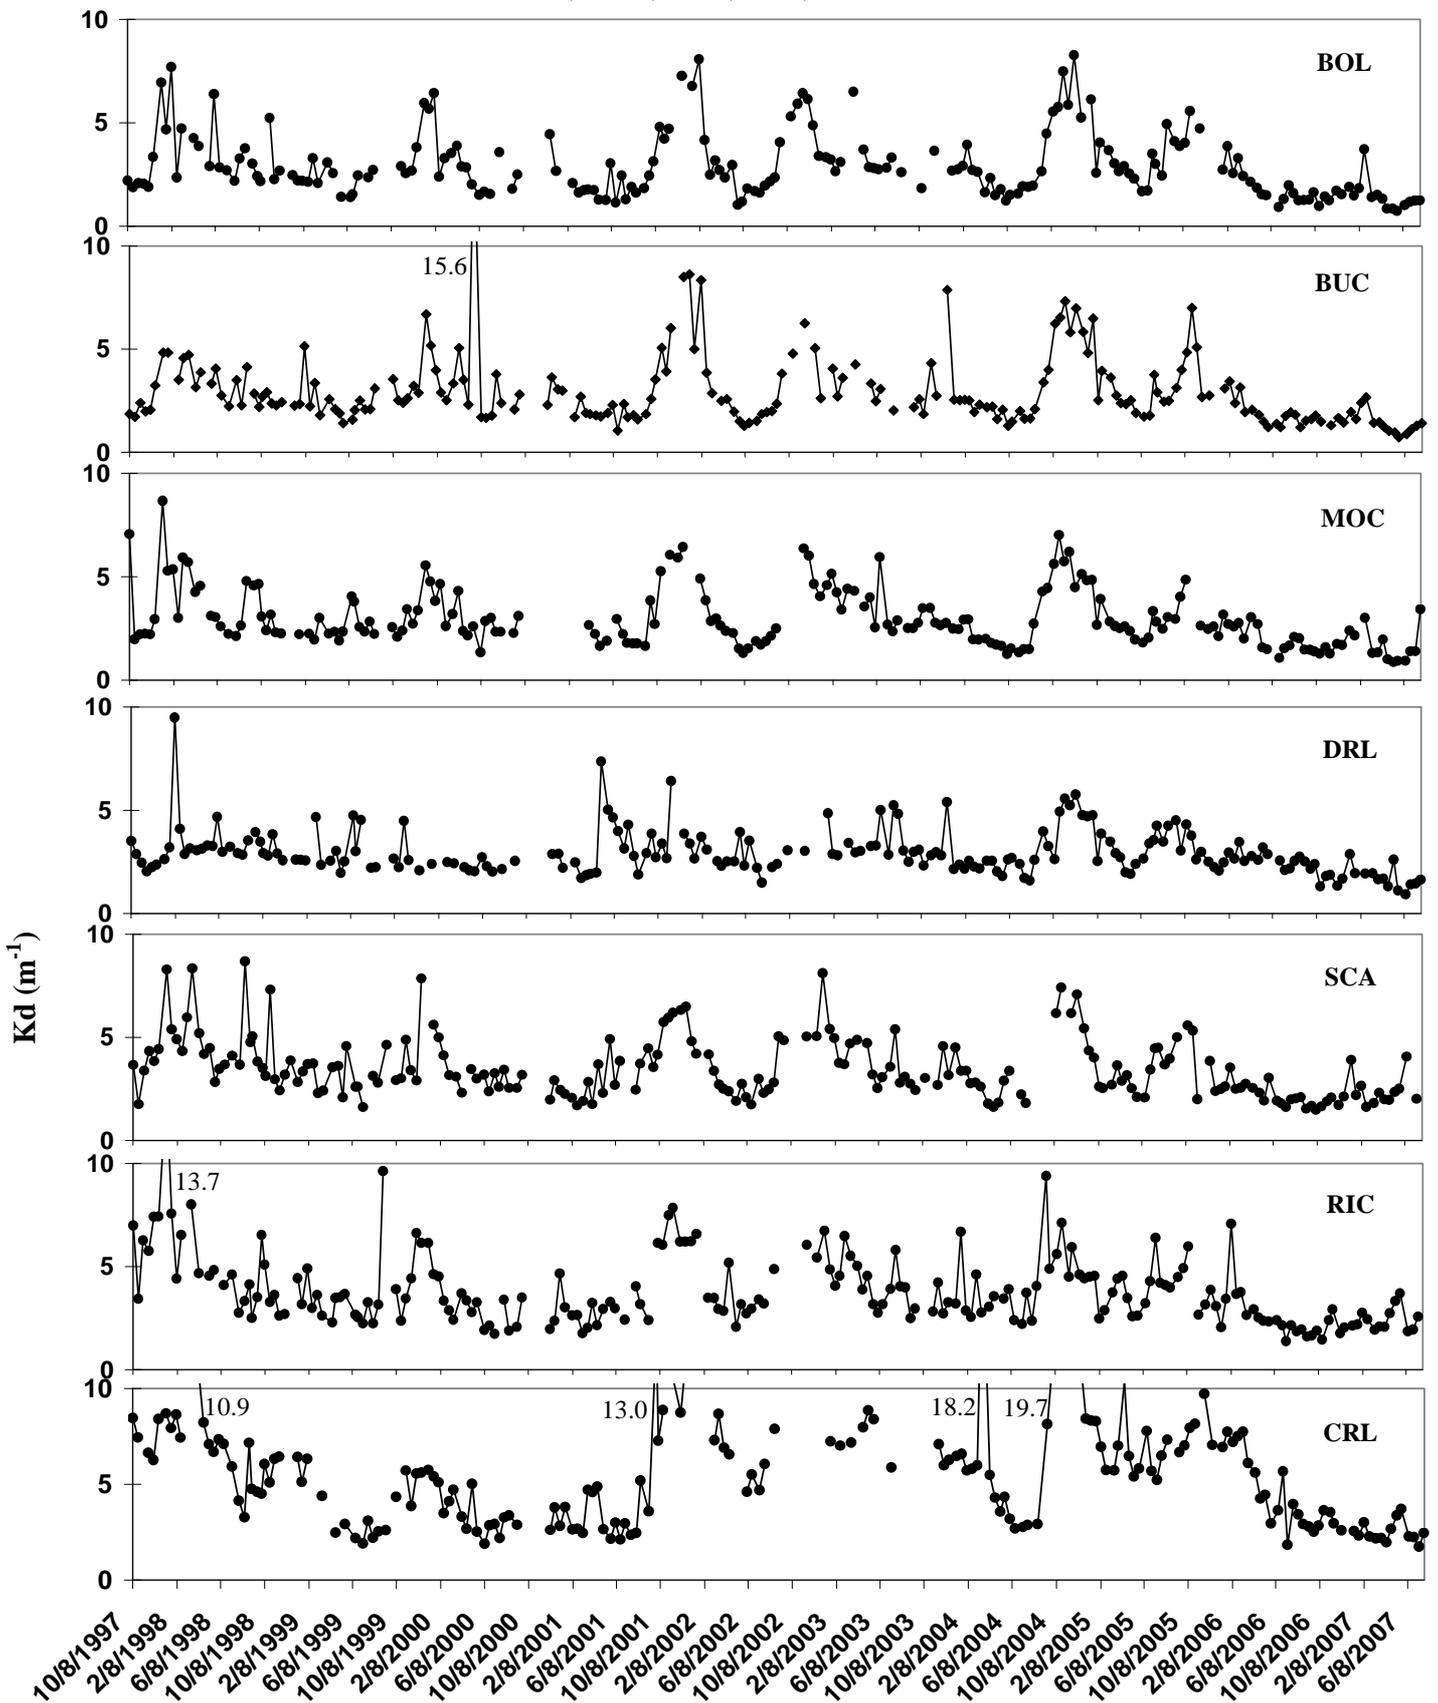
Figure 38: Bi-monthly Kd values, between October 1997 – July 2007, for BOL, BUC, MOC, DRL, SCA, RIC, and CRL

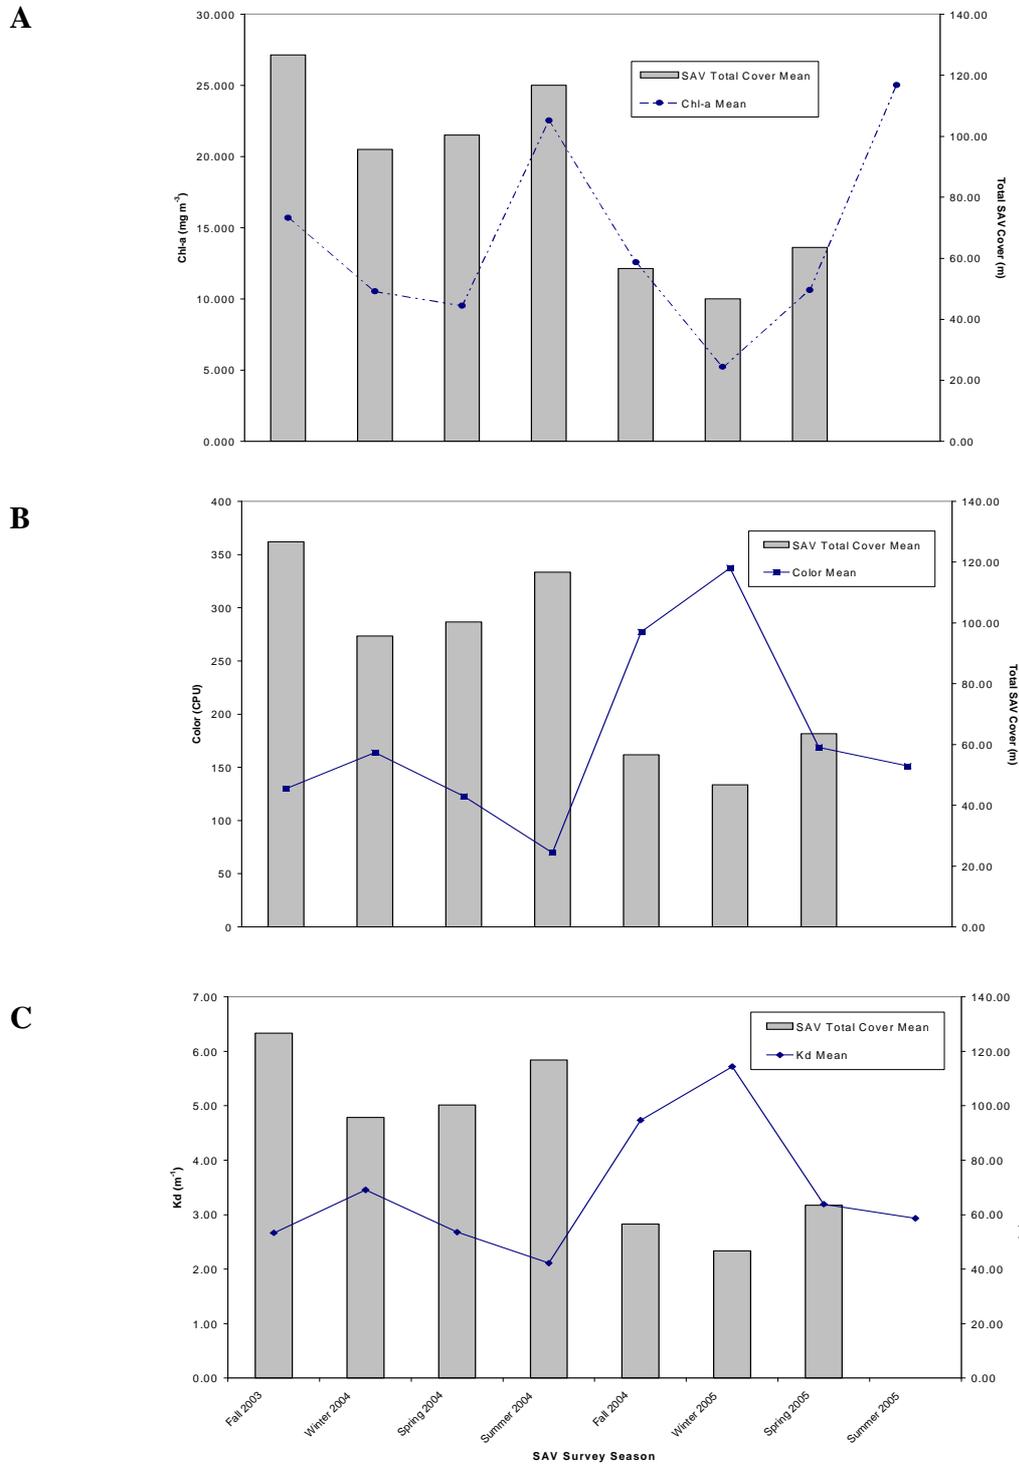
Figure 39: Mean seasonal SAV cover as compared to mean seasonal (A) Chl-a, (B) color, and (C) Kd. Water quality means represent an average of values taken the 3 months preceding SAV surveys. Data from PMN sites: BOL, BUC, MOC, SCA, RIC (Taken from Sagan 2006a)

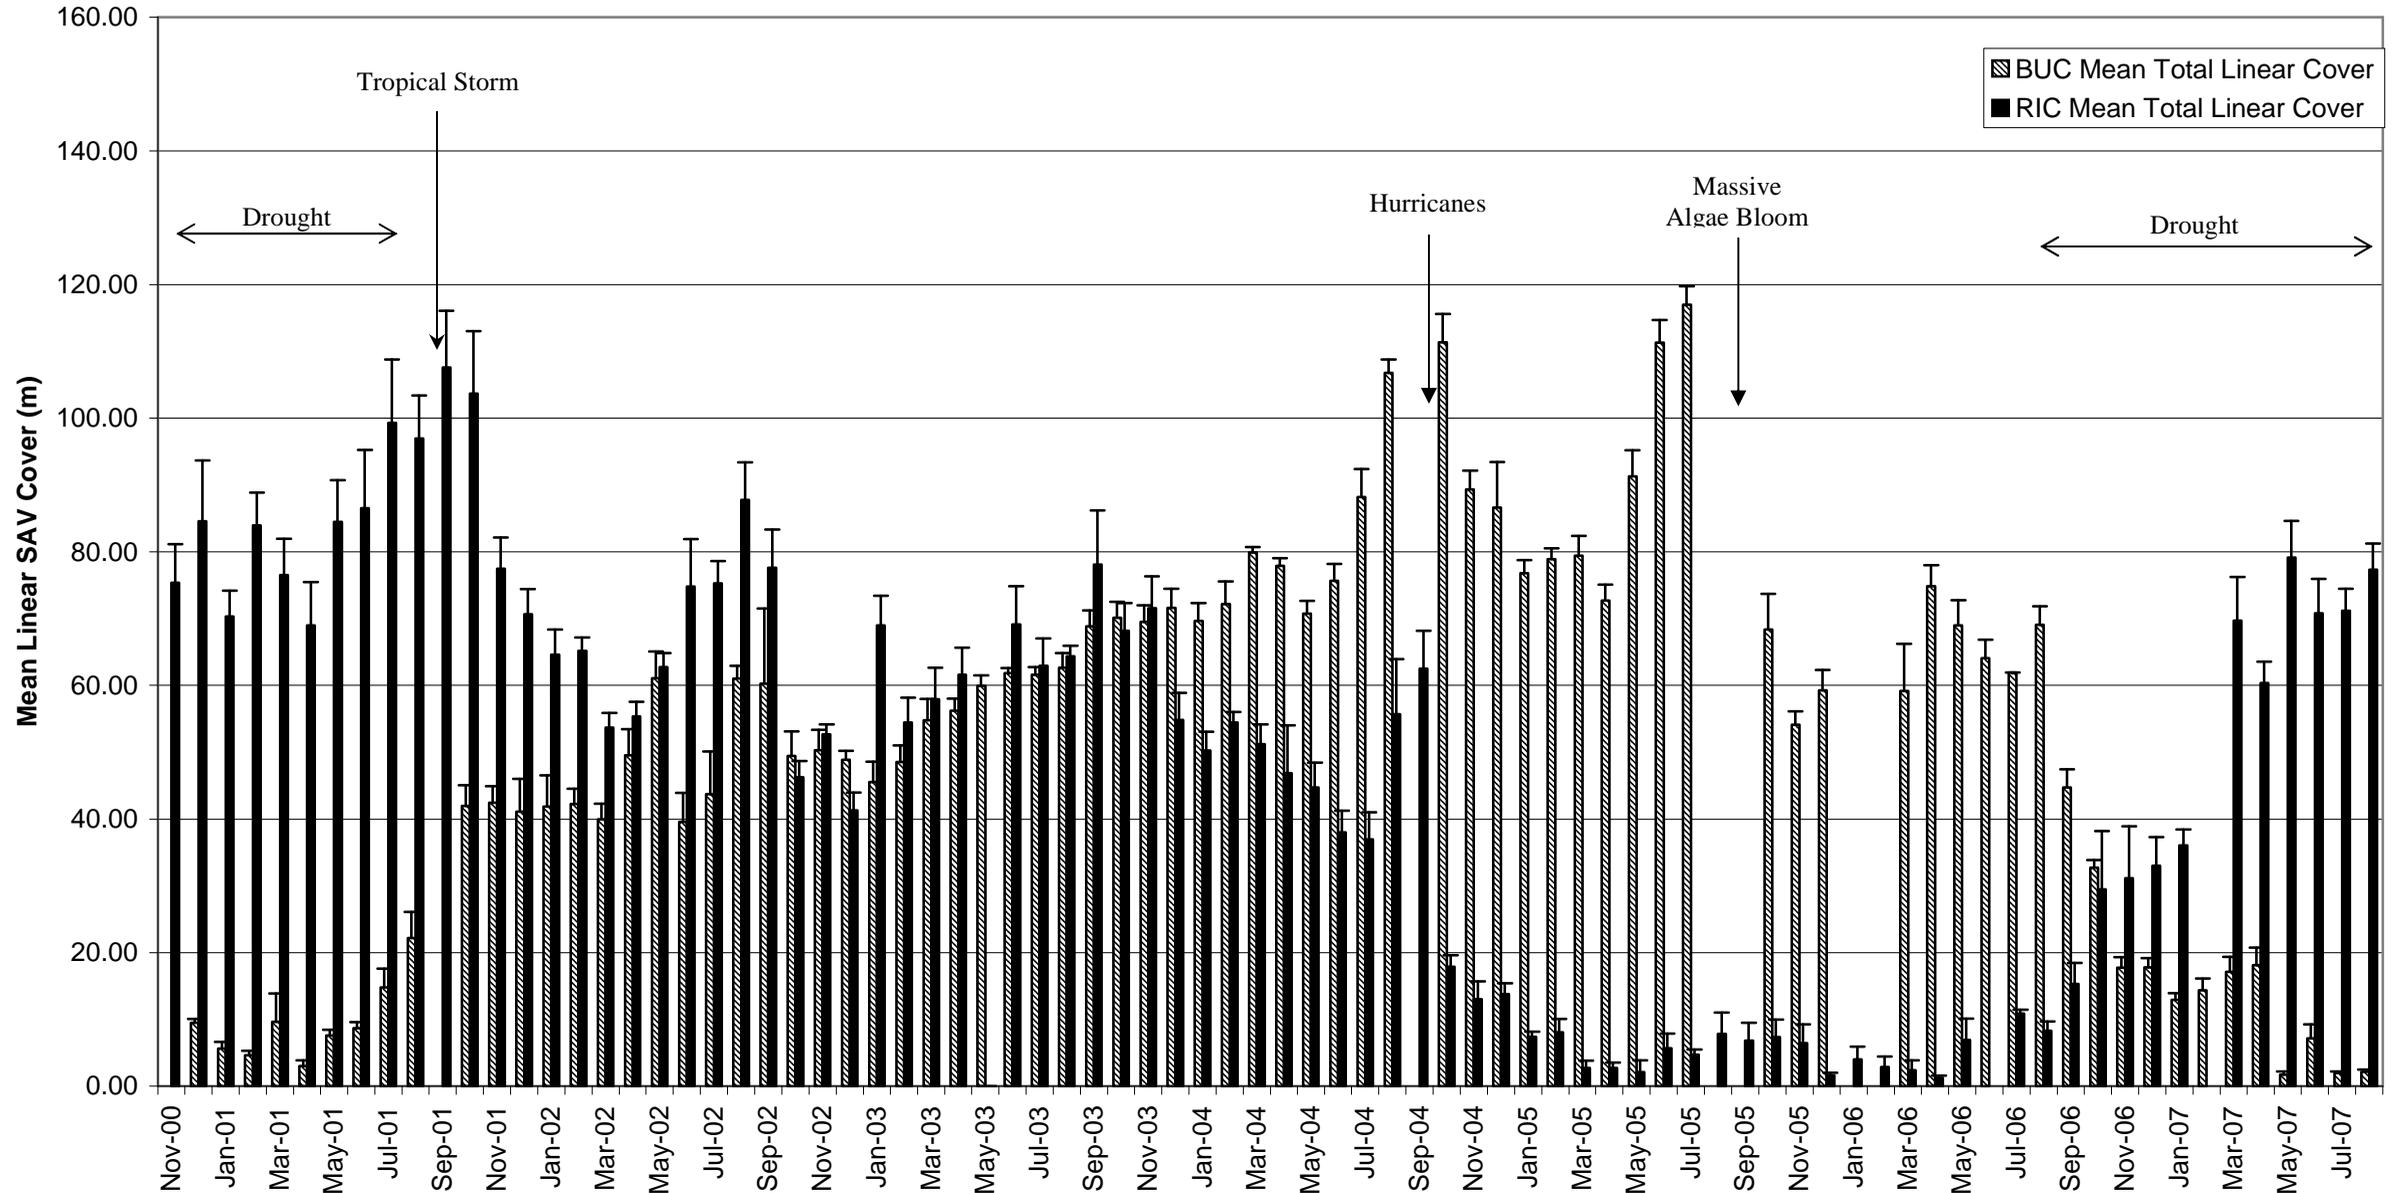
Figure 41: The See Saw Effect: Monthly (n = 5) comparison of total SAV cover for years 2000 - 2007 between upstream (RIC) and downstream sites (BUC)

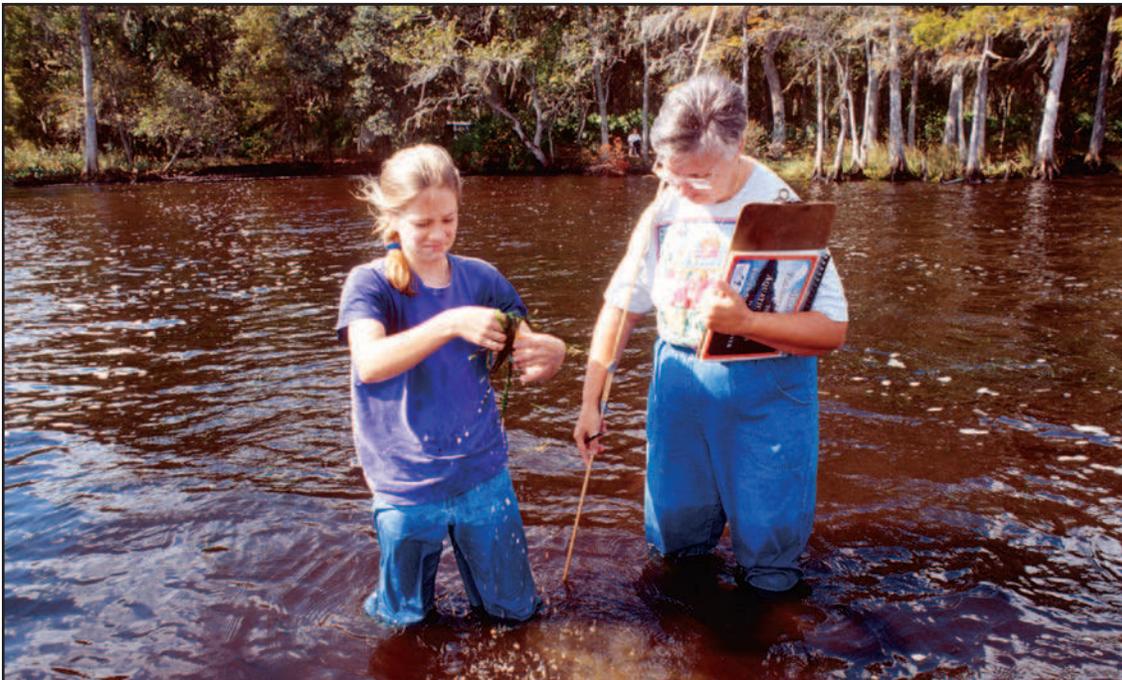
Figure 2. Recording line intercept data

Protocol for data collection of submersed aquatic vegetation: measuring and recording line intercept data

1. Work in groups of two or three. One person records while the other(s) measures.
2. Find the benchmark at your site (normally a green stake with an attached "Study Plot" sign). Stake the beginning (the 0-meter [m] end) of a 50-m transect tape at the benchmark (Figure 1).

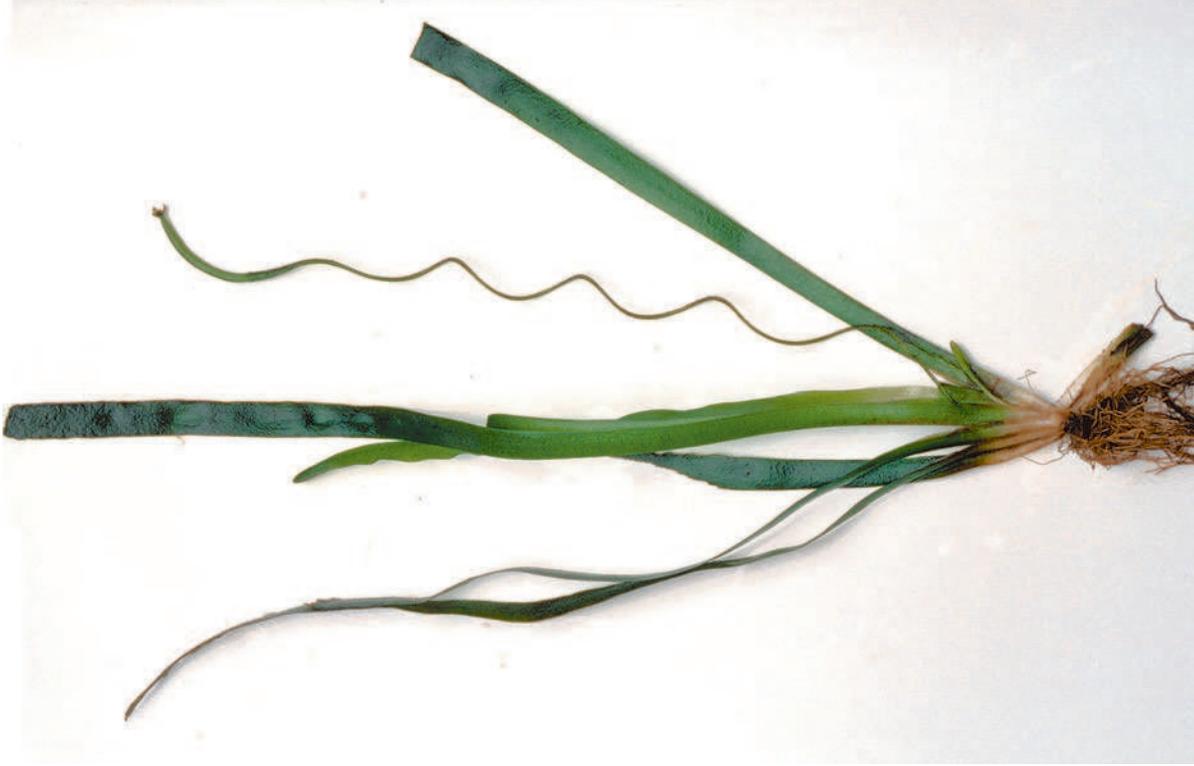
Vallisneria americana with stalked fruit

- Teeth on edge of leaves
- Leaves flat, tape-like; 0.5–4 cm wide
- Leaves taper at tip
- No obvious stem
- Height: 4–90 cm (a small one can be confused with *Sagittaria subulata*)

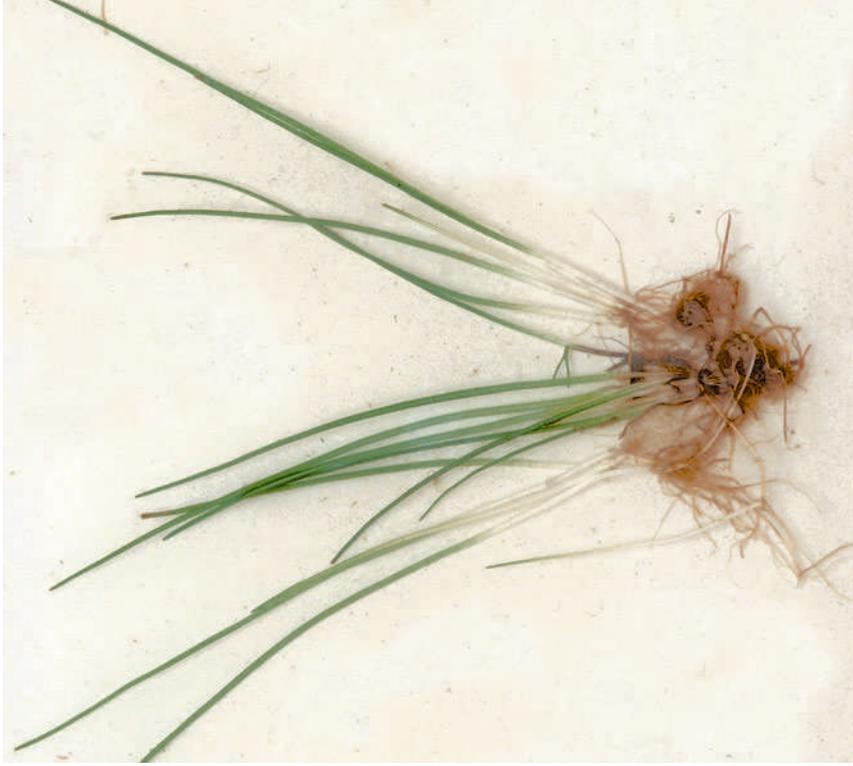
Eleocharis sp.

- No teeth on leaves
- Leaves round, pencil-like; 1–3 mm wide
- Leaves as broad at tip as at base
- Height: 1–5 cm

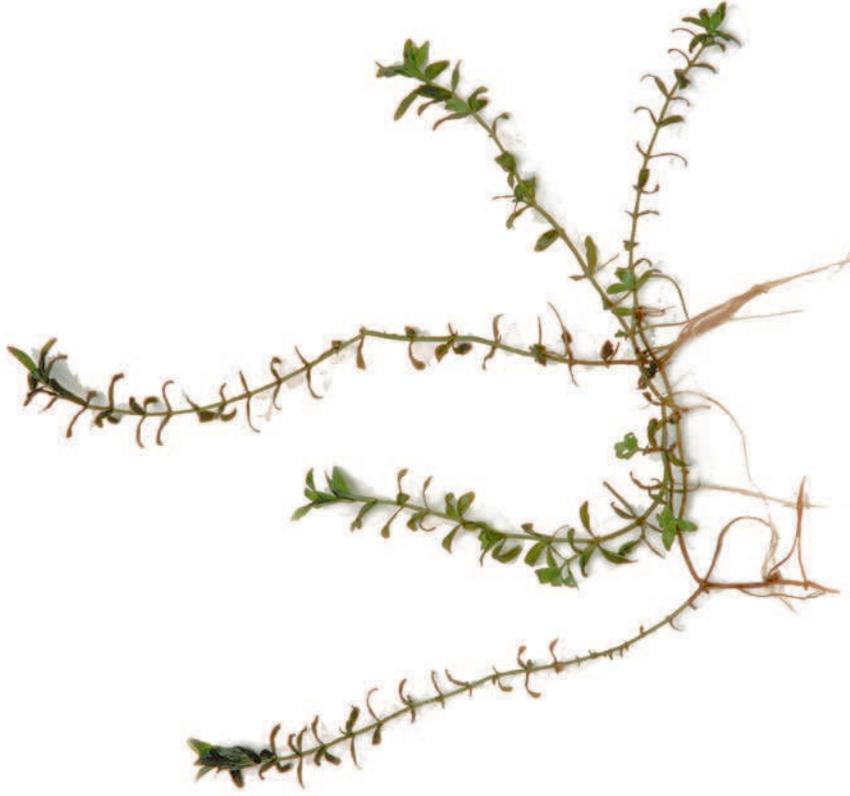
Micranthemum sp.

- Leaf whorls not tightly packed
- Leaf opposite, in whorls of three to four leaves
- No teeth on leaves
- Leaf tip rounded; 2–4 mm wide
- Height: 2–15 cm

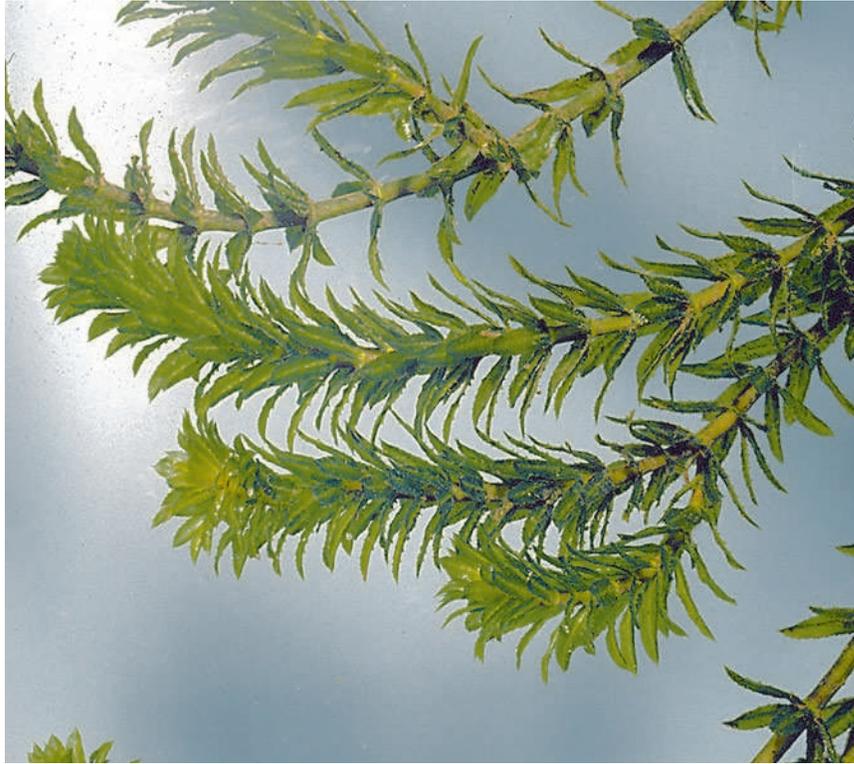
Hydrilla verticillata

- Leaf whorls tightly packed
- Leaves opposite, in whorls of four to eight leaves
- Leaves with conspicuous teeth, making plant scratchy to touch
- Leaf tip pointed; leaves 2–4 mm wide
- Height: 5–15 cm

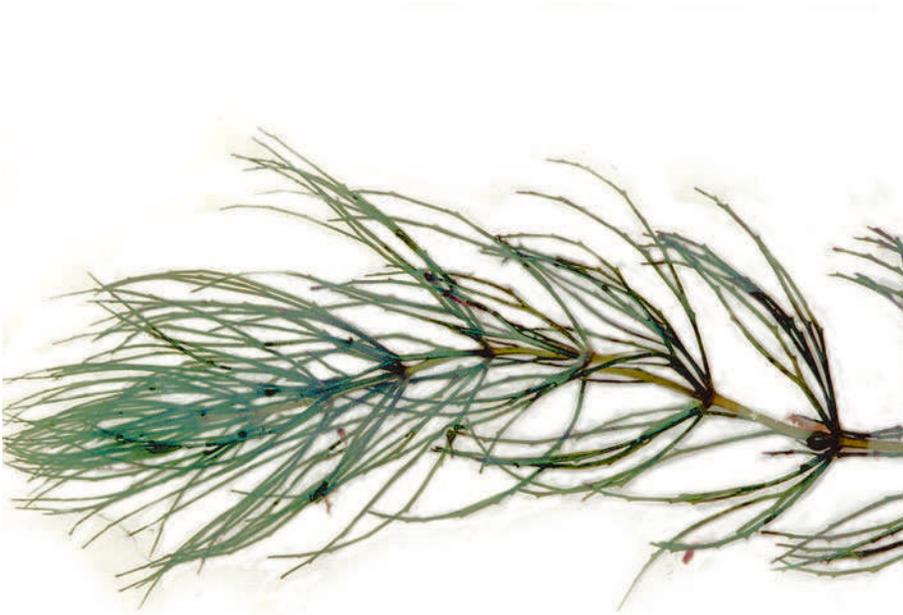
Ceratophyllum demersum

- Ceratophyllum demersum*
- Leaf whorls tightly packed together
 - Leaf forked at tip
 - Leaves pliable and scratchy to touch
 - Height: 10–20 cm

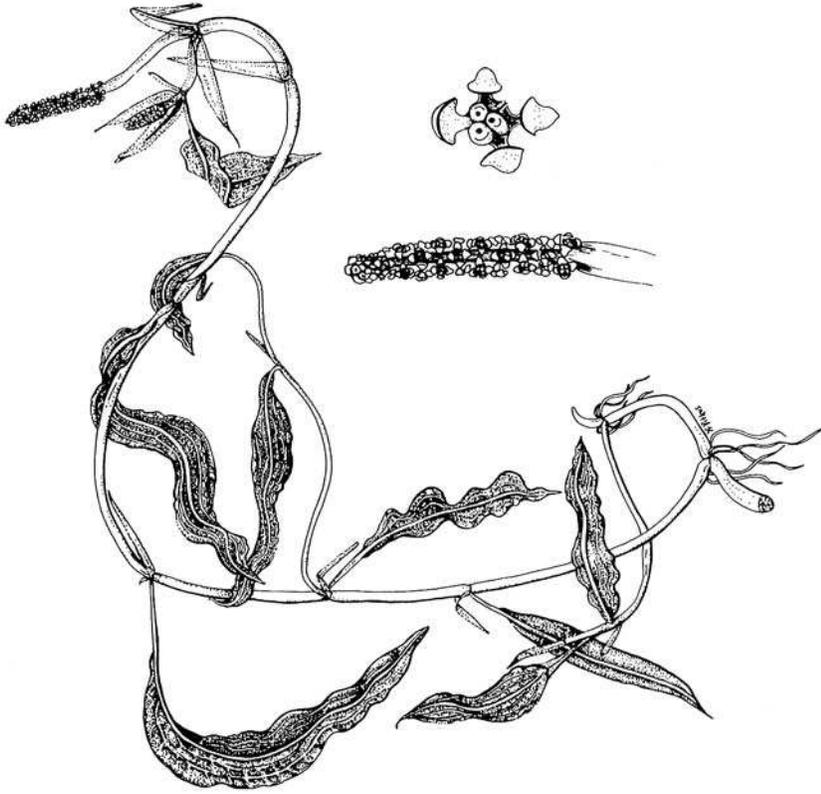
Potamogeton illinoensis

- Potamogeton illinoensis*
- Leaves alternate; 0.5–4.5 cm wide
 - Leaf edges wavy
 - Some leaves floating
 - Stems thick
 - Height: 10–25 cm

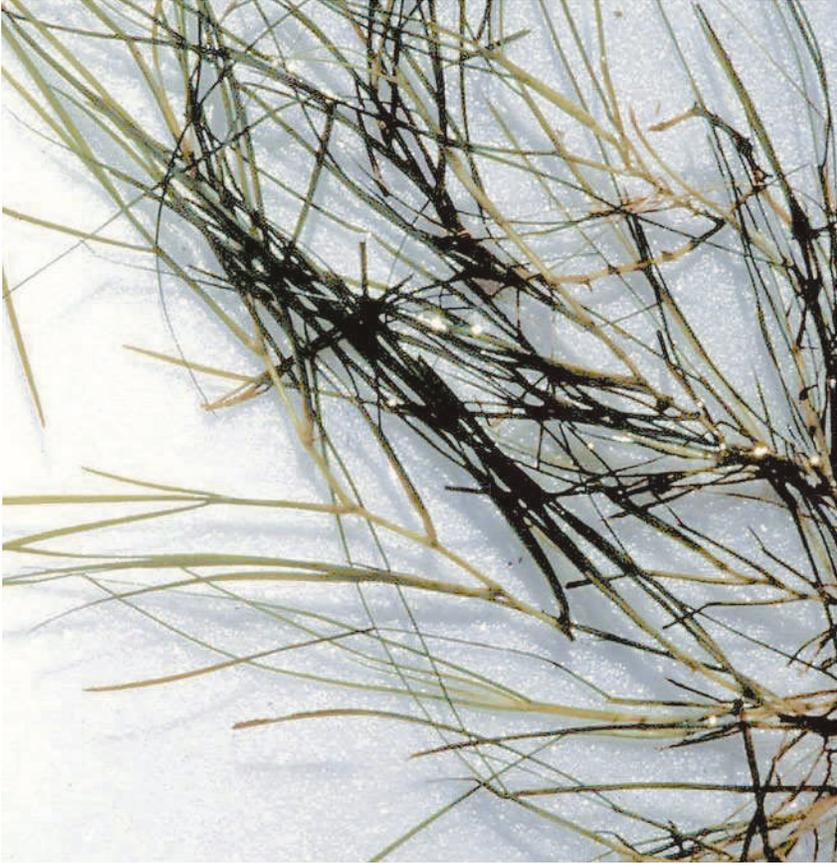
Potamogeton pectinatus

- Potamogeton pectinatus*
- Leaves alternate; 0.5–4.5 cm wide
 - No teeth on leaves
 - Leaves long and narrowing with pointed tips
 - Stems thread-like
 - Height: 5–20 cm

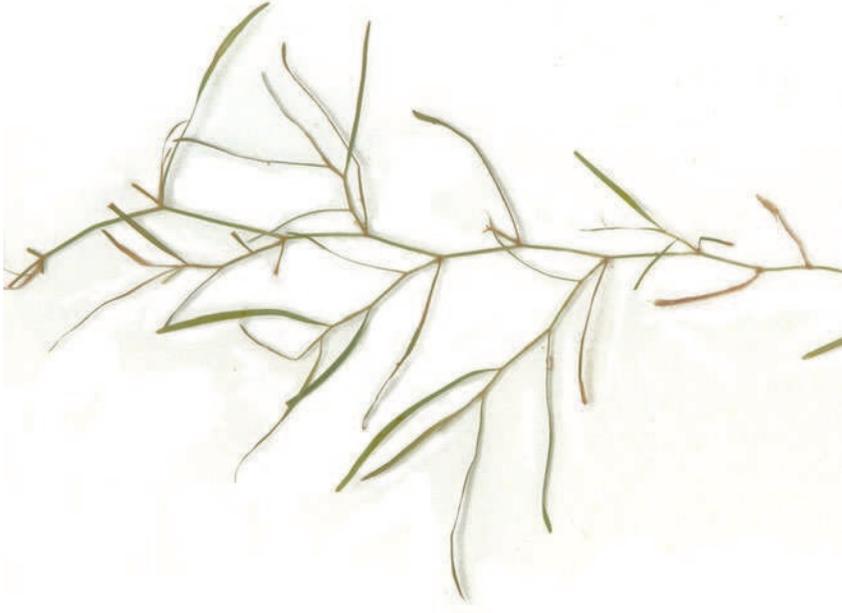
Potamogeton pusillus

- Leaves alternate; 0.5–3 mm wide
- No teeth on leaves
- Leaves long and narrow with blunted or rounded tips
- Stems thread-like
- Height: 5–20 cm

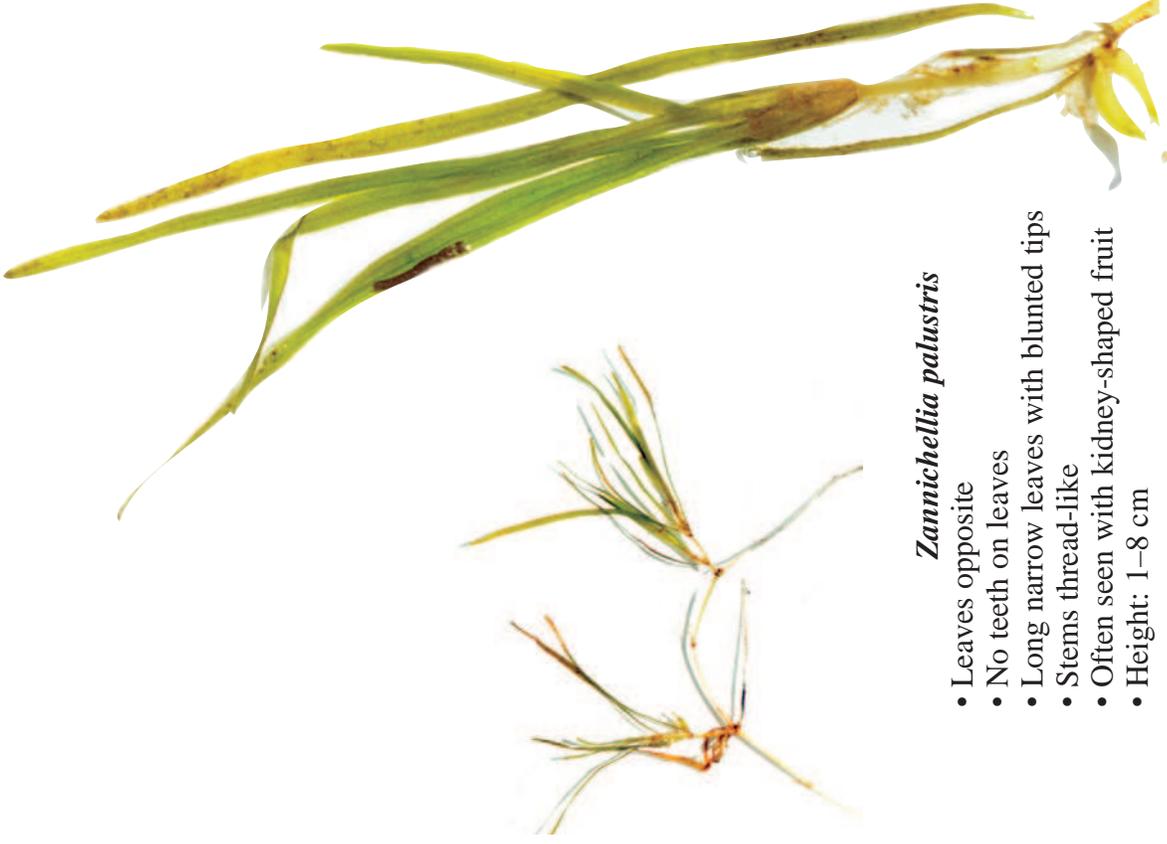
Zannichellia palustris

- Leaves opposite
- No teeth on leaves
- Long narrow leaves with blunted tips
- Stems thread-like
- Often seen with kidney-shaped fruit
- Height: 1–8 cm

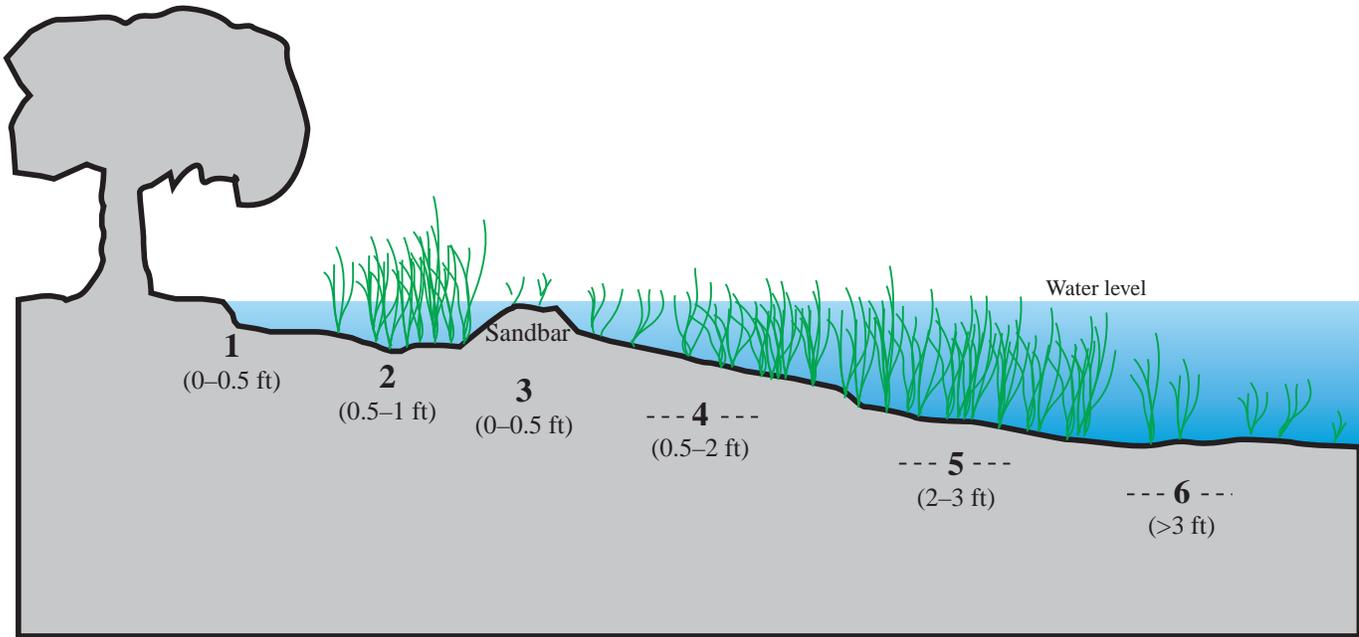
Plant distribution by water depth contour

1. No SAV, but floating plants
2. Algae, emergent and floating plants, *Chara*, *Eleocharis*, *Najas*
3. Sandbar: Algae, *Eleocharis*, *Najas*, *Ruppia*, *Sagittaria subulata*
4. Algae, *Ceratophyllum*, *Chara*, *Micranthemum*, *Hydrilla*, *Najas*, *Potamogeton*, *Ruppia*, *Sagittaria subulata*, *Vallisneria*
5. *Najas*, *Ruppia*, *Vallisneria*
6. *Najas*, *Vallisneria*
