APPENDIX A— ENVIRONMENTAL ANALYSES, METHODS AND DATA

ENVIRONMENTAL ANALYSES

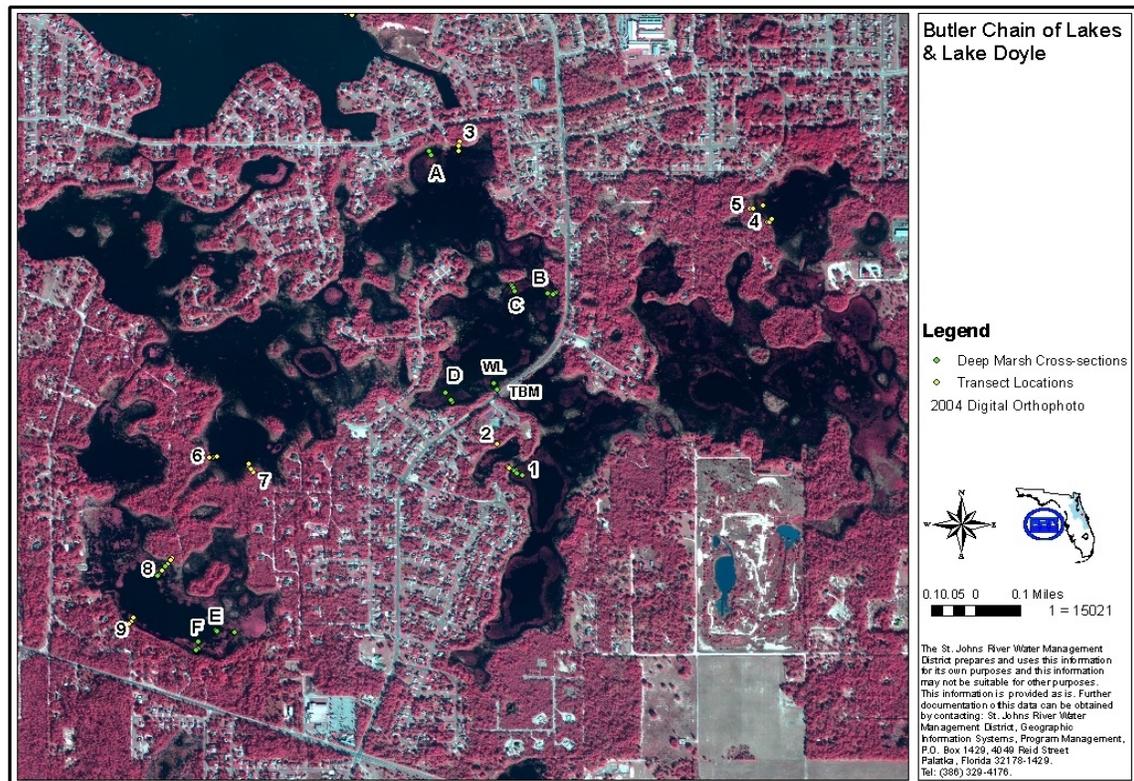
Figure 1. Location of 2009 MFLs Transects and deep marsh cross-sections overlaid on a 2004 digital orthophoto

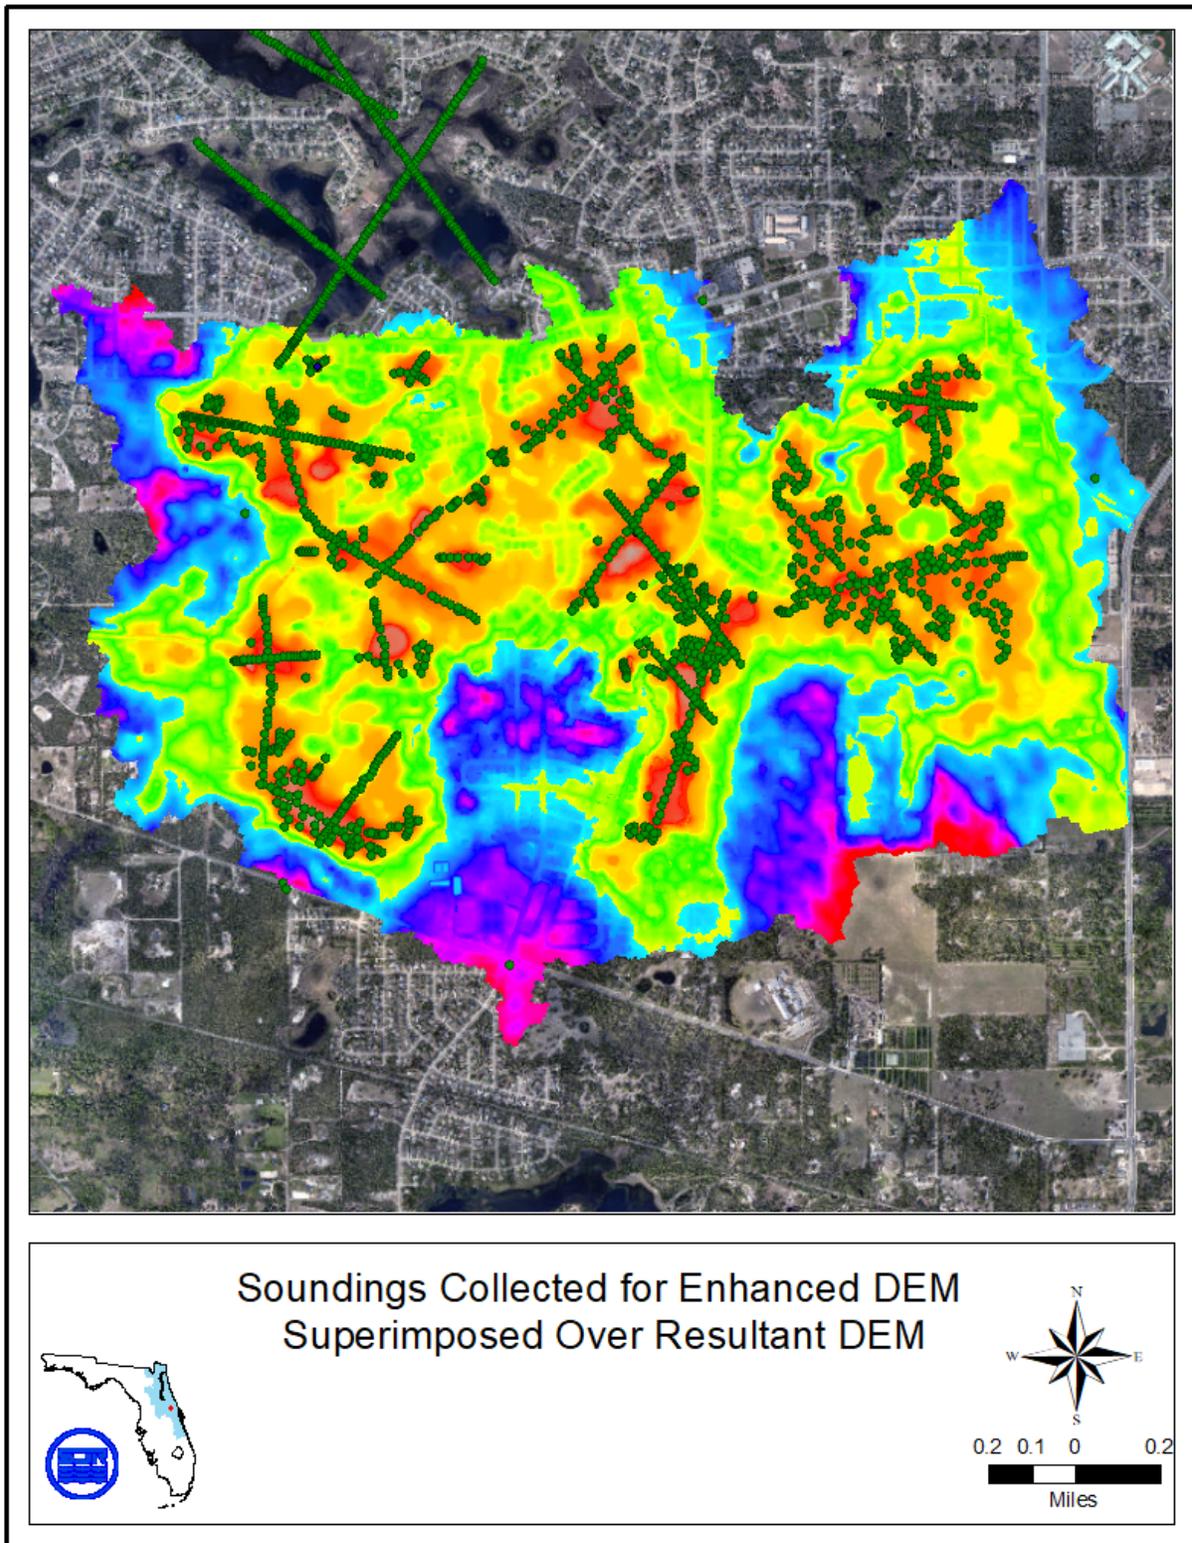
Figure 2. Superimposition of collected soundings along with the DEM developed from them

A hydroperiod-tool based assessment of habitat was undertaken to establish the relationship between groundwater withdrawal and habitat reductions. A detailed digital elevation map (DEM; Figure 2) was not initially available for Lake Butler. Field work from 2018-2019 focused on collecting additional soundings to increase the resolution of the DEM for Lake Butler. Acoustic Doppler Profiling (ADP) and soundings were combined with light detection and ranging (LIDAR) imagery and processed aerial images. Data collection focused on filling gaps within the existing bathymetry and exploratory soundings to identify possible sinkhole locations. See main report for description of hydroperiod tool metrics, impact threshold and habitat area calculations.

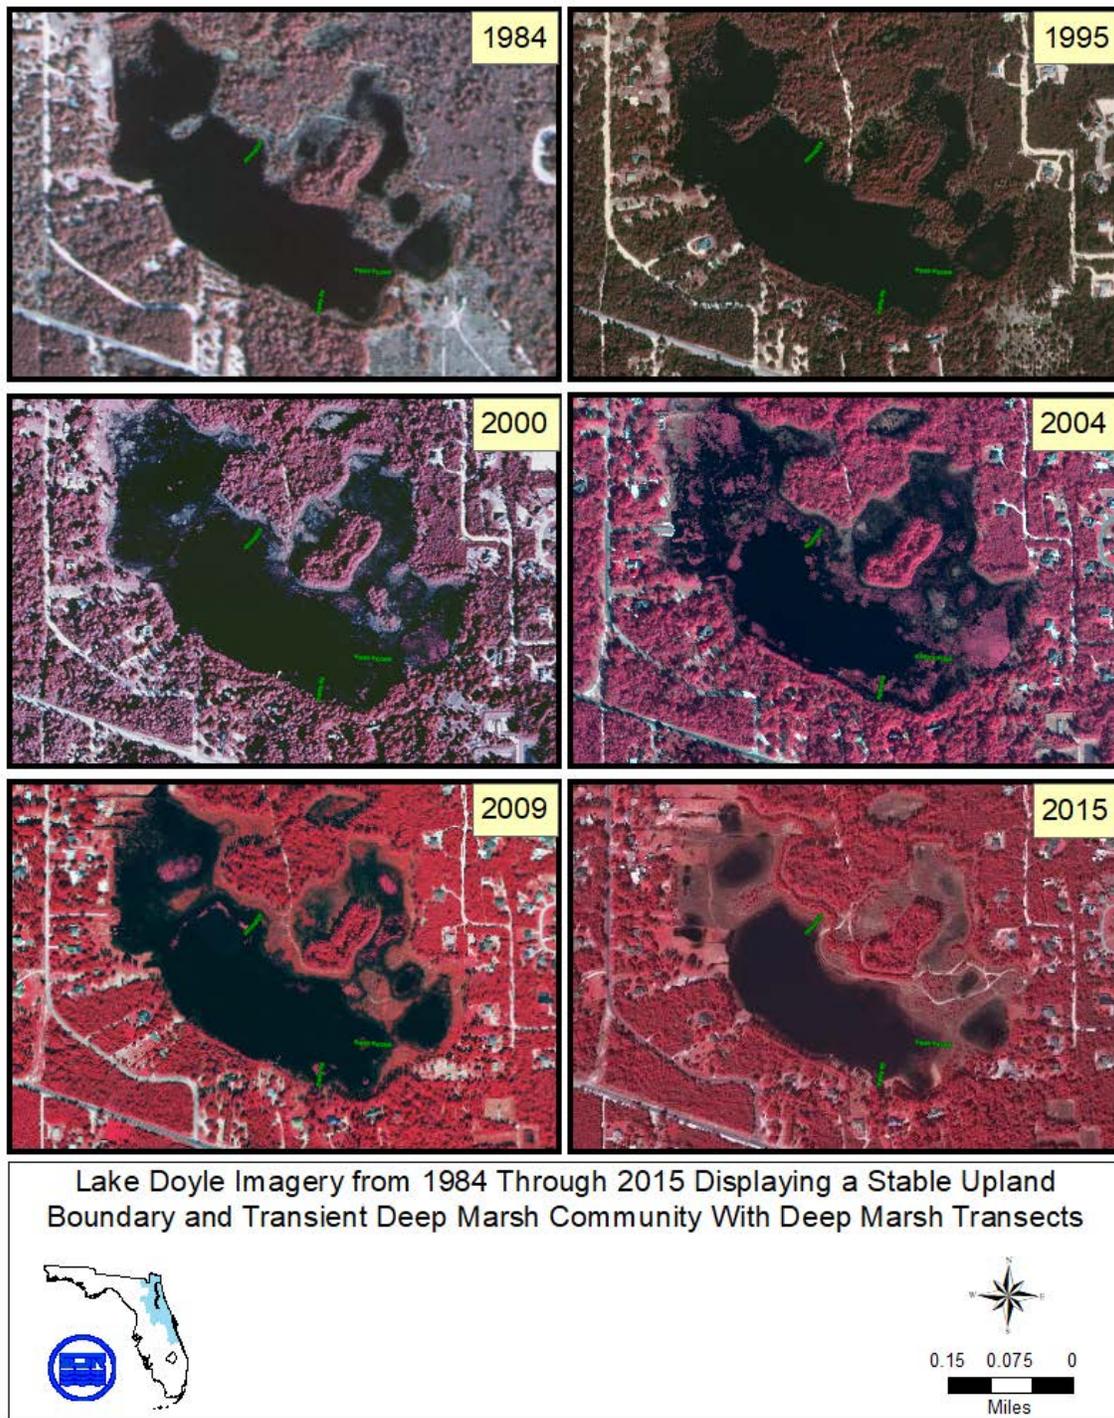
Figure 3. Location of Lake Doyle 2009 MFLs Transects and deep marsh cross-sections overlaid on infrared digital orthophotographs to illustrate the differences in the extent of deep marsh from 1984 through 2015

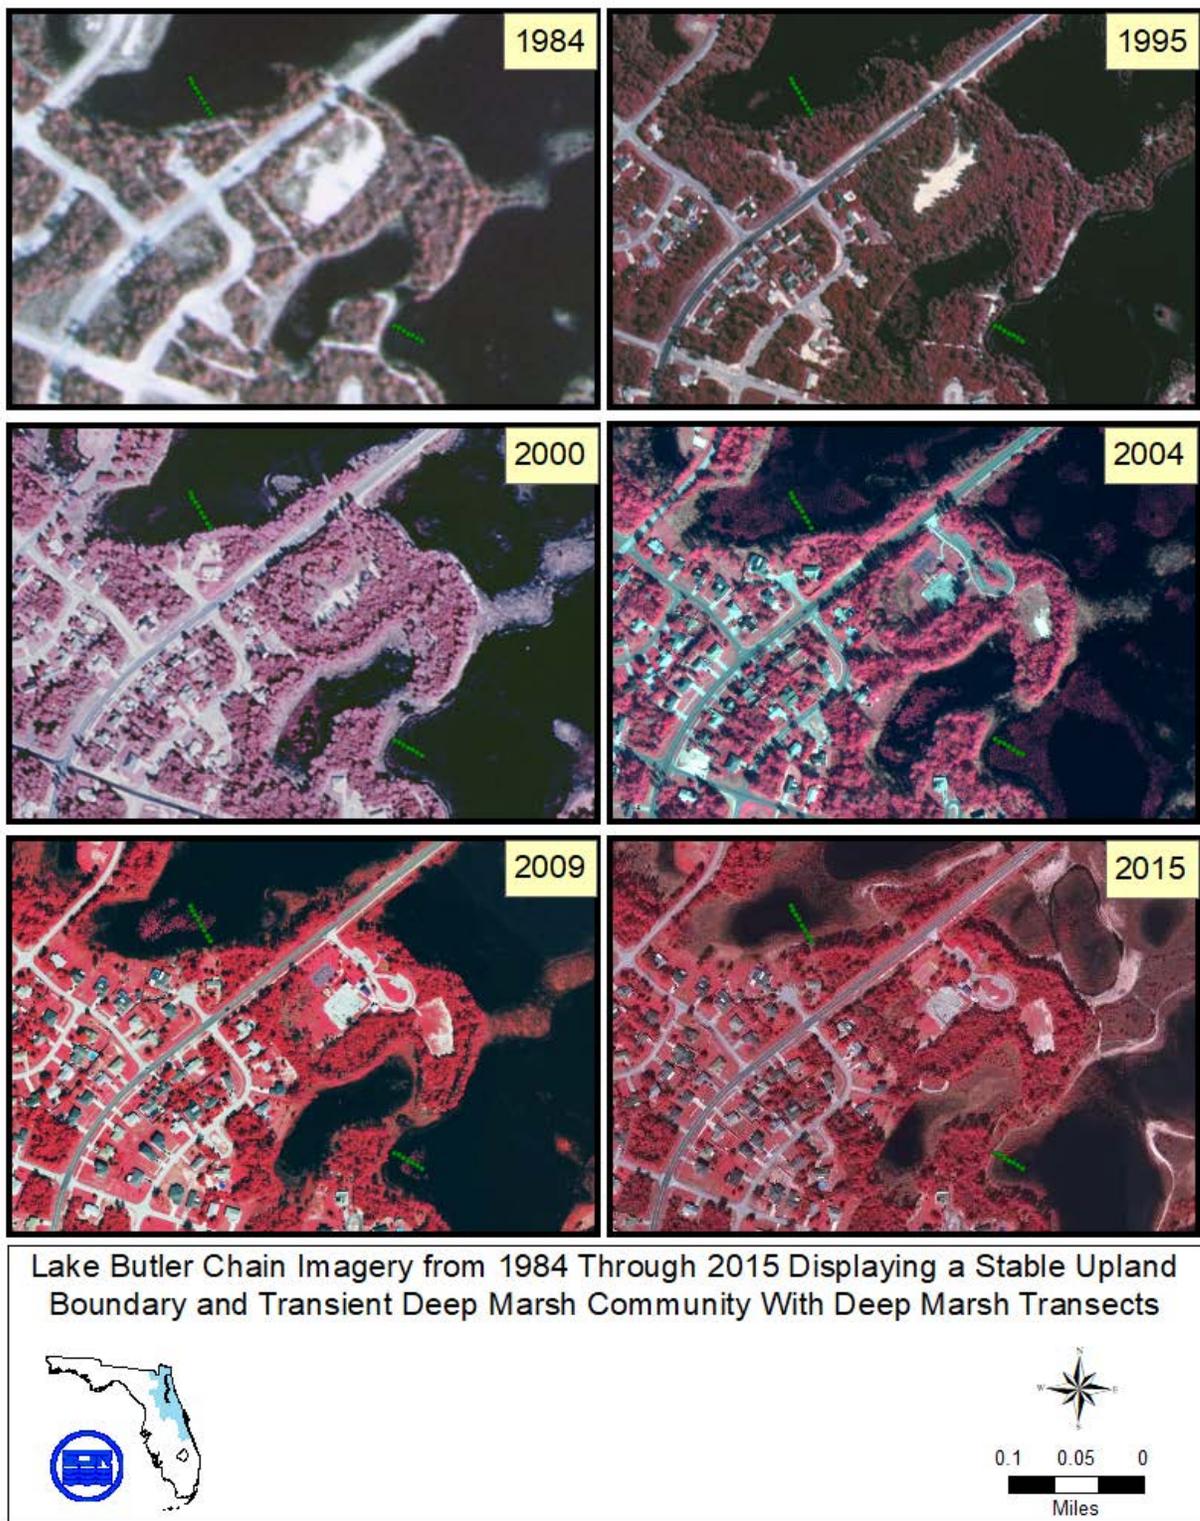
Figure 4. Location of Lake Butler 2009 MFLs Transects and deep marsh cross-sections overlaid on infrared digital orthophotographs to illustrate the differences in the extent of deep marsh from 1984 through 2015

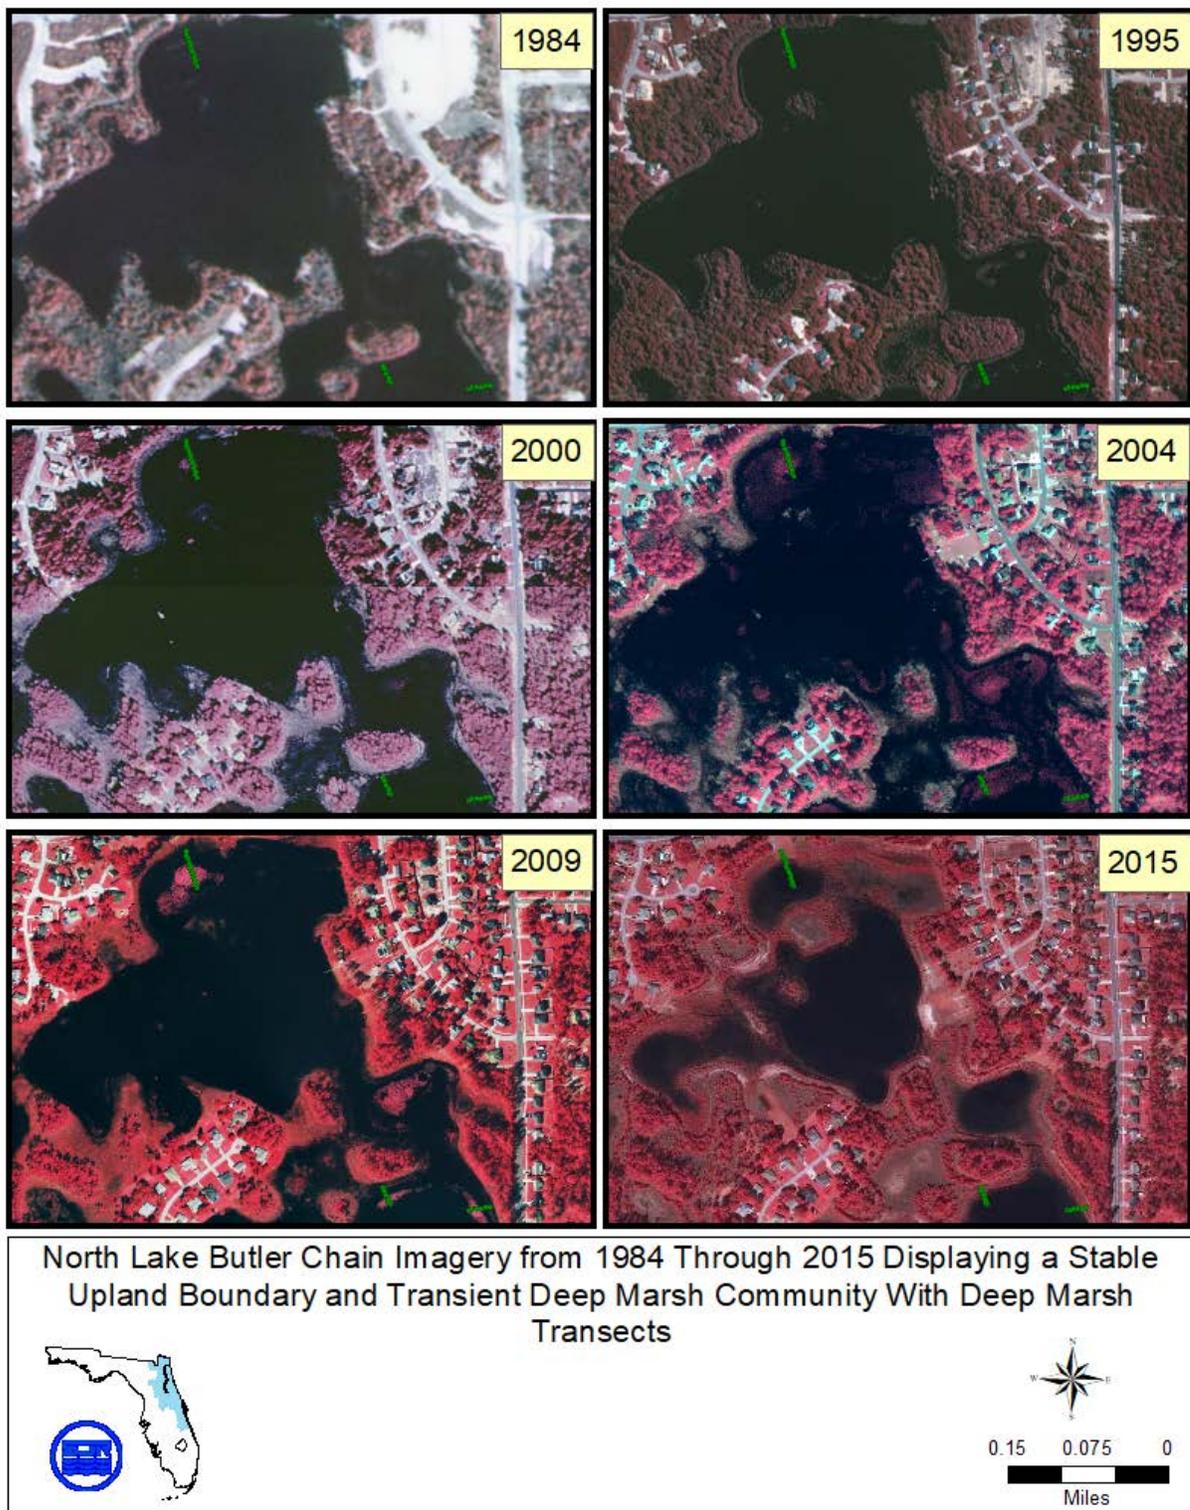
Figure 5. Location of more Lake Butler 2009 MFLs Transects and deep marsh cross-sections overlaid on infrared digital orthophotographs to illustrate the differences in the extent of deep marsh from 1984 through 2015

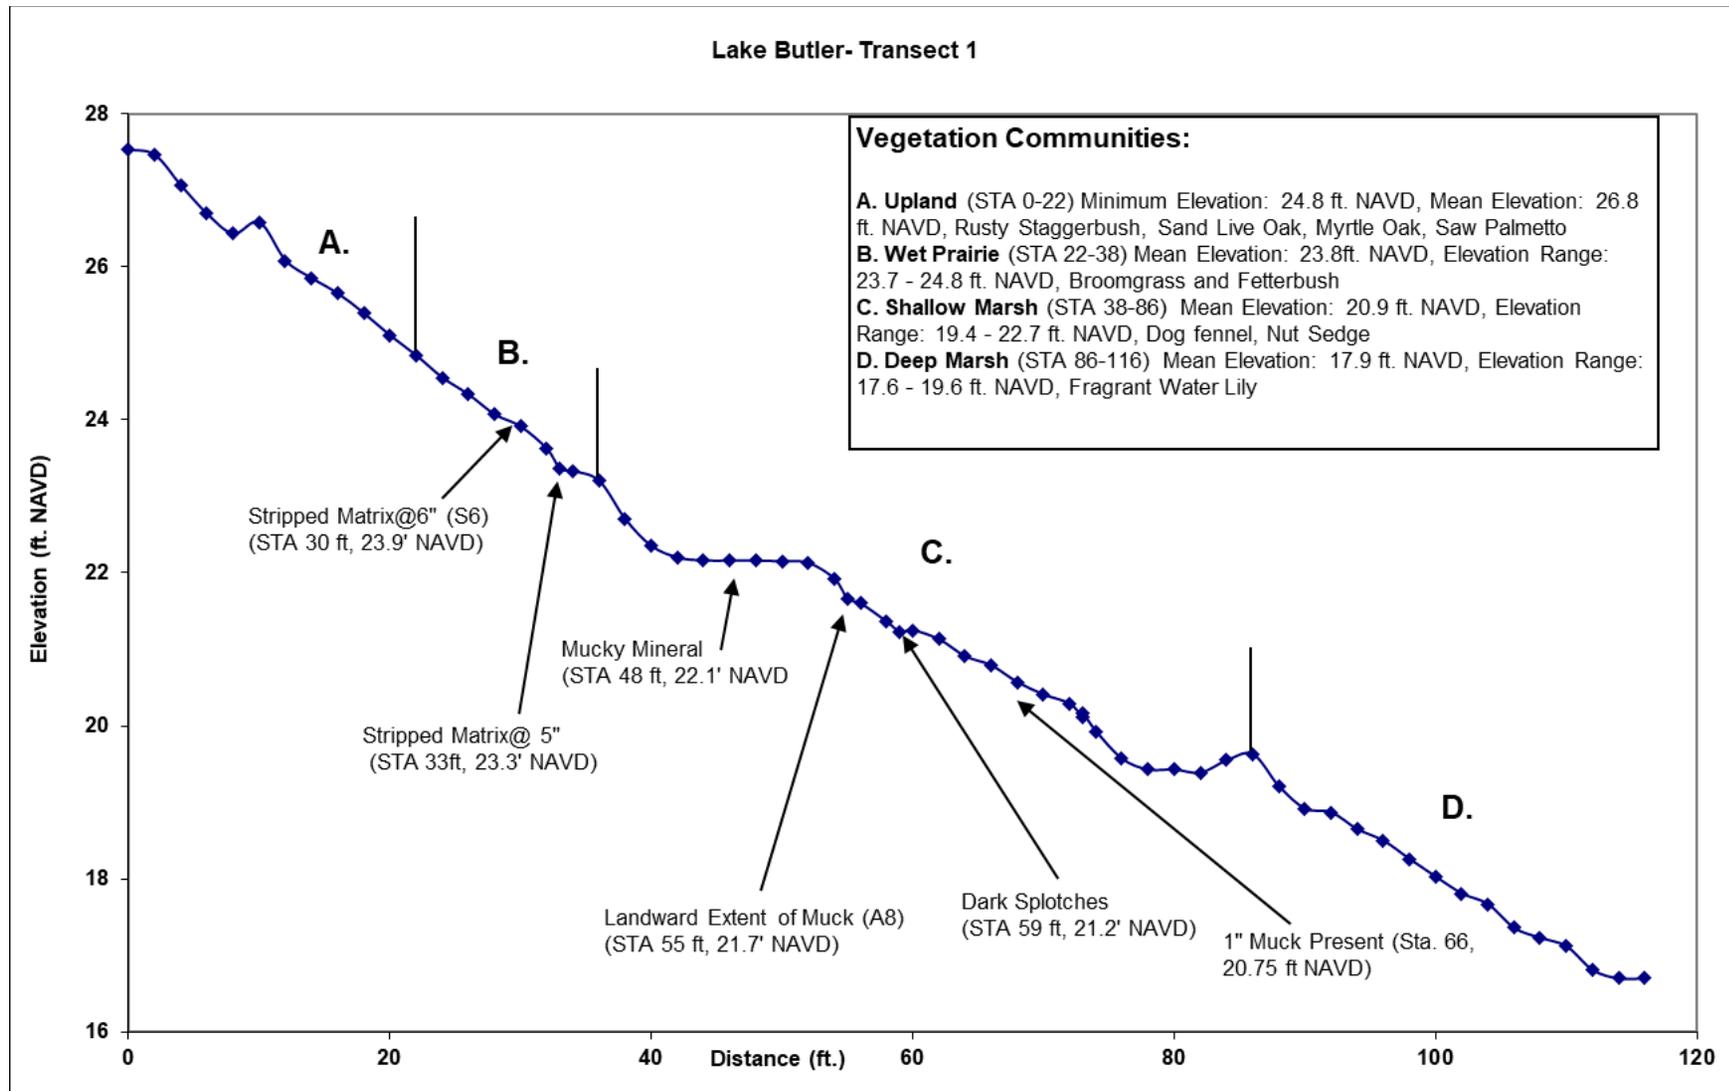
Figure 7. Transect 1 – Relating Soils, Vegetation and Topography in the Lake Butler Chain

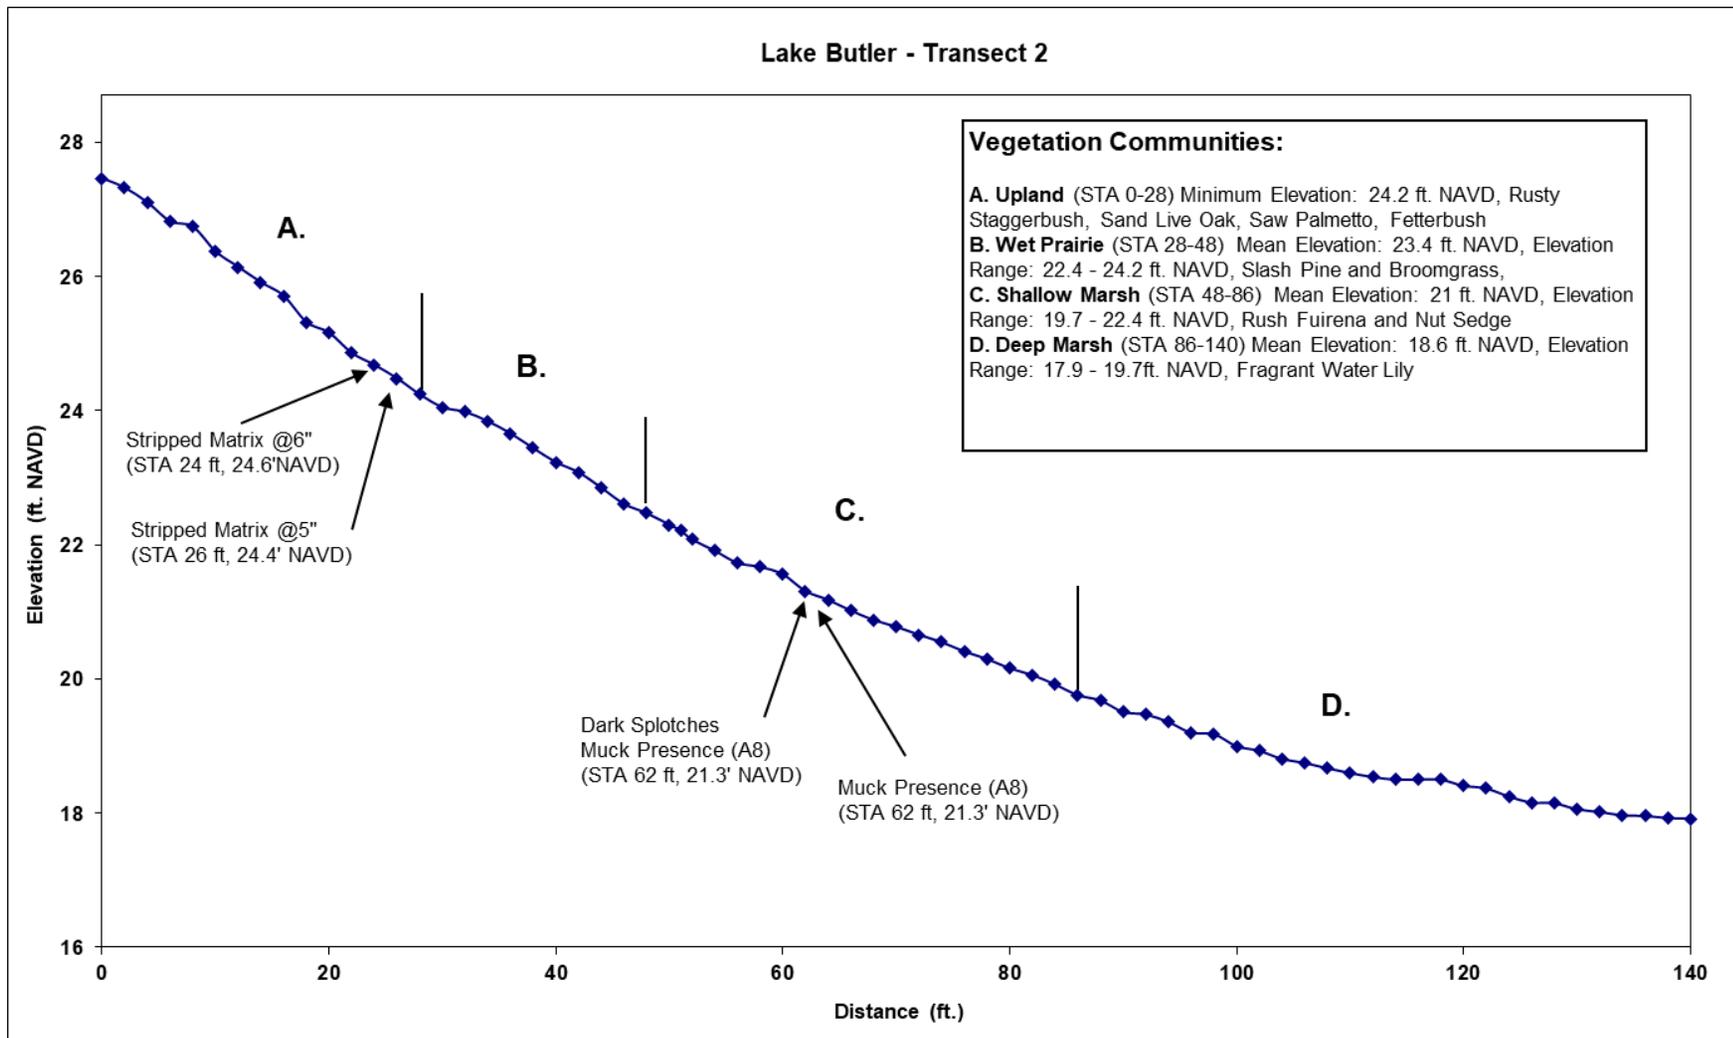
Figure 8. Transect 2 – Relating Soils, Vegetation and Topography in the Lake Butler Chain

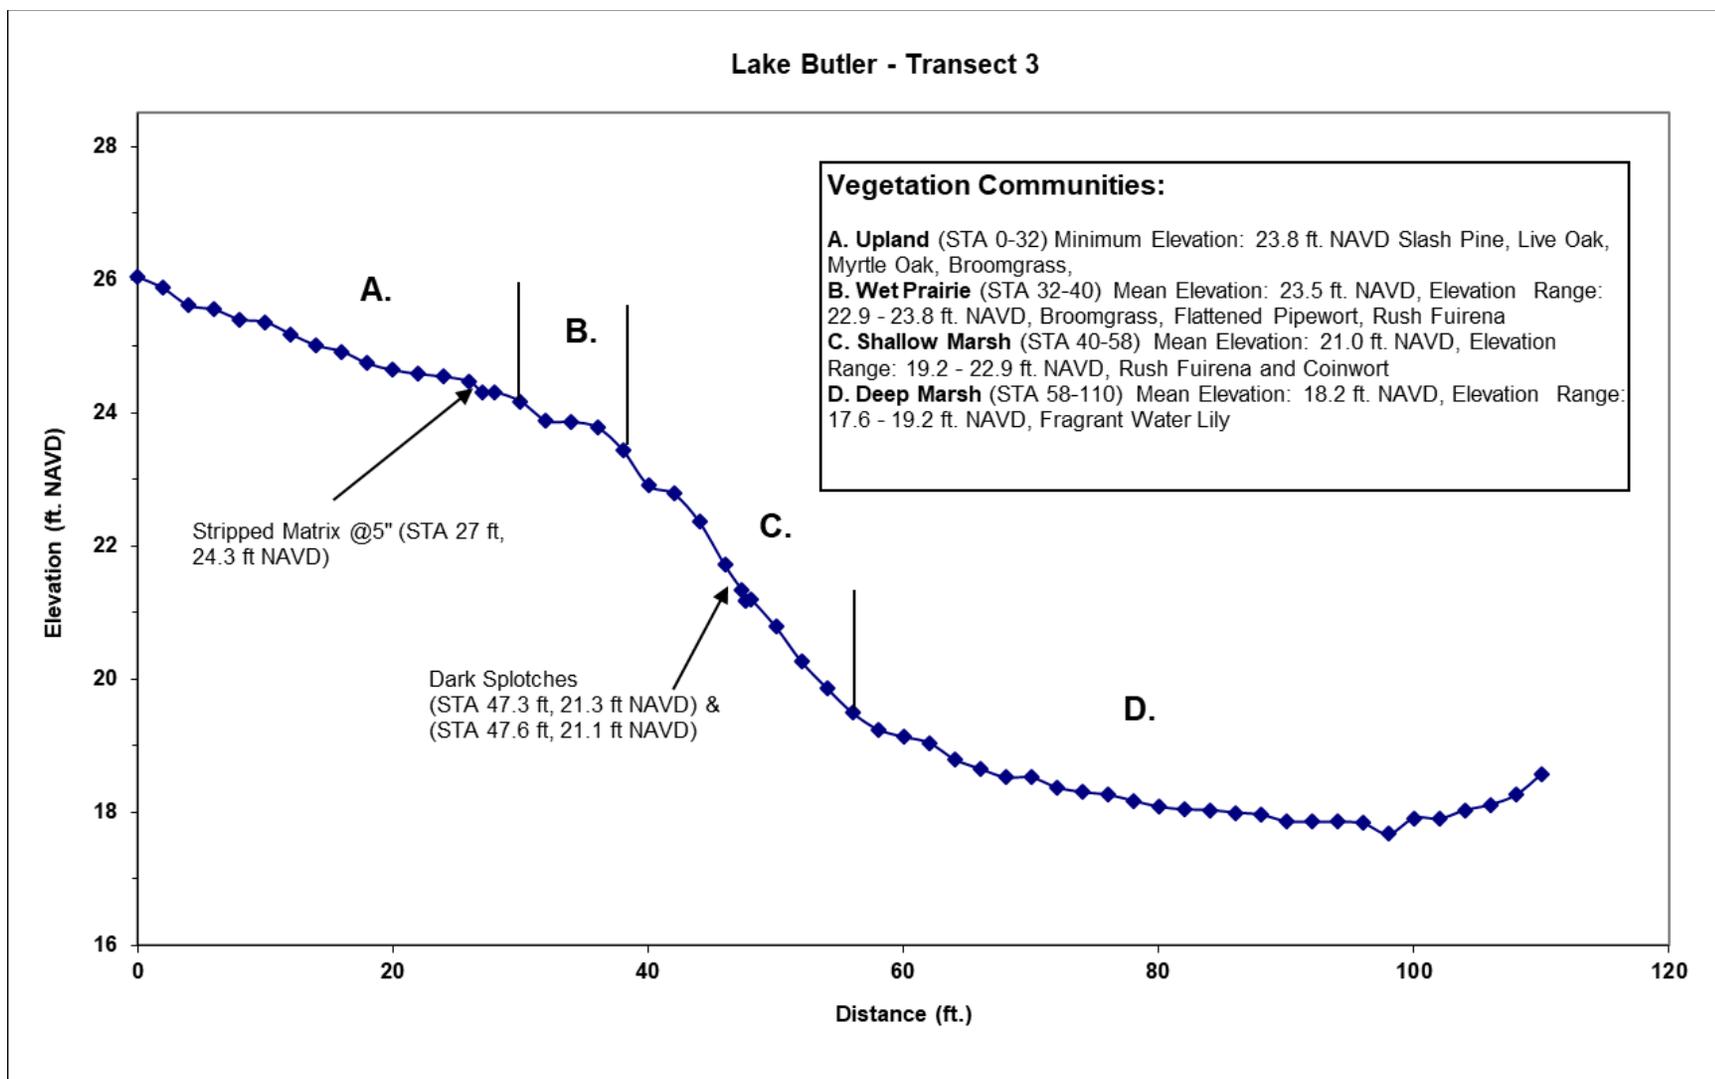
Figure 9. Transect 3 – Relating Soils, Vegetation and Topography in the Lake Butler Chain

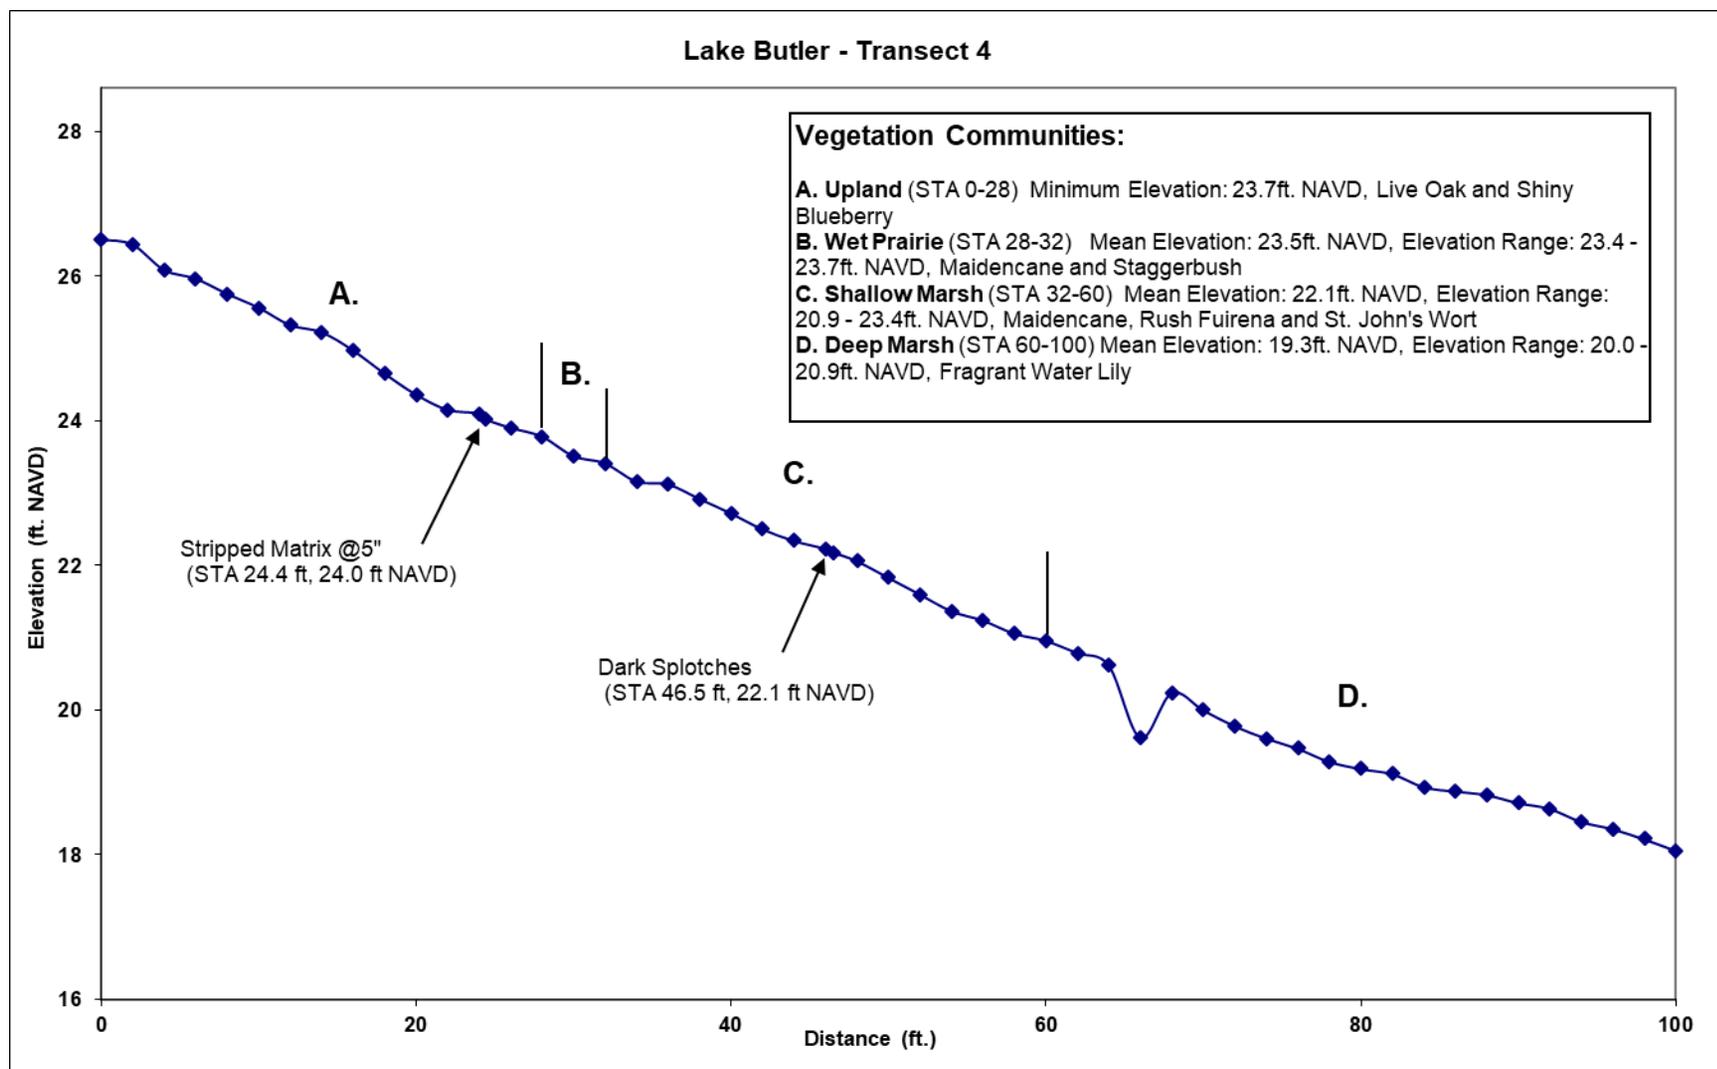
Figure 10. Transect 4 – Relating Soils, Vegetation and Topography in the Lake Butler Chain

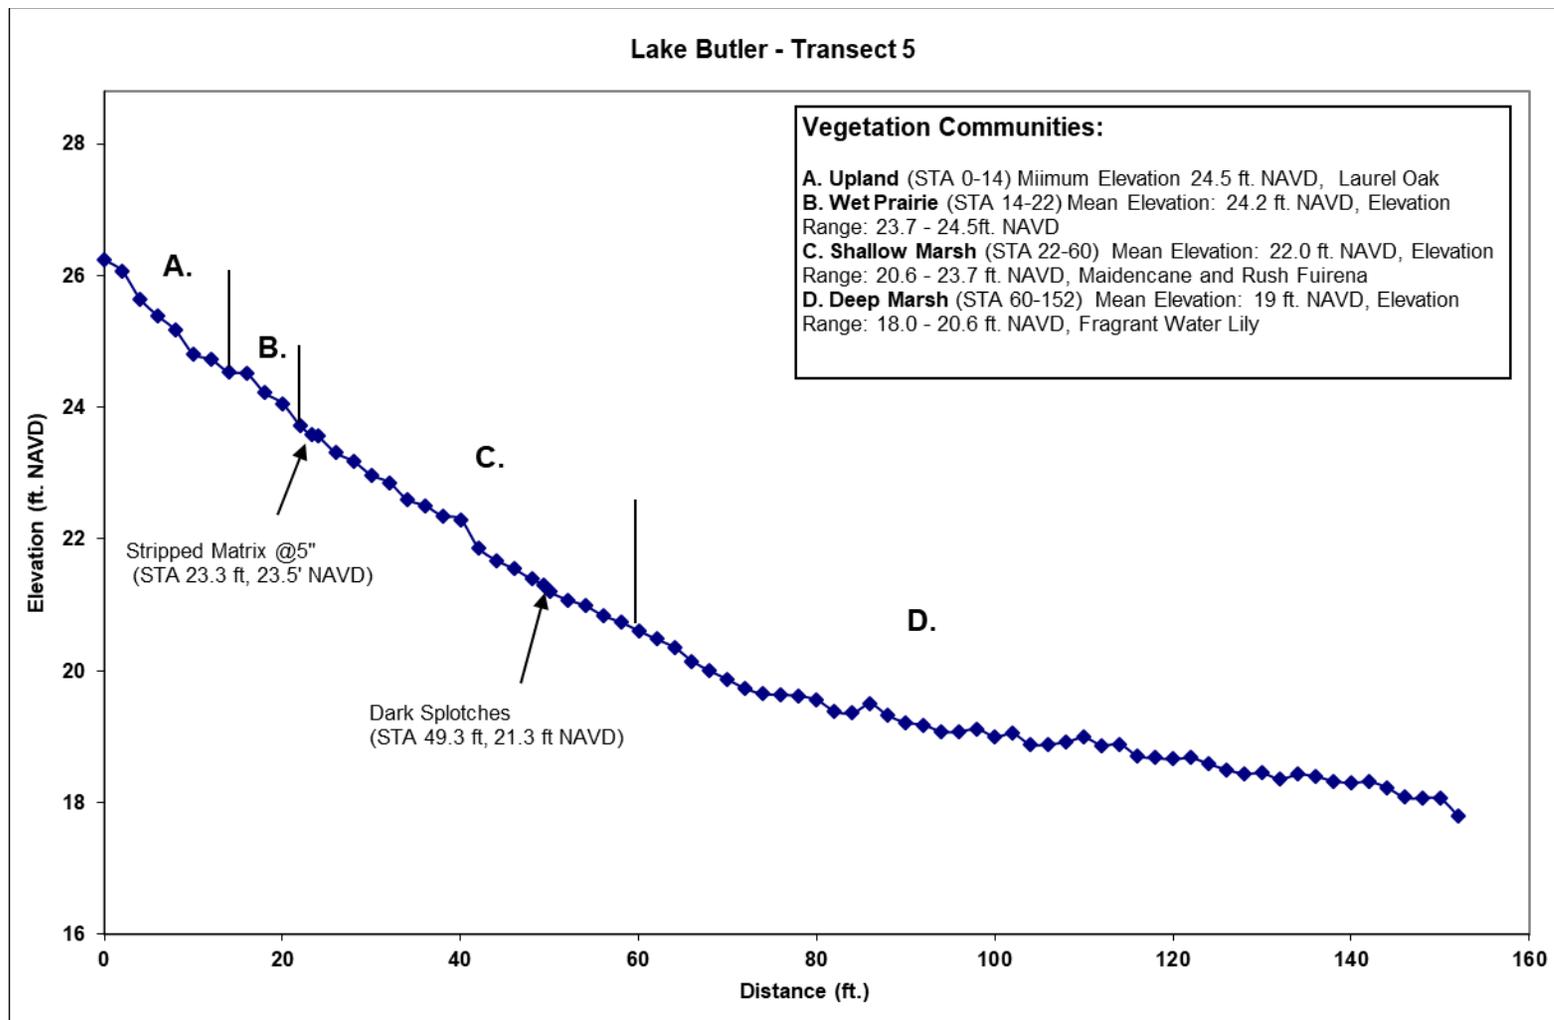
Figure 11. Transect 5 – Relating Soils, Vegetation and Topography in the Lake Butler Chain

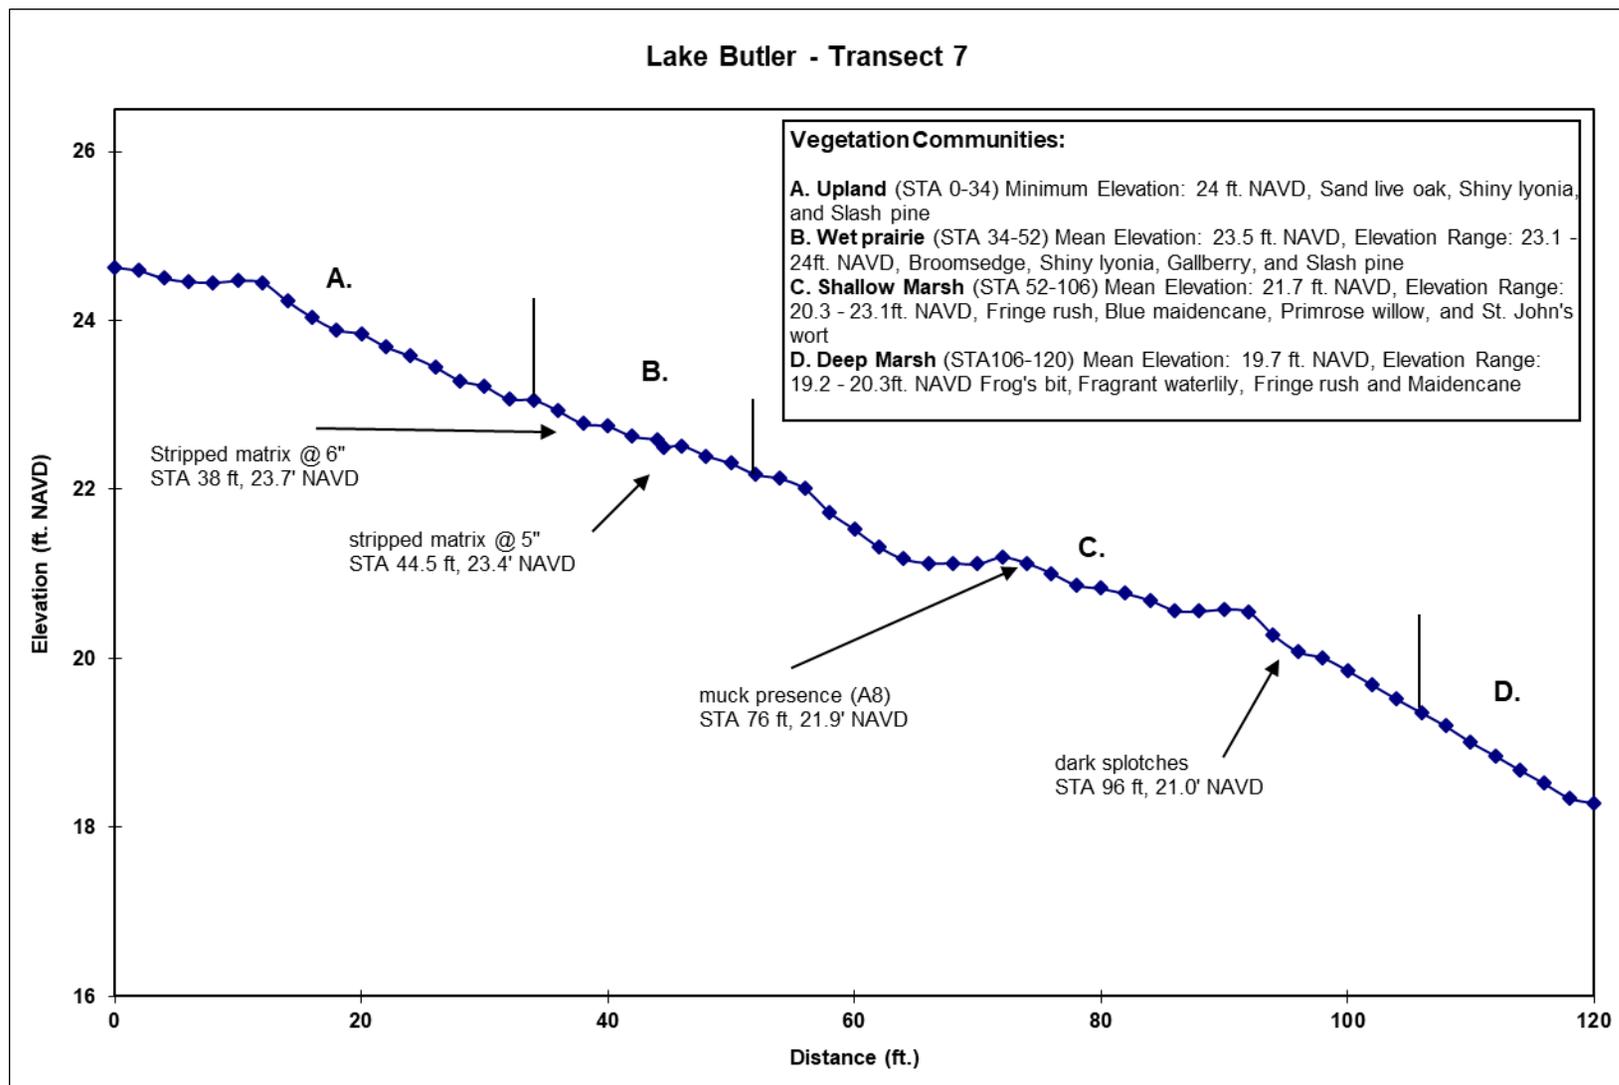
Figure 13. Transect 7 – Relating Soils, Vegetation and Topography in the Lake Butler Chain

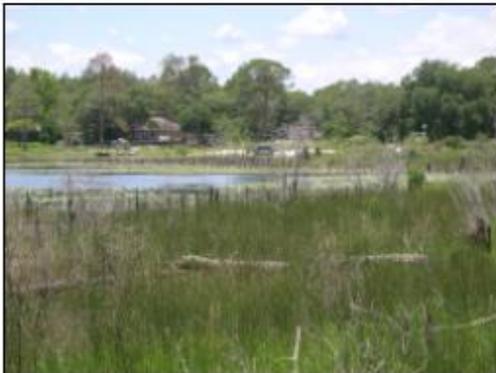
5. Drainage Structure (to Lake Bethel)

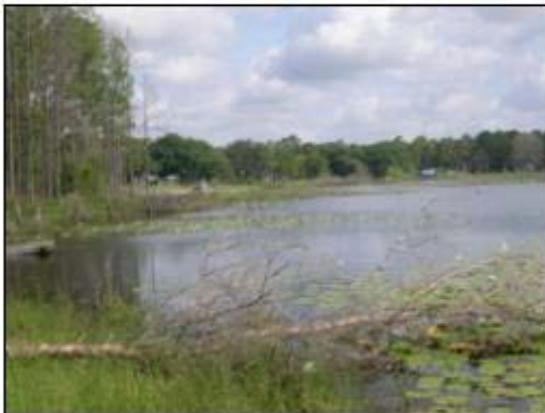
3. Drainage Structure
