Updates Regarding the Implementation of the Recommendations from the *2005 Little Wekiva Watershed Management Plan*

December 2021

Little Wekiva River

Geomorphic Observations and Sedimentation Analysis

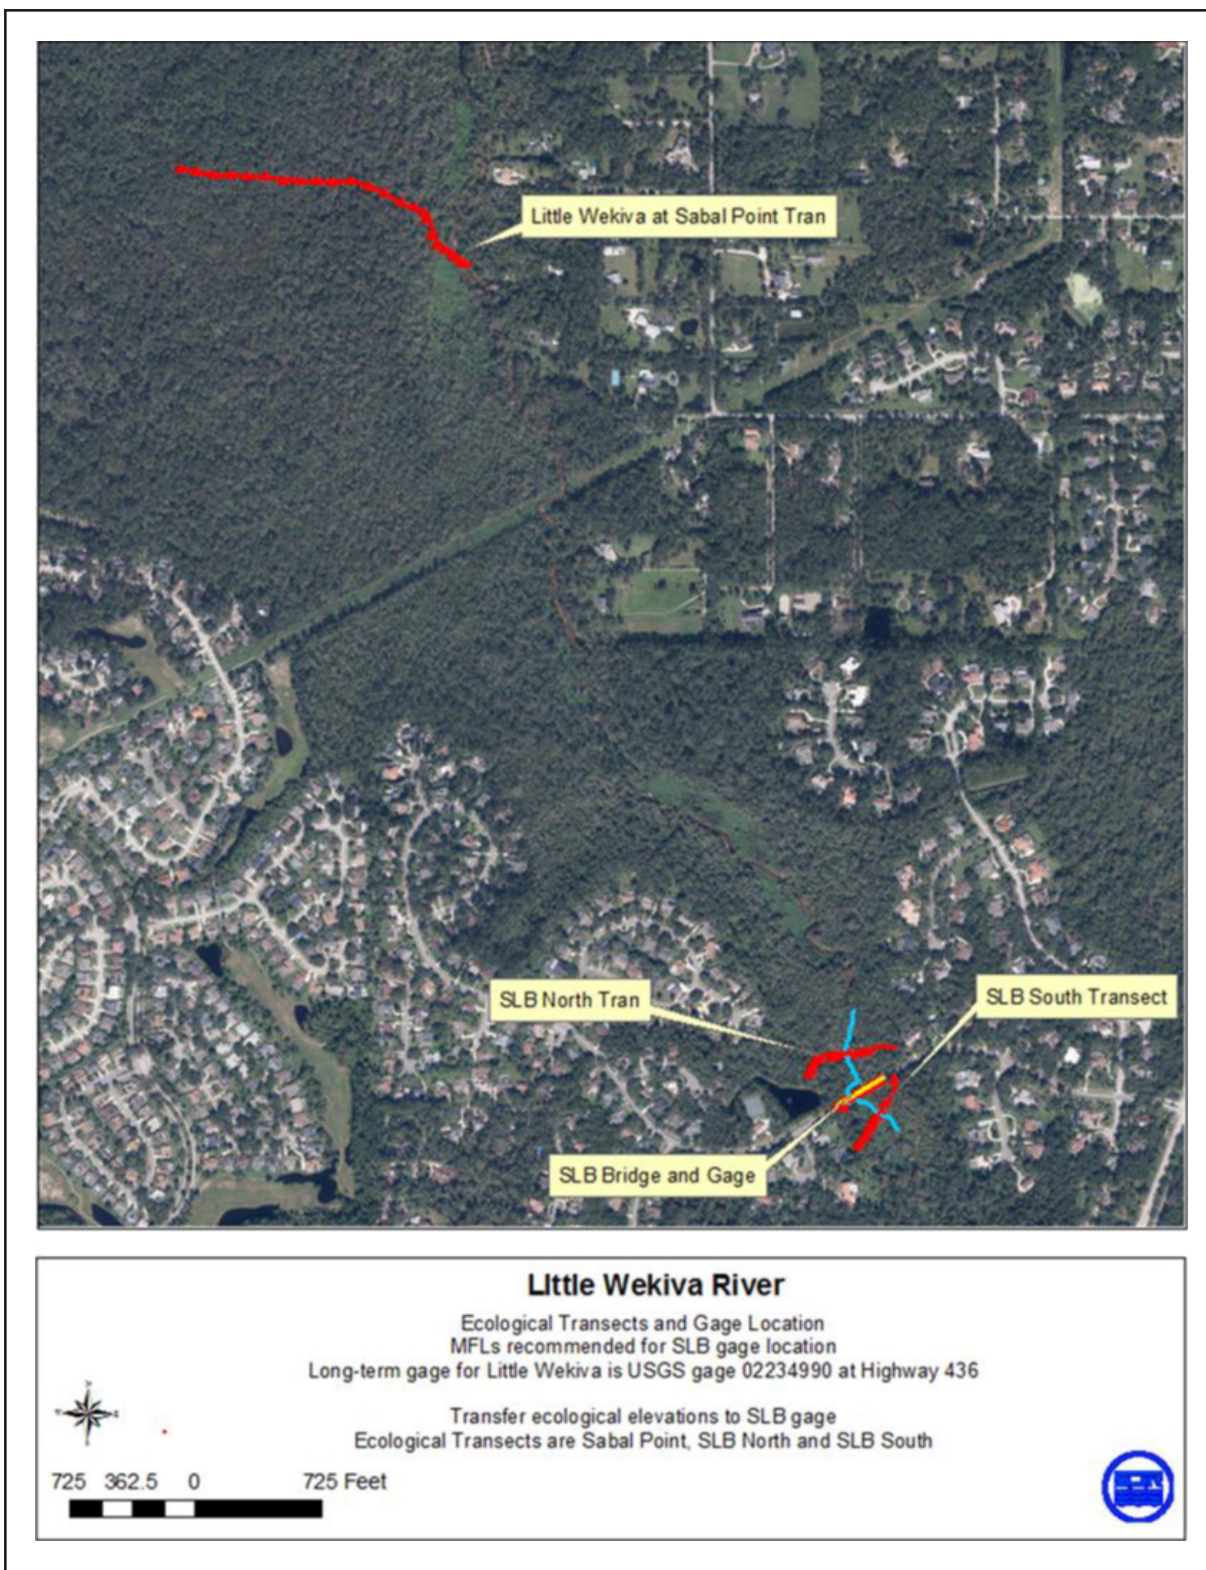
Figure A1-1. SJRWMD Little Wekiva River MFL transects north of S.R. 434.

SJRWMD minimum flows and levels (MFL) field work corroborates these findings. Two transect sites north of S.R. 434 demonstrate sediment accumulation over time (Appendix A, Figure A1-1). The northern Sabal Point transect showed significant sediment accrual between 2013 and 2021 (Appendix A, Figure A1-2), which appeared to displace the main channel to the west from its historical footprint. However, historical imagery suggests that this area has potentially captured sediments in the past and can have dynamic channel migration (Appendix A, Figures A1-3 and A1-4). The southern Springs Landing Blvd. site also appeared to have net sediment accruals of 0.5–1.0 feet from 2017–2021 (Appendix A, Figure A1-5).

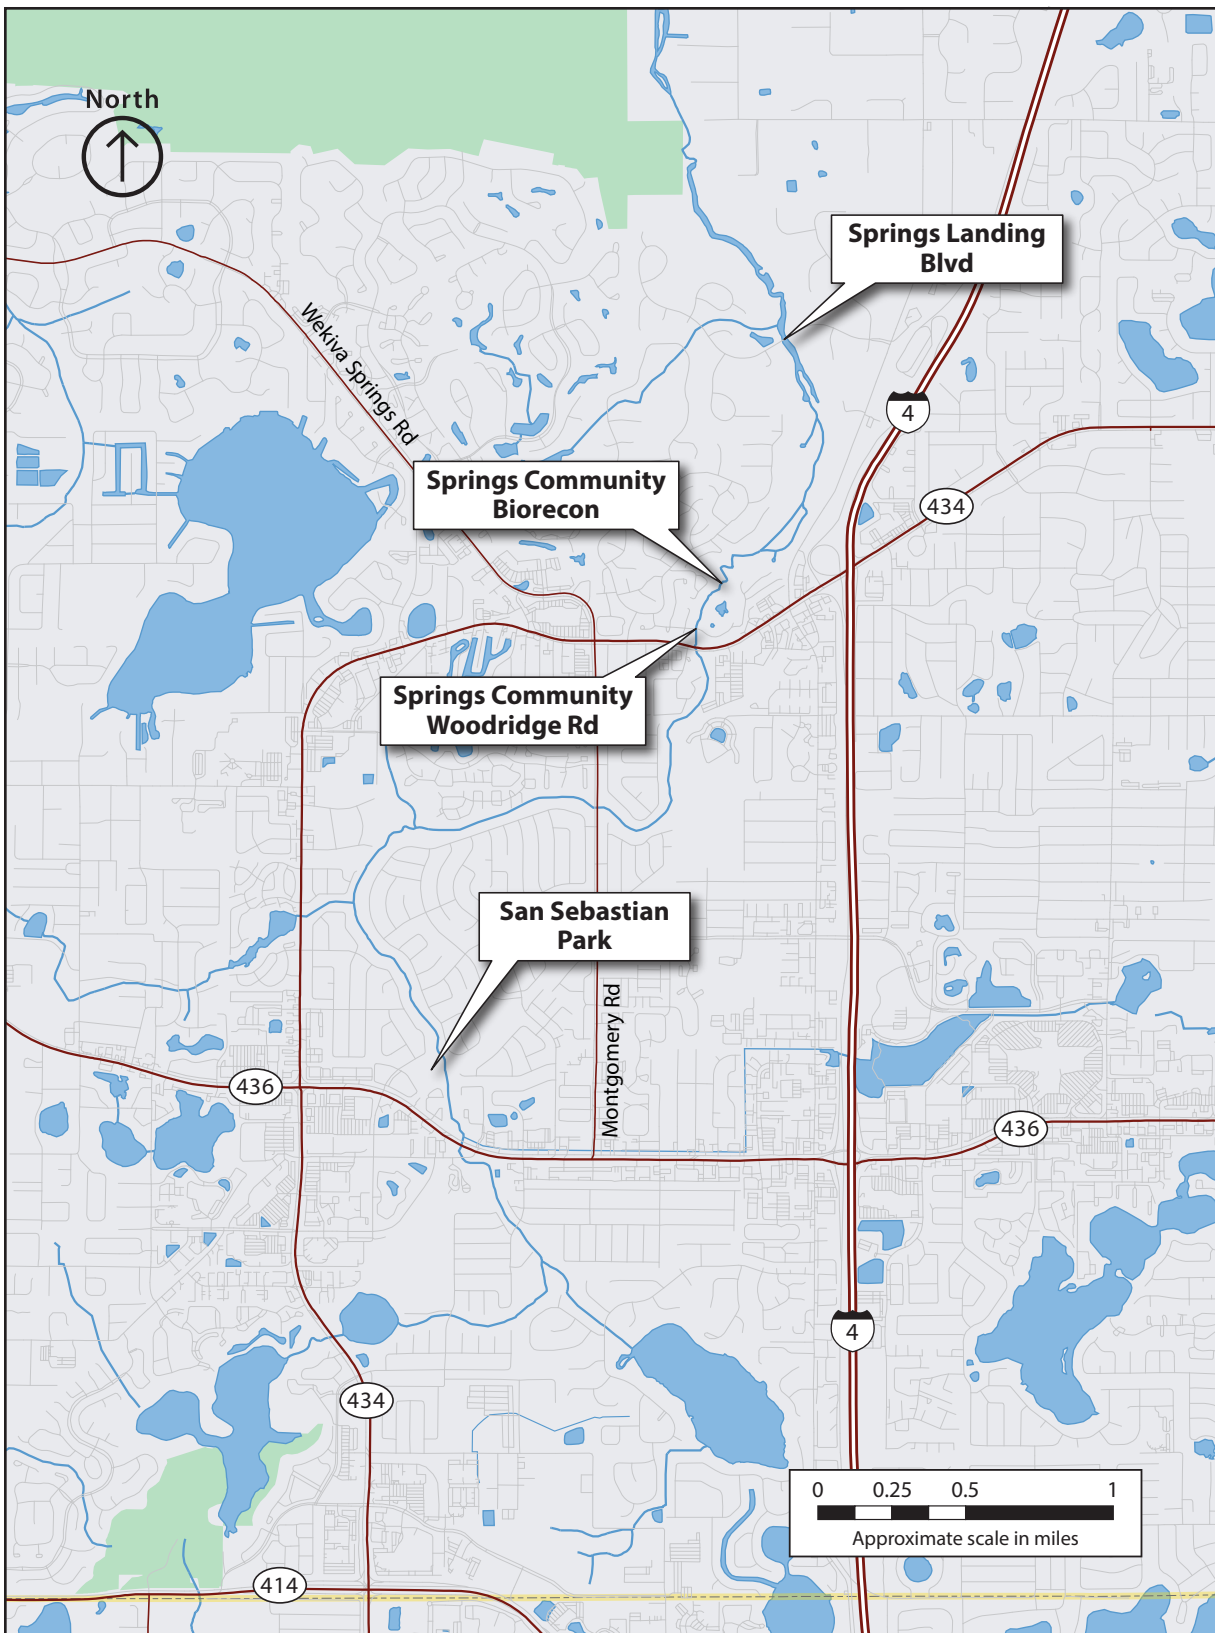
Figure A1-6. Documentation of FDEP Biorecon of the Little Wekiva

Documentation of FDEP Biorecon of the river and a map of the sites visited in fall 2020 are shown in Appendix A, Figure A1-6 on pages 38–44.

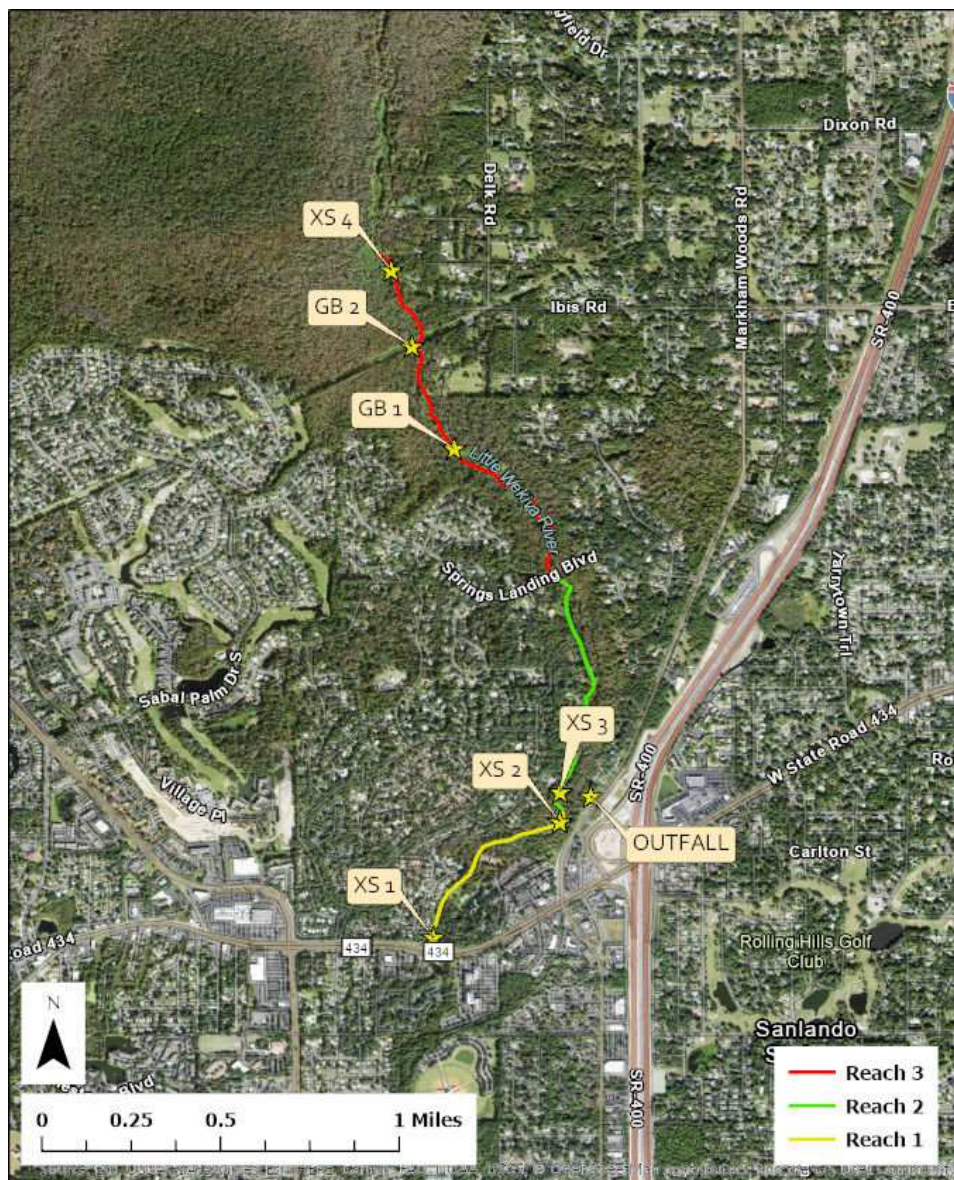
Figure 2: Study reaches shown with callouts for cross sections, grade breaks (GB), and outfall locations.

Reach 2 is located between the outfall location and the crossing of Springs Landing Boulevard as shown in Figure 2. The river here is sinuous with more variable bankfull width throughout the reach. The floodplains consist of suburban developments with a moderate riparian buffer zone. The floodplain vegetation along the reach varies from forested to grass and heavy shrubs, transitioning into wetland species with in-channel plant growth along the lower portions of the reach (Figure 5 a&b). No strong evidence of vertical incision was noted. As a result, the reach has more floodplain connectivity than reach 1. Lateral instabilities were noted in the form of downed and leaning trees throughout the reach (Figure 5c). Sediment size remains consistent with Reach 1, medium to fine grained sands, and was confirmed through a visual inspection. Bedforms continue to be dominated by ripple features like Reach 1. While minor sedimentation throughout the reach was witnessed, it was mainly concentrated along the insides of bends and localized low velocity areas.

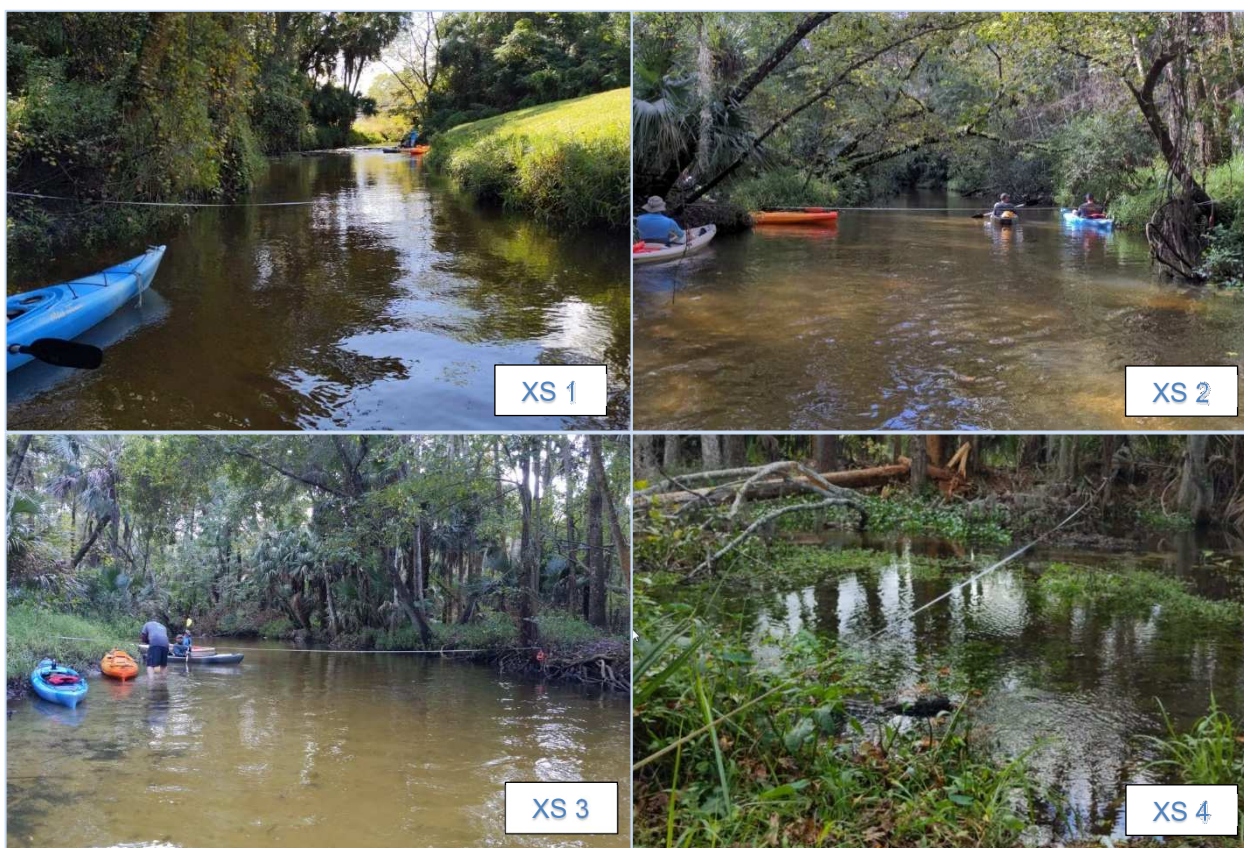
Figure 7: Photos of each cross section.

To help identify stream characteristics several types of data were collected, including cross sections, relative elevations, flow velocities, and channel slope. Four river transects, or cross sections, were collected in the field, their locations are highlighted in Figure 2. It should be noted that the overbanks were not included in the transects due to private property access and safety concerns. Photos of the cross sections are presented in Figure 7. The cross sections are plotted below in Figure 8-Figure 11. Based on bankfull field indicators, flow was assumed to be at bankfull height at the time of the measurements. In addition to the cross-section measurements, surface water velocities, floodplain width, and channel slopes were estimated. Surface velocities were measured in the field using a timed float method. The floodplain widths were obtained from the 100-year water surface bounds obtained from the effective FEMA mapping. Channel slopes were calculated from 2005 LiDAR obtained from NOAA and are presented in Figure 12. Tabulated in stream characteristics are presented Table 1.

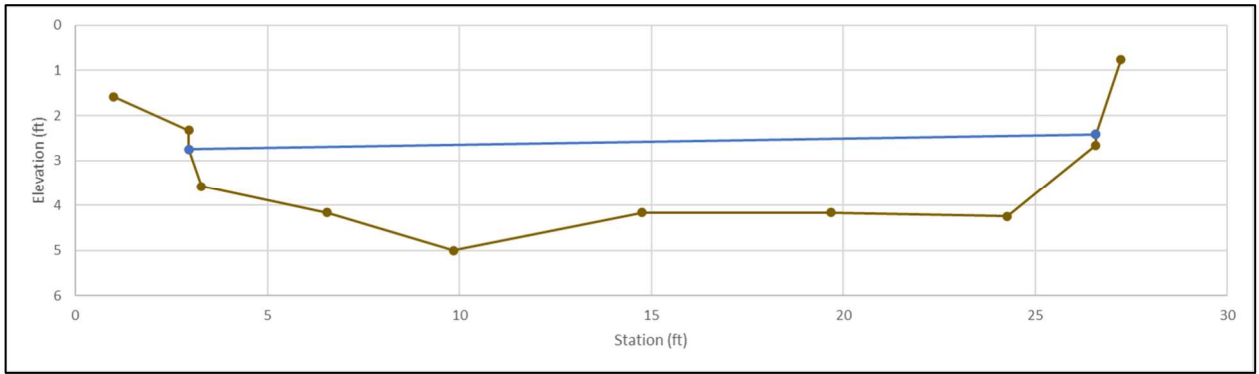
Figure 8: XS 1, the brown line represents ground points, the blue line represents the water surface.

Cross sections 1, 2, and 3 showed similar width to depth ratios and were all in the range of 12-20 which can all be classified as moderate (NEH, 2007). XS 4 width to depth ratio exceeded 60 which can be classified as very high. The entrenchment ratio, which is the measure of how vertically contained a river is (NEH, 2007), was the lowest at XS 1. XS 1, 2, and 3 entrenchment ratios can all be classified as slightly entrenched. XS 4 is not entrenched, and the entrenchment ratio value suggests a multiple thread channel. Surface velocities were virtually identical for XS 1, 2, and 3. The velocity at XS 4 was considerably slower at 0.3 ft/s.

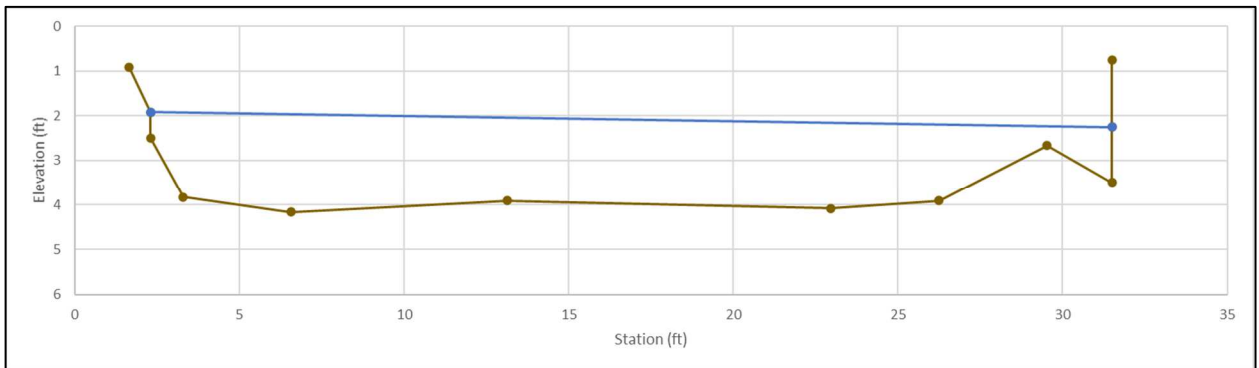
Figure 9: XS 2 plotted, the brown line represents ground points, the blue line represents the water surface.

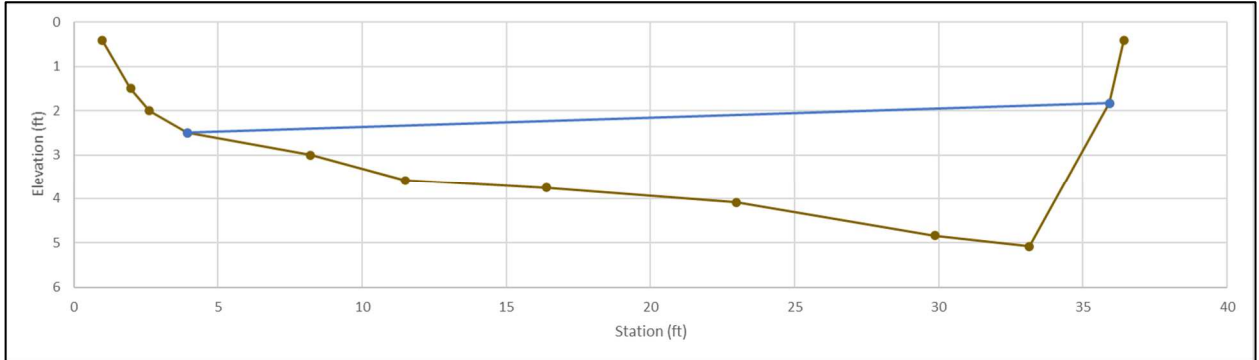
Figure 10: XS 3 plotted, the brown line represents ground points, the blue line represents the water surface.

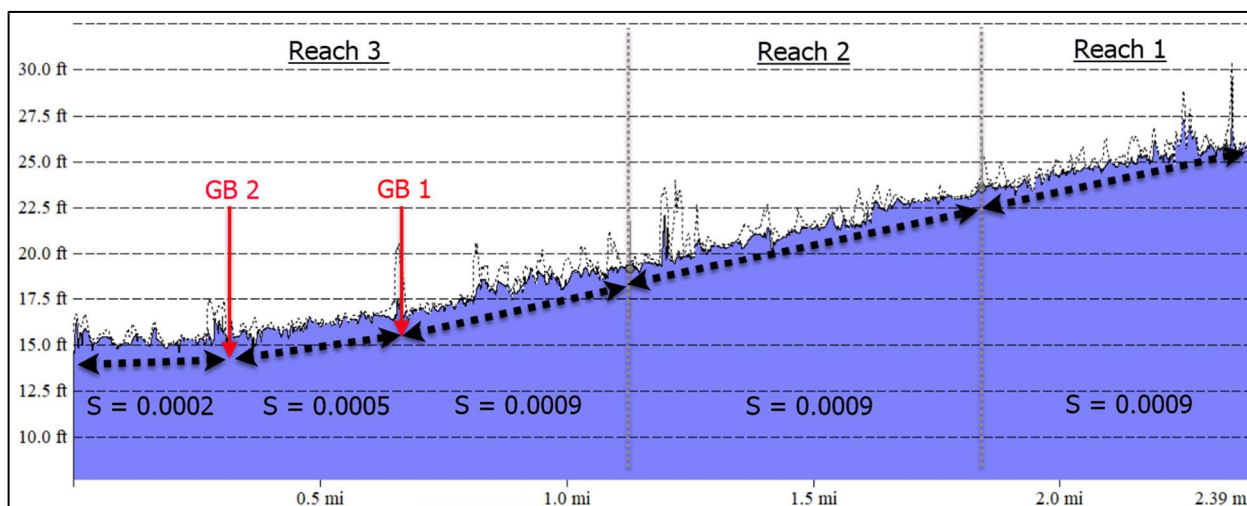
Figure 12: Slope calculations shown in relation to reach locations

Slope measurements were completed using 2005 LiDAR data obtained from NOAA and are shown below in Figure 12. Some changes in elevations may have occurred since then however, the locations of the grade breaks generally matched what was observed in the field. The overall slope was constant until the first noted grade break in reach 3 and was measured to be 0.06° or 0.0009 ft/ft. Between grade break 1 and 2 the slope was measured at 0.03° or 0.0005 ft/ft. Downstream of grade break 3 the slope was measured at 0.01° or 0.0002 ft/ft. The locations of the grade breaks are shown in Figure 2 and seem to coincide with the increase in floodplain width.
