TECHNICAL PUBLICATION SJ 80-7
RESULTS OF TEST DRILLING
AND MATERIALS INVESTIGATION
OF BORROW AREAS

Water Resources Department
St. Johns River Water Management District
Palatka, Florida
July 1980

SUBJECT: Results of Test Drilling and Materials
Investigation of Borrow Areas
Project No. 2002319

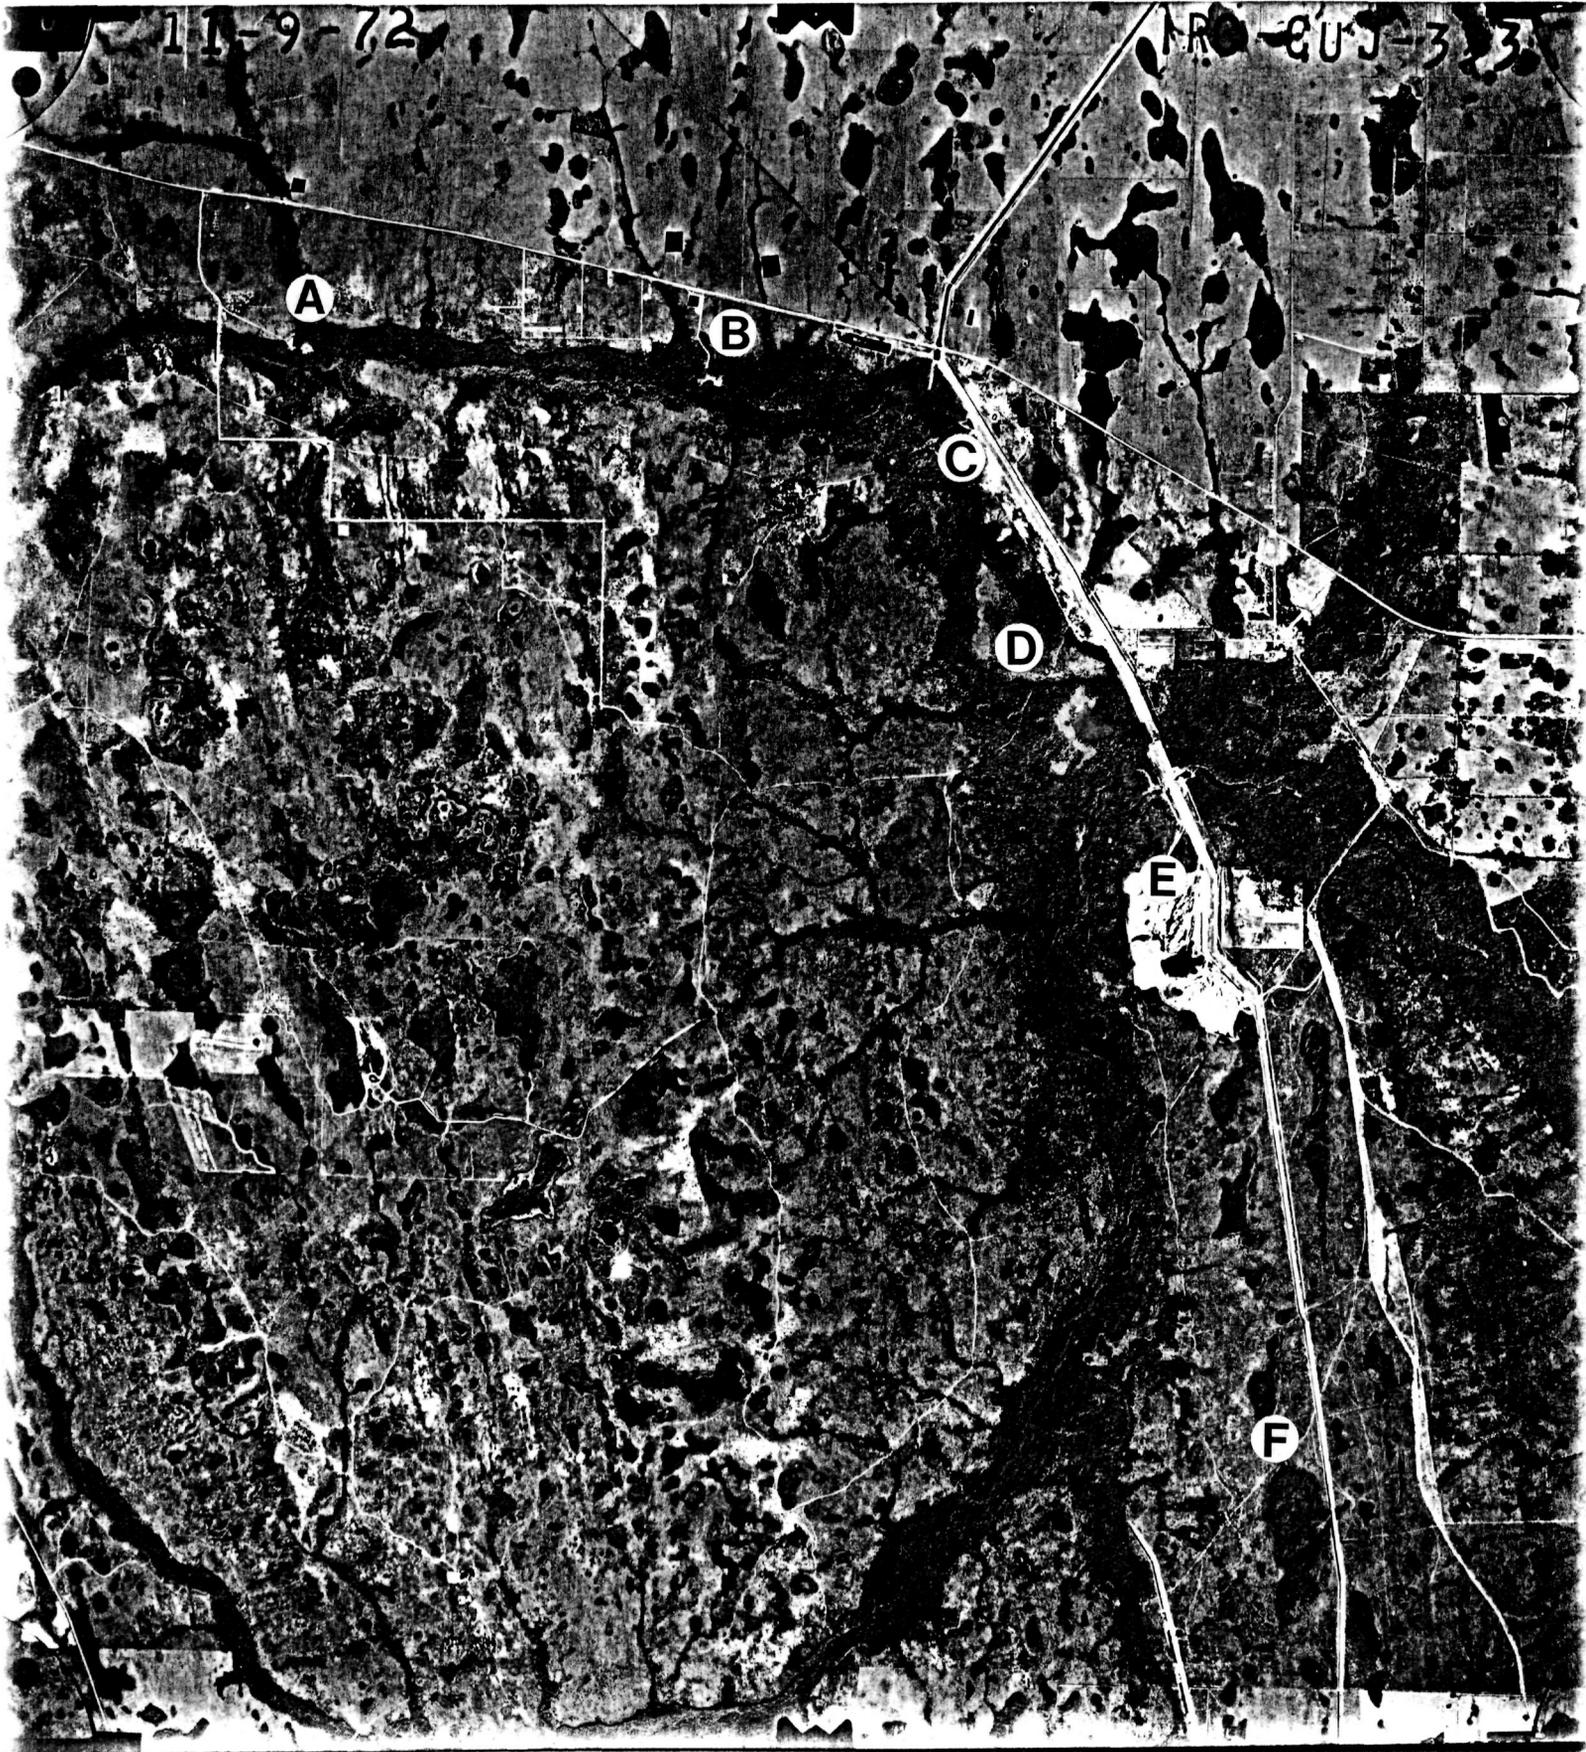
FIGURE 2. -- Aerial Photo (1:80,000) of Bull Creek Wildlife Management Area and Locations of Testing Areas (A-F)

Six locations within the Bull Creek Wildlife Management Area, Osceola County, and owned by the District were examined as potential sources of shallow shell deposits (Figure 2). Exploration in Areas A and B represent efforts to quantify future reserves in areas known to have contained usable deposits of shell material. Exploration in Areas C through F was an attempt to find new reserves of recoverable shell in desirable locations with respect to existing roads and levees.
